Earthquake Reconnaissance: Guatemala, February 1976

D.H. Weichert
Division of Seismology & Geothermal Studies
Earth Physics Branch
Department of Energy, Mines & Resources
Ottawa, Ontario K1A 0Y3

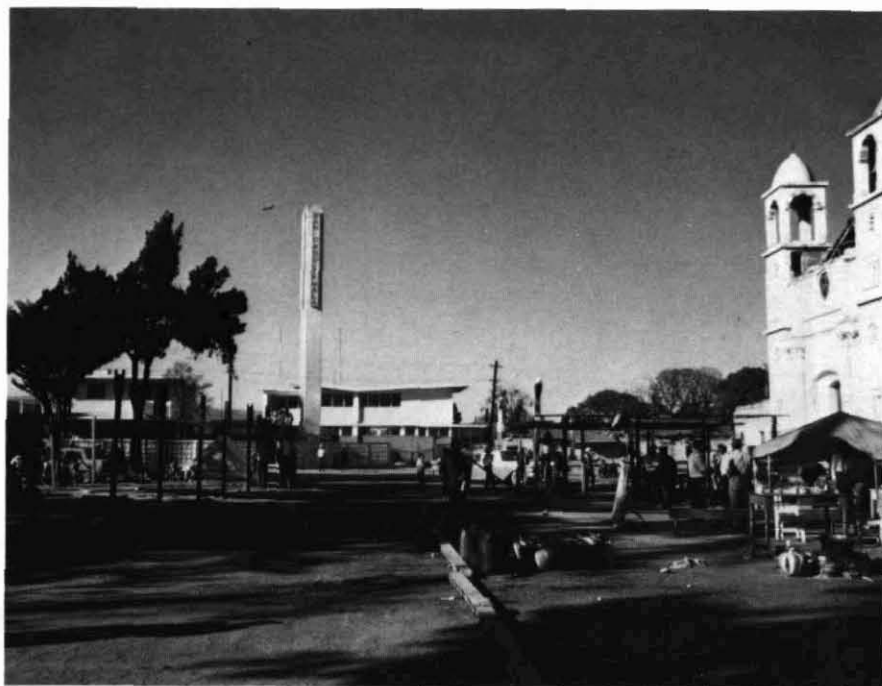
Figure 6
Chimaltenango: modern bank building and decorative brick wall remained standing.

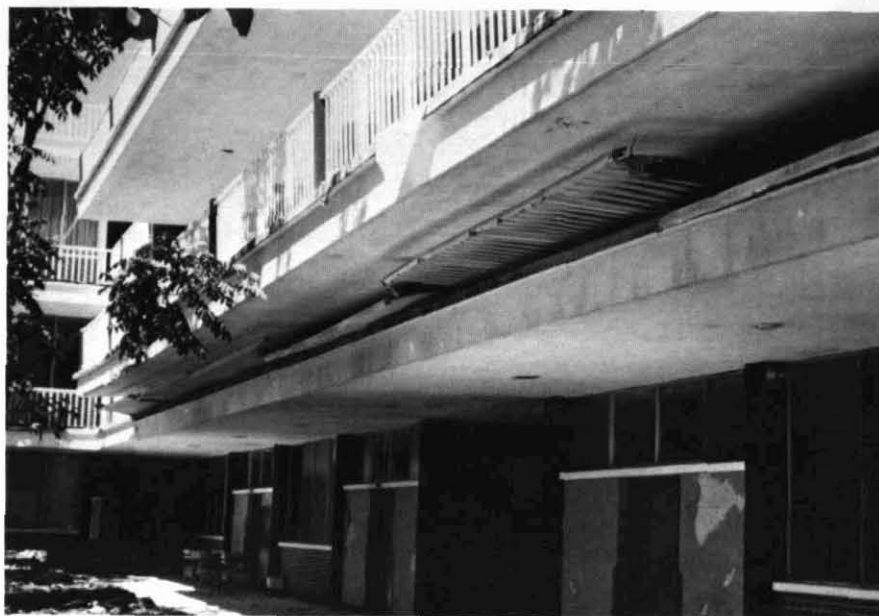
Complete collapse of heavy concrete canopies supported by rather fragile looking reinforced concrete columns was widespread, but not surprising. Collapses of engineered buildings were rare and usually attributable to doubtful design. Figure 7 shows a view of a collapsed second story of a school: it contained no shear walls. Collapse of some columns caused the Terminal Hotel to break in half. At the Camino Real Hotel, an unusual architectural effect was achieved by a supporting X-type outside frame. Here, many of the eastern legs in the ground floor were shattered

Figure 7
Collapsed second floor of a school in southeast Guatemala City, about 30 km from fault.
