## Heritage Stone 3. Degradation Patterns of Stone Used in Historic Buildings in Brazil

A. G. Costa

Volume 43, numéro 1, march 2016

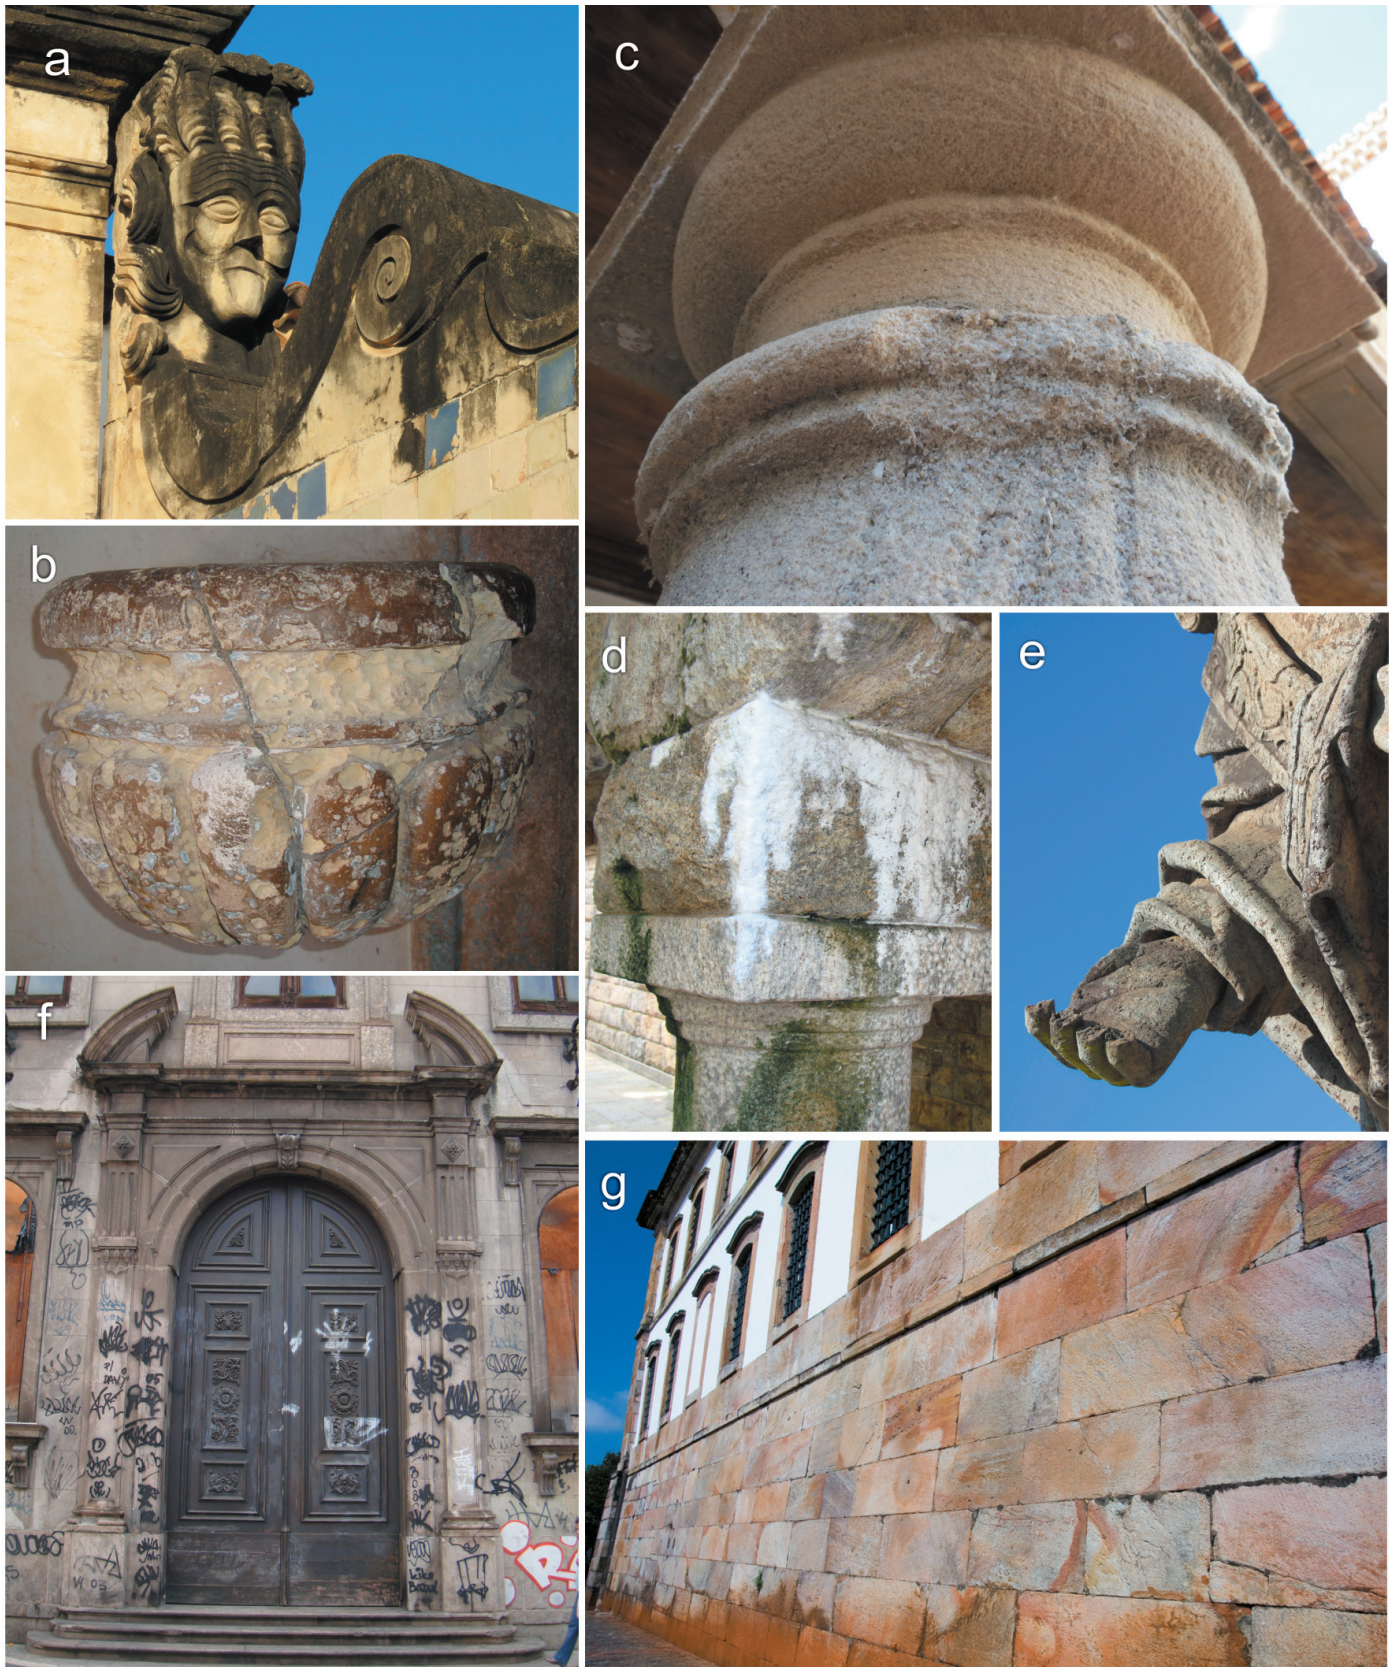
**Figure 3.** Examples of damage that attest to some of the processes responsible for decay or alteration of the stone in some historic monuments built in Brazil. a) Biological colonization and black crust on limestone in the São Francisco's Convent in João Pessoa (state of Paraíba); b) crack and alveolization of limestone in the Church of São Pedro dos Clérigos in Recife (Pernambuco); c) disintegration of calcarenite in São Francisco's Convent in João Pessoa (state of Paraíba); d) encrustation associated with gneiss in the Palacete Laje in Rio de Janeiro (state of Rio de Janeiro); e) missing part on one of the prophet statues at the Bom Jesus Sanctuary of Congonhas (state of Minas Gerais); f) graffiti on the Church of Santíssimo Sacramento in Rio de Janeiro (state of Rio de Janeiro); g) patina formed on quartzite in the old Chamber and Prison House in Ouro Preto (state of Minas Gerais).

cavities or alveoli formed on the rock surface have also been observed. Other degradation patterns were noted, such as fragmentation of the stone surface, blistering, presence of crusts associated with deposits of soot and dust (representing the accumulation of both foreign material and that produced by the rock itself), changes in colour, efflorescence, sub-efflorescence, encrustations interfering with surface morphology and with the colouration of the rocks involved, patinas, graffiti, and varying degrees of biological colonization by mold, lichen, algae and plants.

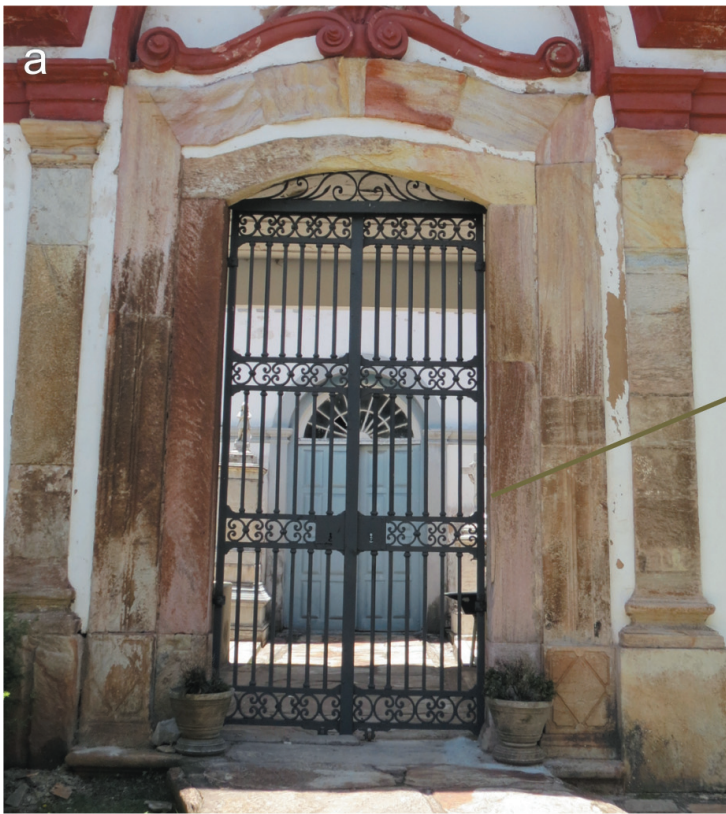
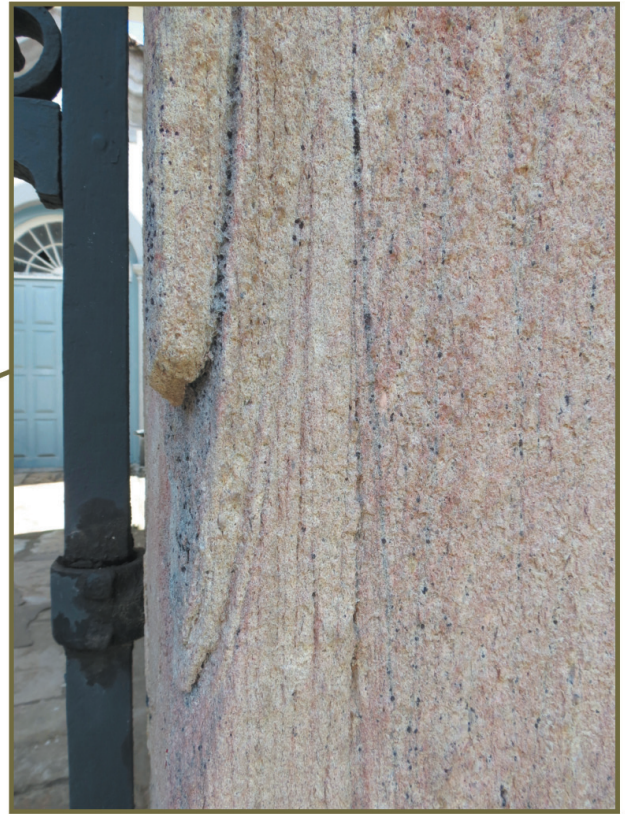
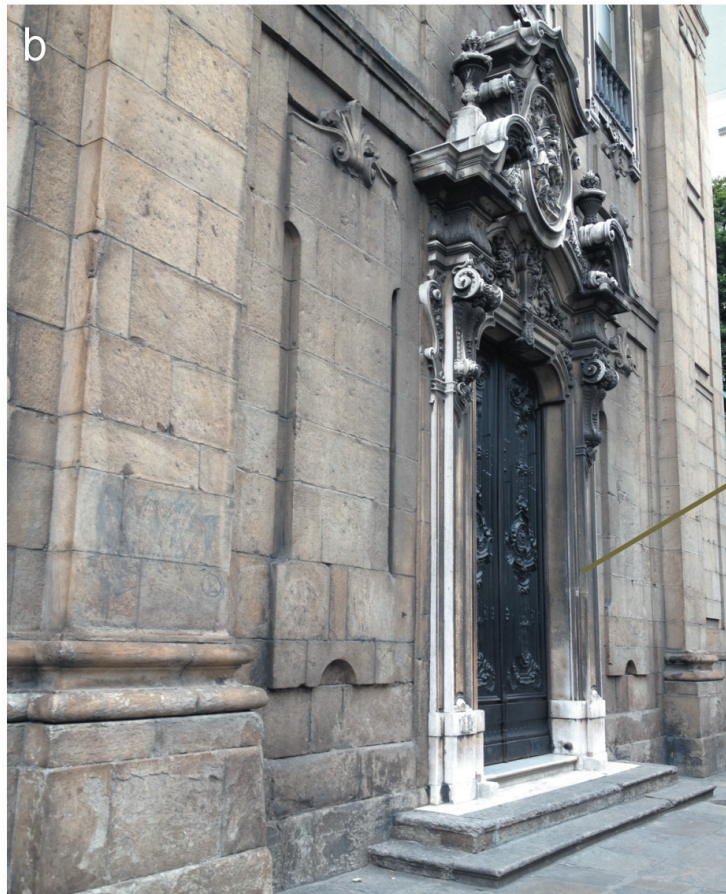
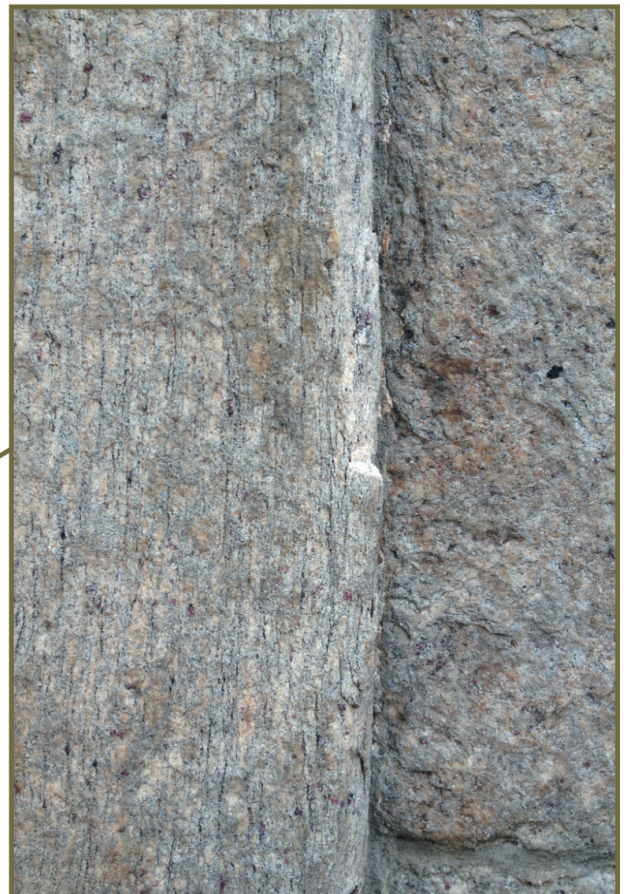
Some types of degradation were directly influenced by the textures and structures present in the stone employed. The presence or absence of a foliation, as well as variations in mineral content, are important factors. For example, where foliated rocks such as schist have been used, decay processes occur faster. Depending on the content of mica, planar structures may develop, and detachments ranging from delamination to exfoliation parallel to the stone structure demonstrate the strong influence of the rock's anisotropy.

Susceptibility is also associated with the type of rock-cutting method employed: blocks have been cut indiscriminately both parallel and perpendicular to rock foliation planes with concern for matching the type of cut with the requirements in each of those applications. Thus, in the parallel-cut blocks, where foliation planes lie vertically (Fig. 4), decay occurs rapidly as a result of surface delamination or exfoliation and separation of one or more layers. In some cases of detachment, separation involves submillimetric to centimetric elements such as flakes or scales parallel to the stone surface, although not following the stone structure. In such cases, as is observed at the external and flat wedges of the Capela de Nossa Senhora do Carmo (Chapel of Our Lady of Carmo) in Ouro Preto (Minas Gerais state), the process was identified as spalling (Fig. 5).

**Figure 4.** Detachment processes observed in parallel-cut blocks in which surface exfoliation is parallel to vertical foliation planes (schistosity) in a) a sericite-quartzite application in Ouro Preto, Minas Gerais, and b) a garnet gneiss application in the city of Rio de Janeiro.

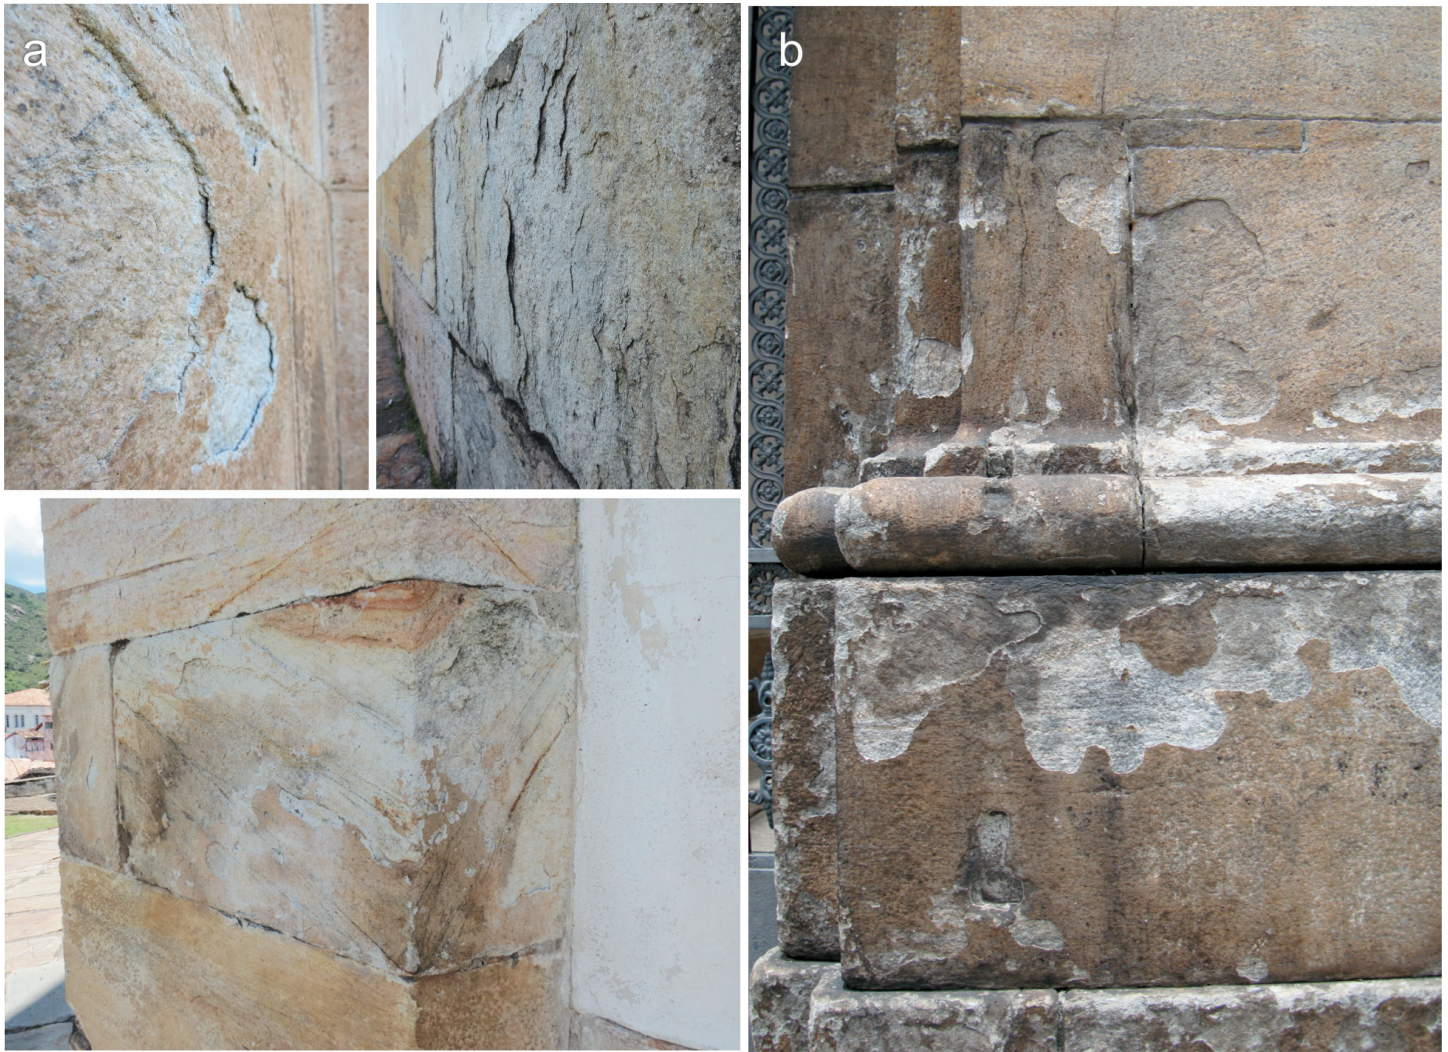
**Figure 5.** Example of stone detachment as flakes or scales (spalling). In this case, detachment is parallel to the block surface but not to the rock structure, as observed in a) the external and flat wedges of quartzite at the Carmelite Chapel, Ouro Preto, Minas Gerais, and b) gneiss at the Carmelite Church in Rio de Janeiro.

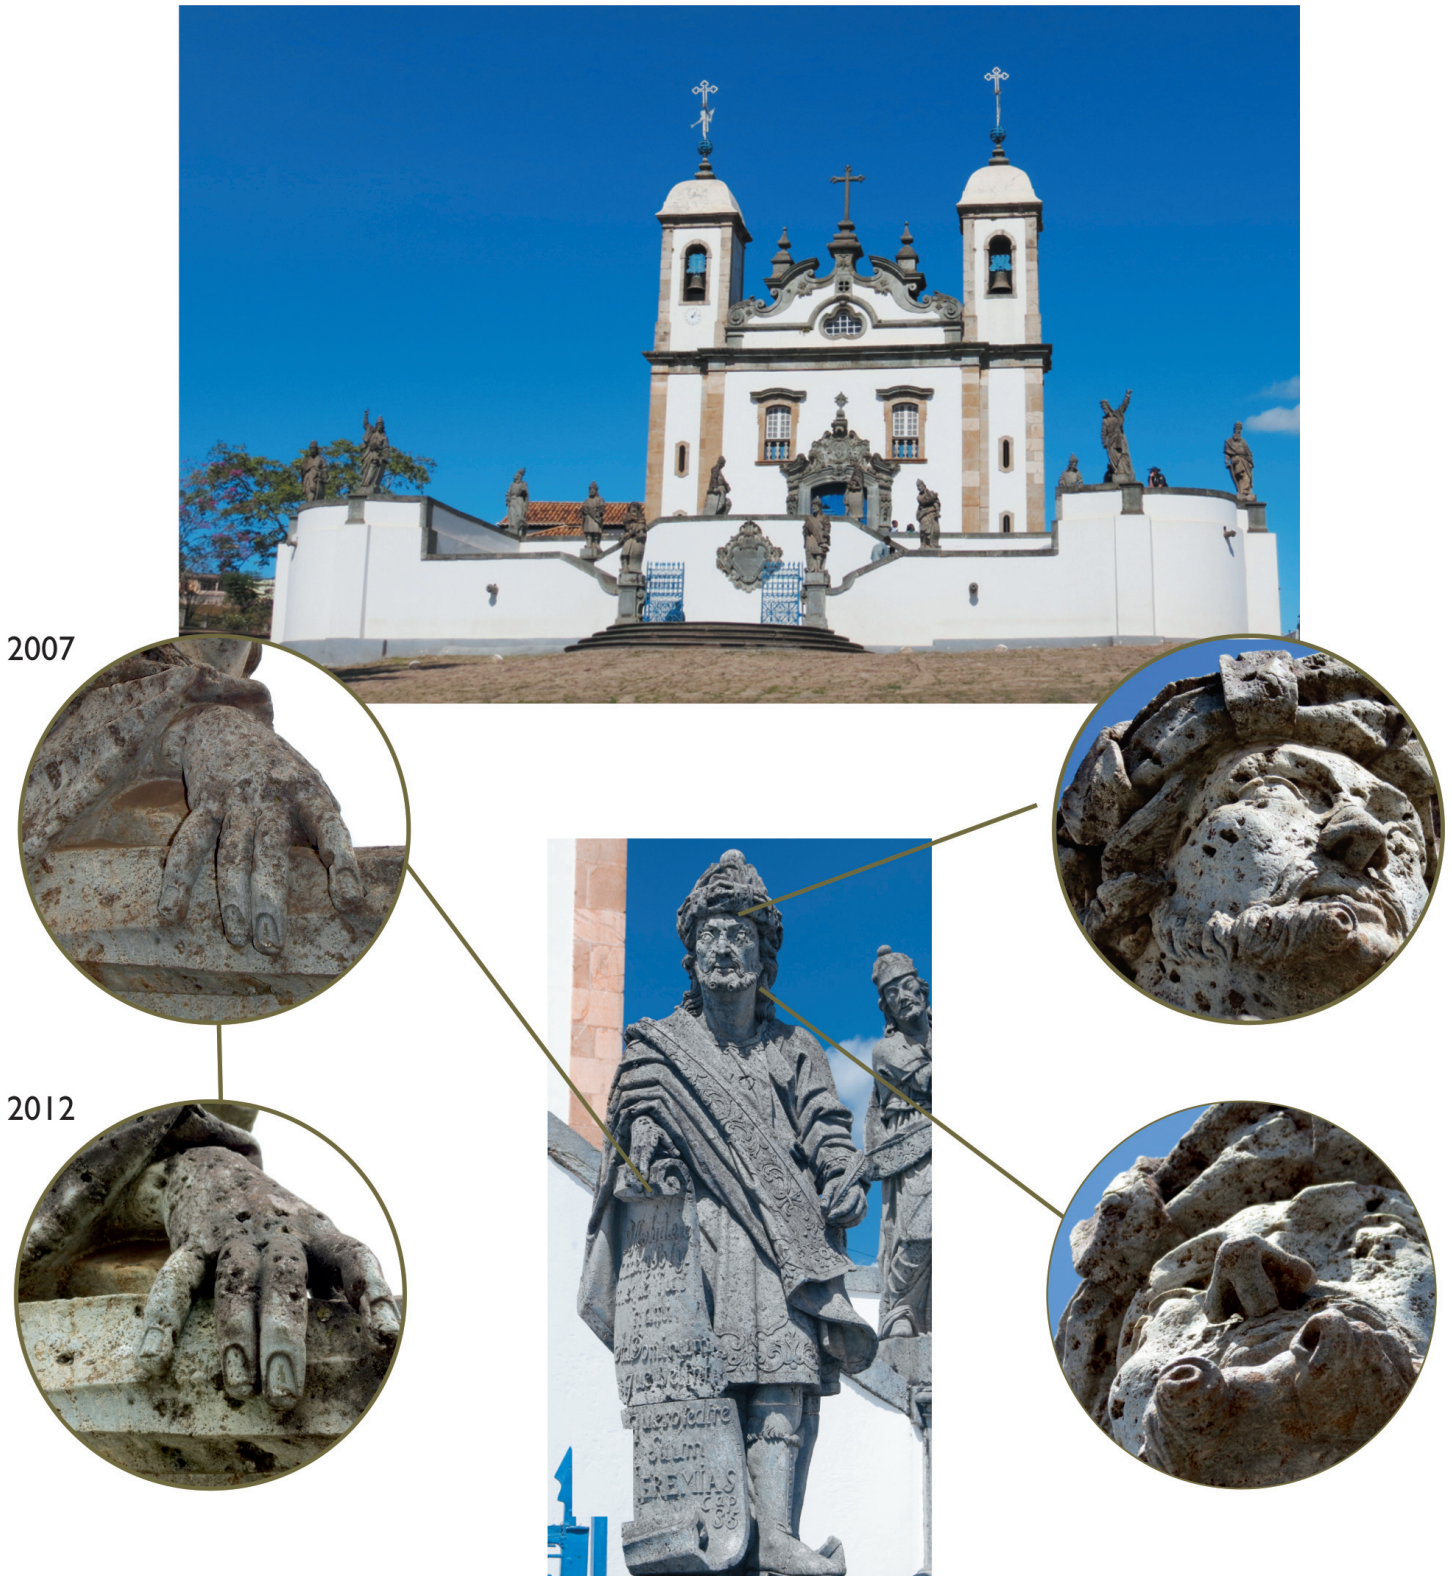
The presence of sedimentary structures inherited in metamorphic rocks may influence processes of degradation, such as in some of the quartzite used. Banding by compositional variation, or cross-bedding, occurring alone or in combinations, can lead to different degrees of degradation, and the effect of these structures may be enhanced by differential erosion. Some of the processes observed were strongly influenced by the mineralogical composition of the rocks employed, as in the case of steatite. Although prone to scratching because of the softness of its main mineralogical component, steatites contain a significant number of different minerals, and each mineral phase has its own coefficient of thermal expansion, contributing to the appearance of fissures and cracks. Broadly speaking, however, the main types of damage observed in steatite applications involve the appearance of cavities, because minerals formed from local enrichment of iron oxide or sulfide (pyrite) are easily removed by alteration/weathering. The common presence of carbonate crystals, usually dolomite, also contributes to the formation of such cavities through dissolution, accelerated in part by acid rain. An instructive example of the process of cavity or alveoli formation in steatite is seen in the statues of the prophets installed in the churchyard of the Santuário do Bom Jesus (Good Jesus Sanctuary) in Congonhas, Minas Gerais. Visual examination over the past 15 years has showed that, within the last 7 years, the process has accelerated. Throughout this period, it was noted that stains

gave rise to cavities, some of which were 0.5 to 1.0 cm deep (Fig. 6).

**Figure 6.** Deterioration of steatite (soapstone) works produced in the late 18<sup>th</sup> century, such as those shown here in Congonhas Sanctuary, mainly caused by weak rock resistance, and by biological and anthropological factors leading to cavity or alveoli formation.

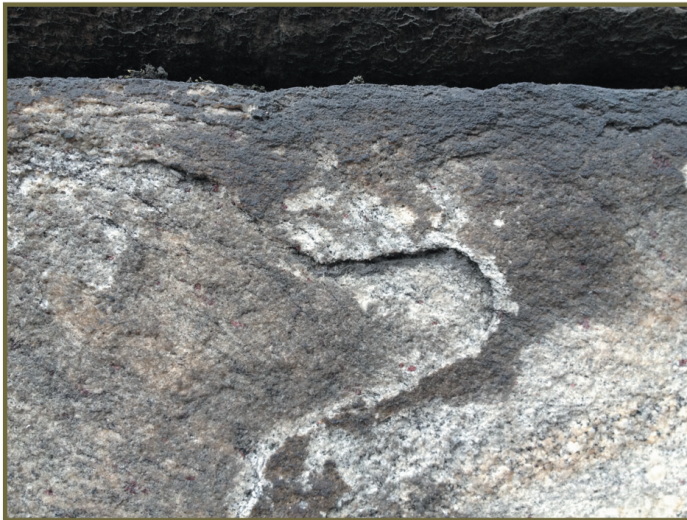
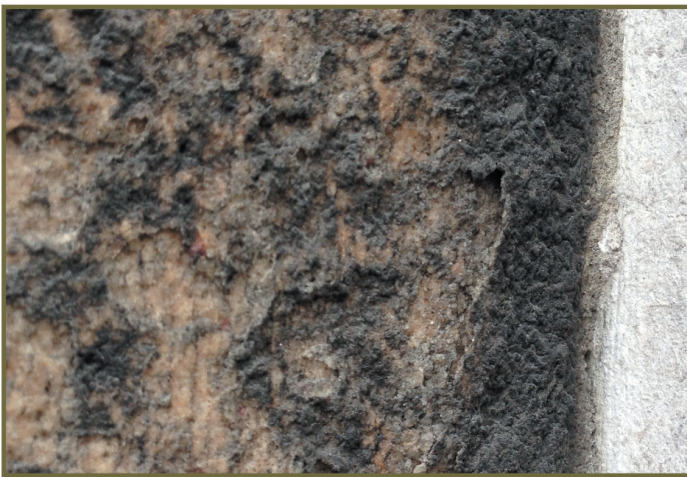
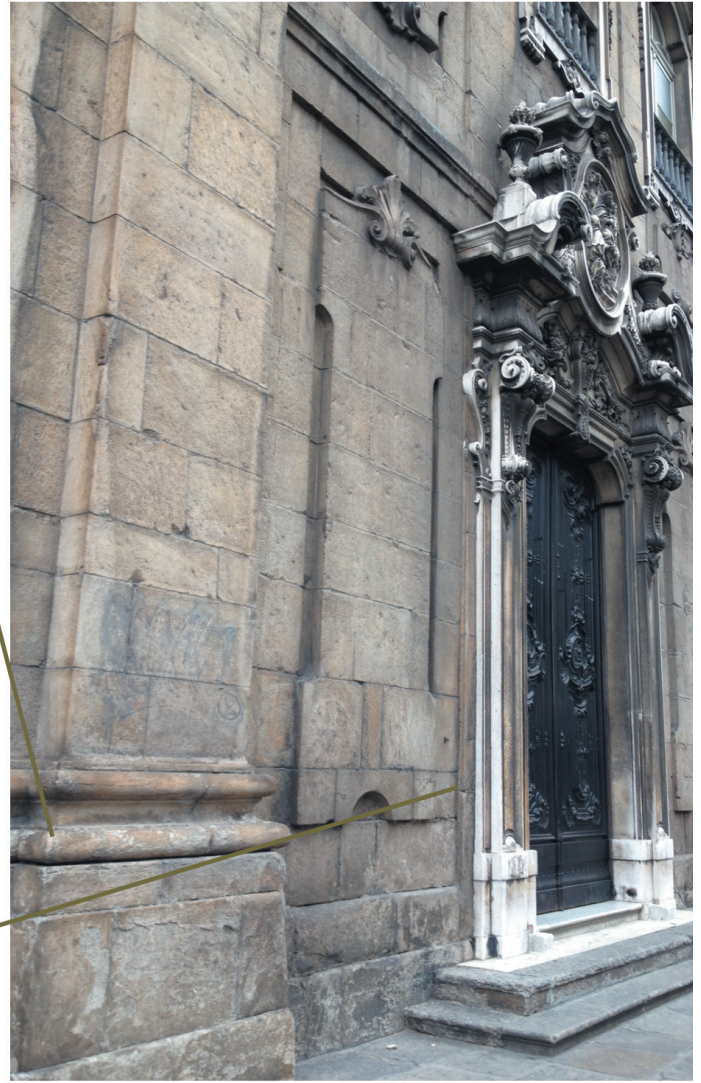
Finally, in historic sites located in urban centres heavily affected by air pollution, such as in Rio de Janeiro and São Paulo, external surfaces are commonly covered by grey to black deposits of varying consistencies and degrees of adhesion to the substrate. In some cases, these deposits occur in areas protected from the rain; in others they are in areas exposed to open air and may be directly affected by rain water. The deposits differ in thickness and shape, ranging from inconsistent layers of pulverulent (powdery) material on horizontal surfaces, to surface deposits well adhered to the substrates. As black crusts, they are frequently associated with serious problems of stone degradation, manifested as exfoliation or blistering (Fig. 8).

**Figure 8.** Degradation observed in historical buildings and identified as black crust. Formed by the accumulation of particles deposited on the flat surface of fine-grained garnet gneiss, the crust is associated with a blistering process on the façade of the Carmelite church, Rio de Janeiro.
