## Active Earth: Rain-induced Landslides in the Canadian Cordillera, July 1988

S. G. Evans and J. J. Clague

Volume 16, Number 3, September 1989

### Rain-Induced Landslides in the Canadian Cordillera, July 1988

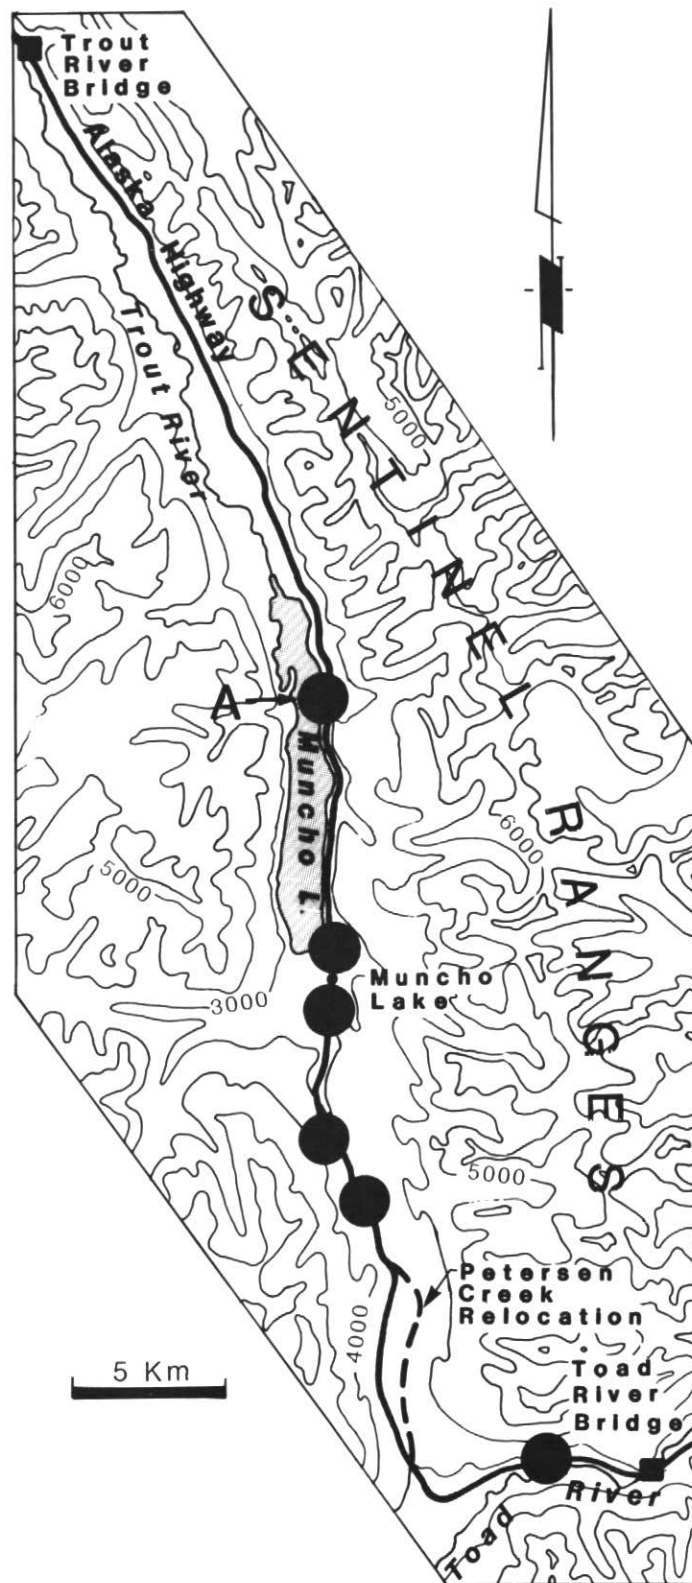
In 1988, the Alaska Highway was closed at 2000 h on July 12. It was severed in six locations by sediment-water flow processes, either by the destruction of the roadbed itself or by the deposition of material on the surface of the road (Figure 2). These flows were triggered by rainfall of 68.8 mm in 48 hours on July 12 and 13 (Figure 4). The Alaska Highway was re-opened at 1800 h on July 14, 1988.

**Figure 2** Alaska Highway route in the vicinity of Muncho Lake, British Columbia. The Highway was severed at 6 locations (black circles) by debris flow and associated sediment-water flow processes during the July 1988 rainstorm.

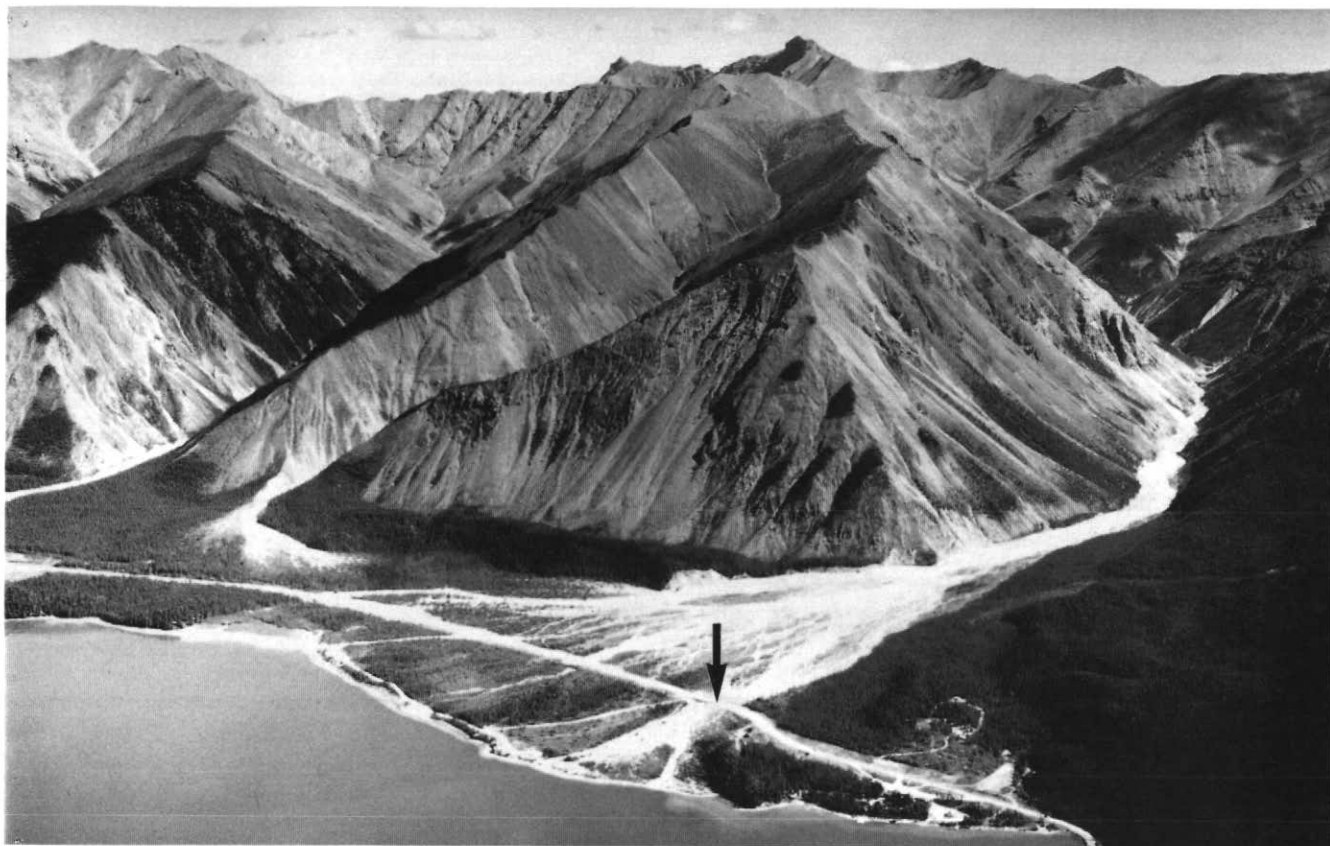
**Figure 3** Oblique aerial photograph illustrating the nature of the watersheds developed in the Paleozoic carbonates of the Sentinel Ranges in the vicinity of Muncho Lake. Note active fan surface and steep bare slopes. The Alaska Highway was severed at the location indicated by the arrow (A in Figure 2) during July 1988 rainstorm. Elevation difference between Muncho Lake in foreground and peak on centre skyline is 1255 m.

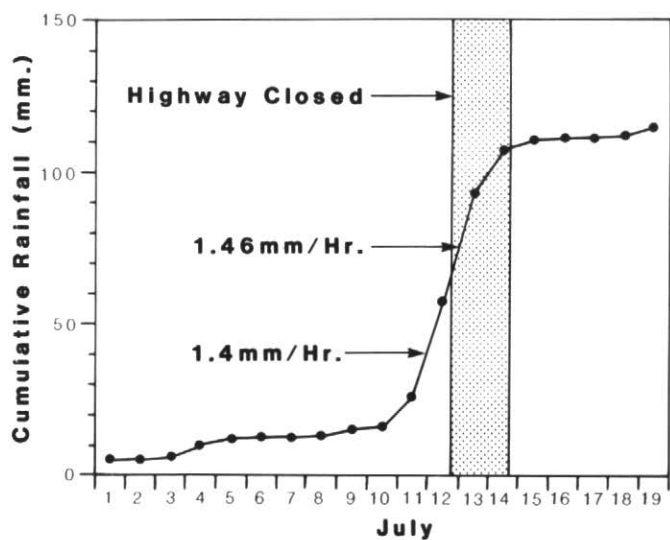
**Figure 4** Cumulative rainfall measured at Muncho Lake, July 1-19, 1988. The Alaska Highway was closed at 2000 h on July 12 and was re-opened at 1800 h on July 14.

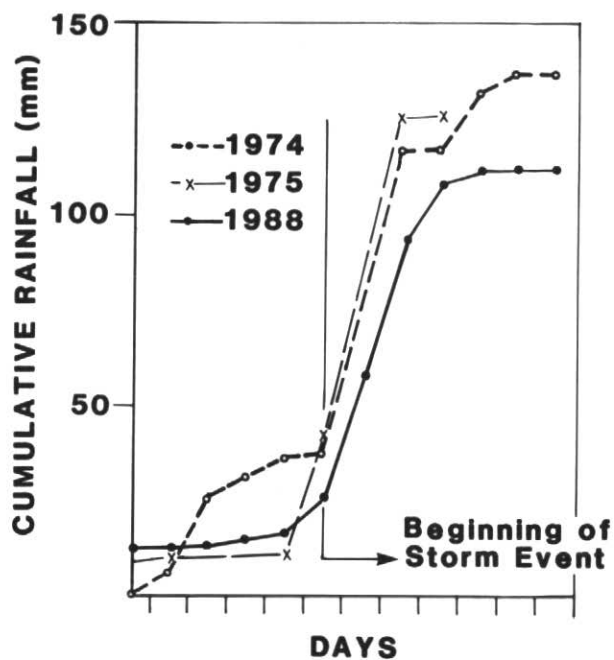
The cumulative rainfall for the 1988 event, as measured at the Muncho Lake meteorological station, is compared to the rainfall for the destructive storm events of 1974 and 1975 in Figure 5. Data for the 1979 event were unavailable. It appears that although there are substantial differences in antecedent rainfall, there is a broad similarity between the intensity and magnitude of the rainfall that triggered the debris flows.

**Figure 5** Comparisons of cumulative rainfall at Muncho Lake for the 1974, 1975 and 1988 debris flow events.

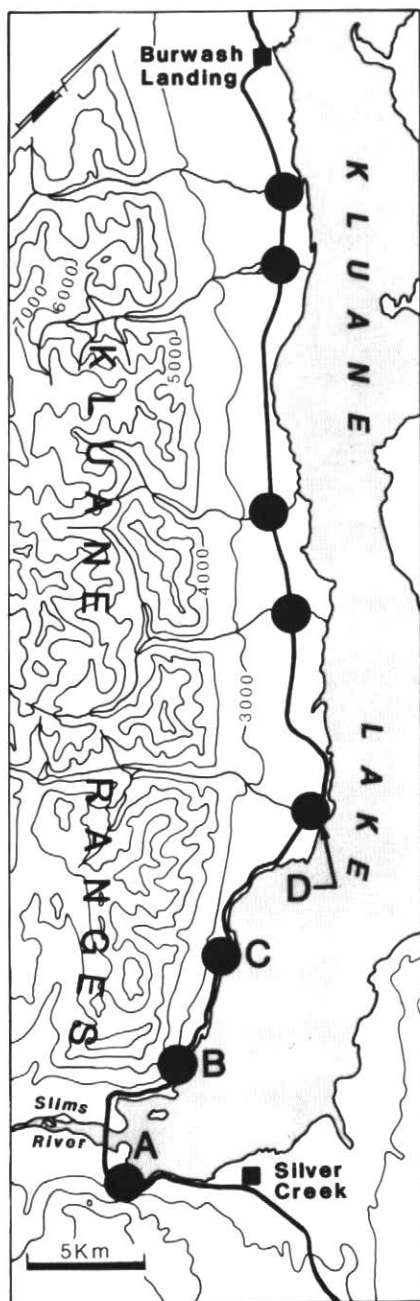
**Figure 6** Alaska Highway route in the vicinity of Kluane Lake, Yukon Territory. The highway was severed at 8 locations (black circles) by debris flow and associated sediment-water flow processes during the July 1988 heavy rainfall. A-D are locations discussed in text.

In July 1988, the Alaska Highway was severed at numerous locations between Silver Creek and Burwash Landing (Figure 6). A major debris flow covered more than 500 m of highway about 1.5 km east of the Slims River bridge (A in Figure 6, Figure 7). It occurred approximately 2 km west of the site of a previous major debris flow (Figure 7) which blocked the Alaska Highway after a period of intense rainfall in the summer of 1967 (Hughes *et al.*, 1972).

Between this point and Burwash Landing, the Alaska Highway was severed by debris flows or sediment-water flows at six locations where it crosses major alluvial fans. Large amounts of coarse material were mobilized on the surfaces of these fans as braided channels shifted due to the plugging of existing channels, the erosion of natural levees and the breaching of artificial berms. A typical example of an active fan along the foot of the Kluane Range (Williscroft Creek) is shown in Figure 9 (C in Figure 6).

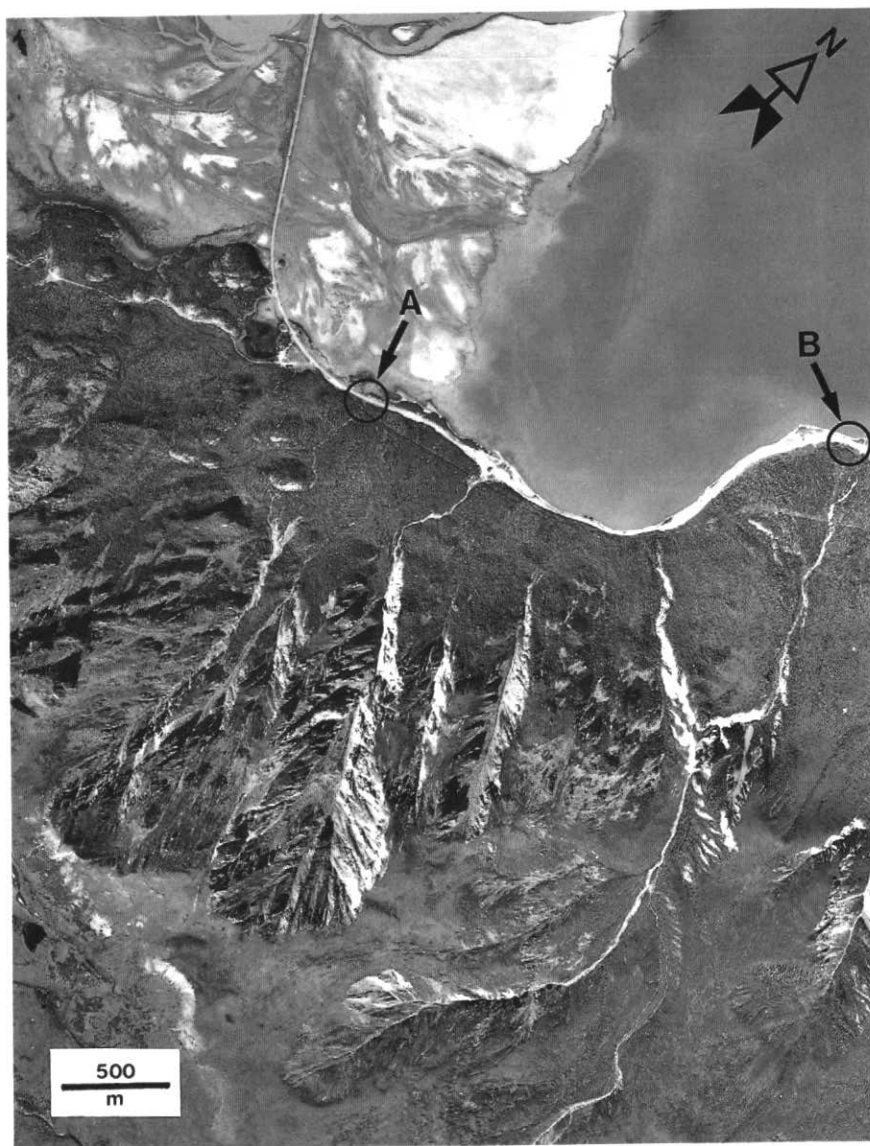
**Figure 7** Aerial photograph (Canada A23820-19) showing the location of a major rainfall-triggered debris flow (A) which blocked the Alaska Highway in July 1988. Also shown (B) is the location of a debris flow which blocked the Alaska Highway in 1967.

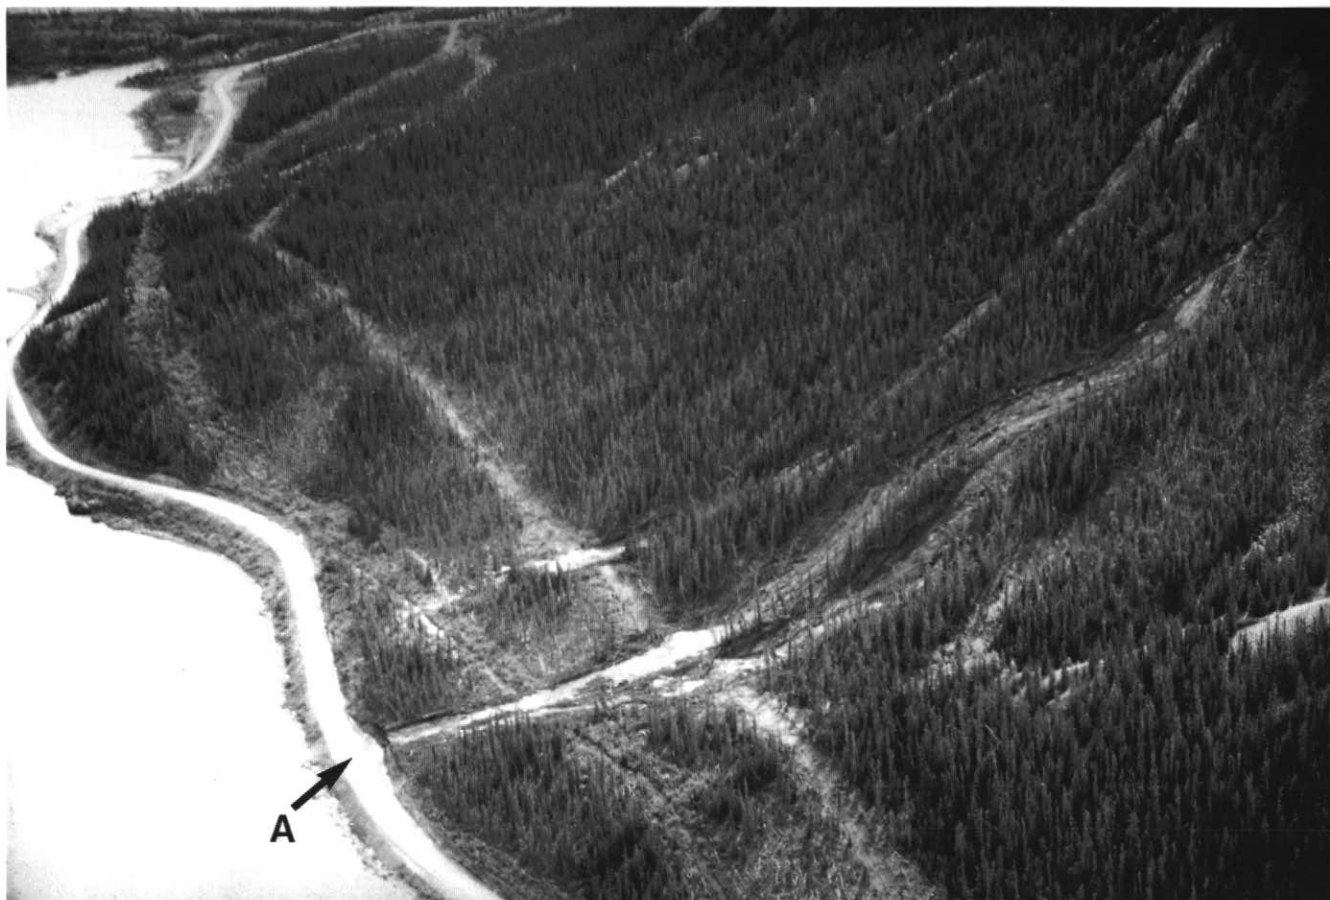
Two debris avalanches occurred in Holocene colluvium on slopes above the highway approximately 3.5 km north of the Slims River (B in Figure 6). Debris of one of these landslides blocked the road (Figure 8).

**Figure 8** Oblique aerial photograph of two debris avalanches which occurred on open slopes above the Alaska Highway during the July rains. The Highway was blocked at A. Kluane Lake is seen on the left of the photograph.

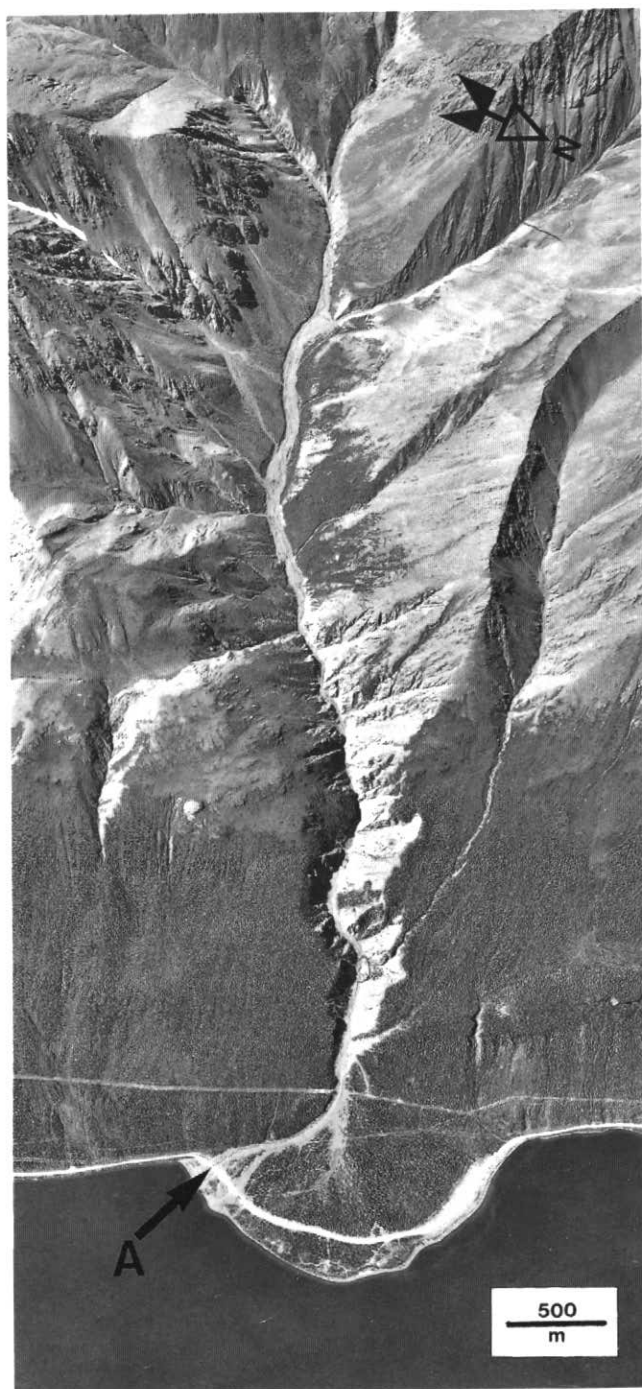
Figure 9 Aerial photograph (Canada A23820-50) of a typical mountain watershed in the eastern slopes of the Kluane Ranges (Williscroft Creek). The Alaska Highway was severed at A during the July rains.

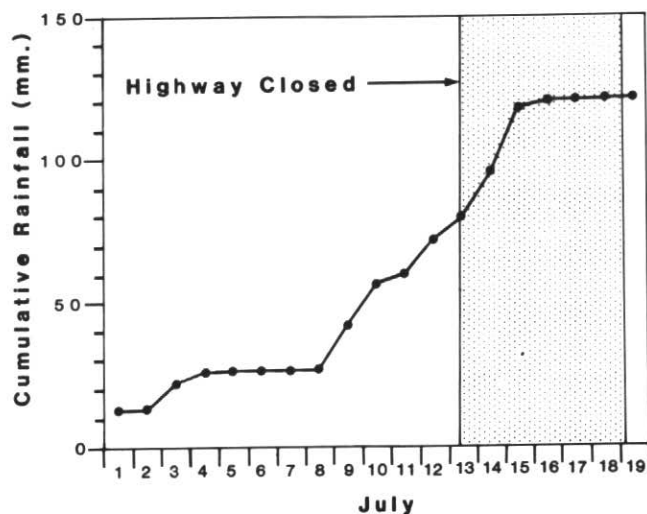
opened to the travelling public at 0100 h on July 19. Records from Burwash Landing indicate sustained rainfall from July 8 to July 15 (Figure 10). During this period 91.6 mm fell at an average rate of 13 mm/24 hours.

Figure 10 Cumulative rainfall at a Burwash Landing, July 1-19, 1988. The Alaska Highway was closed between 0315 h on July 13 and re-opened to traffic at 0100 h on July 19, 1988.

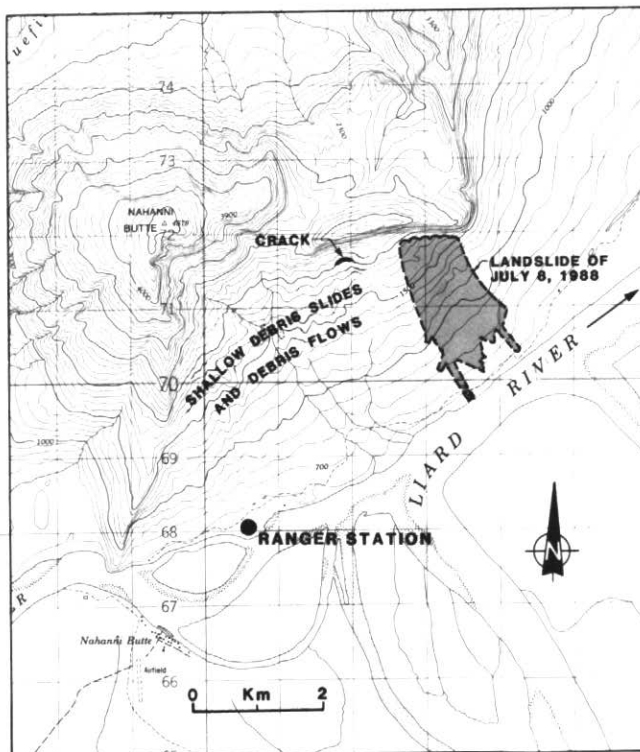
The July rainstorms triggered a large landslide (ca. 1.5-2 km<sup>2</sup> in area) in Quaternary sediments 3 km northeast of the Nahanni National Park Ranger Station at Nahanni Butte, NWT (Figures 1 and 11). There were numerous other smaller slope failures in this region during these storms.

The large landslide took place on a slope that dips about 10° away from a 200 m high limestone escarpment toward South Nahanni and Liard Rivers (Figure 11). Sediments underlying this slope are over 100 m thick and heterogeneous in character. Much of the sediment is colluvium (rubble and diamict) derived from the escarpment by rockfall and other processes. The slope

The large landslide northeast of the ranger station (Figure 11) developed over a period of several days, although most of the displacement probably occurred within hours of initial failure. On the upper part of the colluvial slope, directly below the limestone escarpment, sediments moved downward and outward along one or more deep-seated, curving shear planes. Farther downslope, sediments slid rather passively along shear planes oriented more or less parallel

Figure 11 Topographic map of the Nahanni Butte area, NWT, showing the locations of the Nahanni National Park Ranger Station and the large landslide that occurred on July 8, 1988.

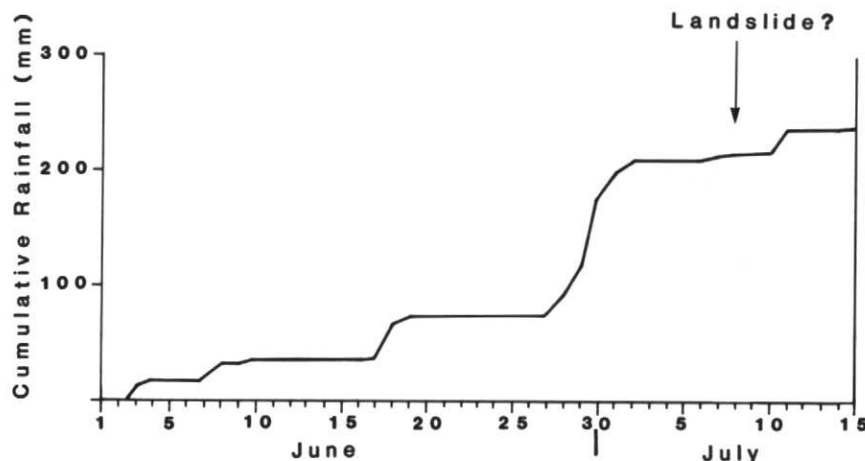
Approximately 136 mm of rain fell at Nahanni Butte between June 28 and July 2, 1988 (Figure 12). This is far in excess of normal precipitation for the entire months of June and July. Interestingly, there appears to have been a lag of about one week between the termination of the heavy rains and the large failure northeast of the ranger station; only 6 mm of precipitation is recorded between July 3 and July 8 when the landslide is thought to have occurred.

Figure 12 Cumulative rainfall at Nahanni Butte, June 1-July 15, 1988.

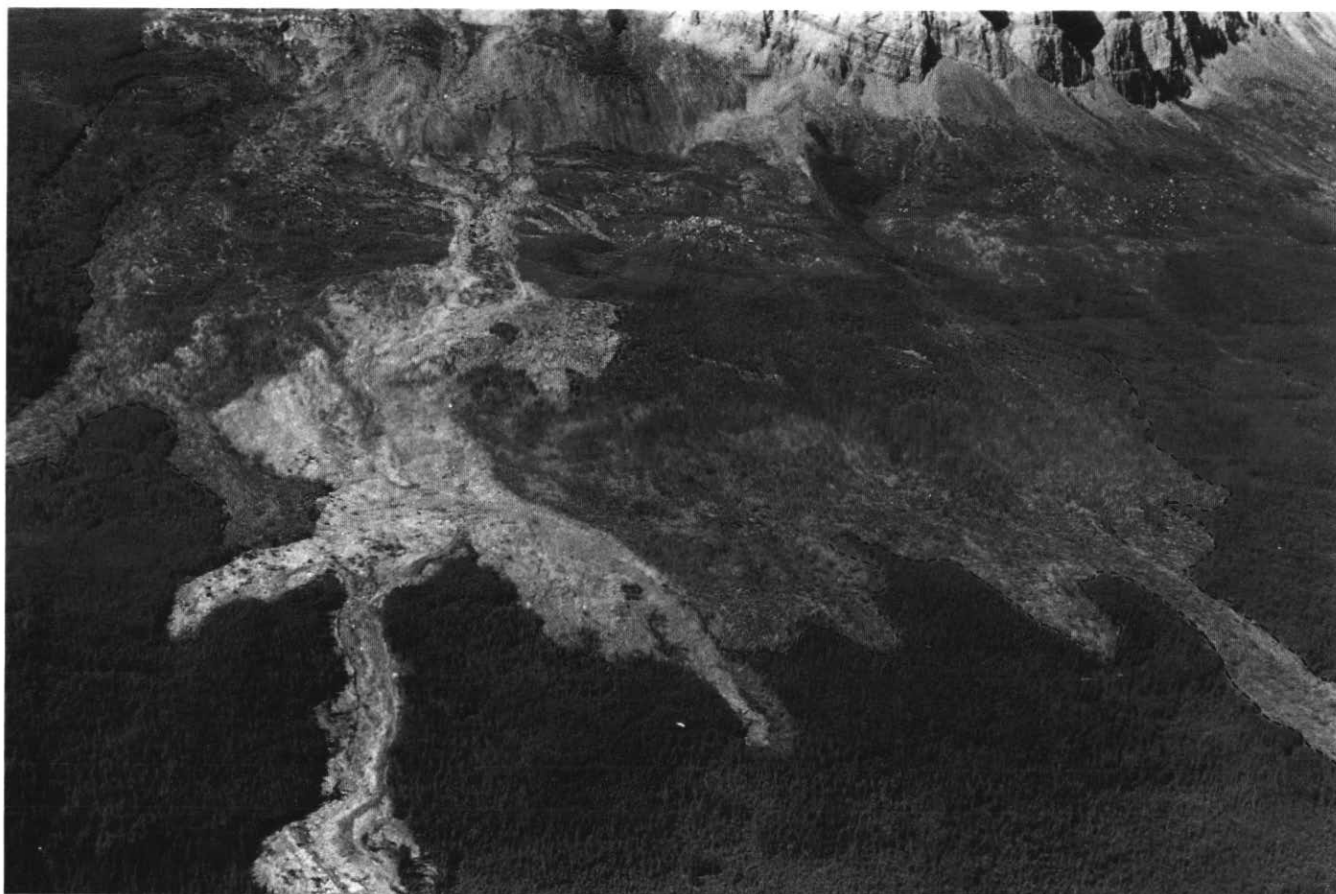
to the ground surface, disrupting and locally destroying vegetation and extensively fracturing the ground. A large, mobile mudflow swept across this portion of the slope to beyond the terminus of the main slide (Figure 13). A tongue of this flow reached Liard River after travelling almost 2 km. Other tongues of debris moved downslope from the south and west margins of the landslide; these, however, retained surface vegetation and thus probably moved more slowly than the main mudflow.

The landslides at Nahanni Butte raise concerns about the safety of the Nahanni Park Ranger Station which is located at the foot of the colluvial slope on a low terrace adjacent to South Nahanni River. The Ranger Station was not affected by the 1988 landslides, but there is a possibility of it being damaged or destroyed in the future during a prolonged period of heavy rain. Although the hazard in the short term is low, since heavy rains similar to those in June

Figure 13 Oblique view of the landslide complex noted in Figure 11. The boundary of the landslide is indicated by a dotted line. Note the unvegetated track of a multi-lobed mudflow that travelled from the upper part of the complex to the Liard River.

and July 1988, are infrequent, there is sufficient danger in the long term to consider relocating the station.
