Slope Failure Hazard in the Atlantic Provinces: A Review

Volume 49, 2013

Slope failure hazard in Canada's Atlantic Provinces: a review

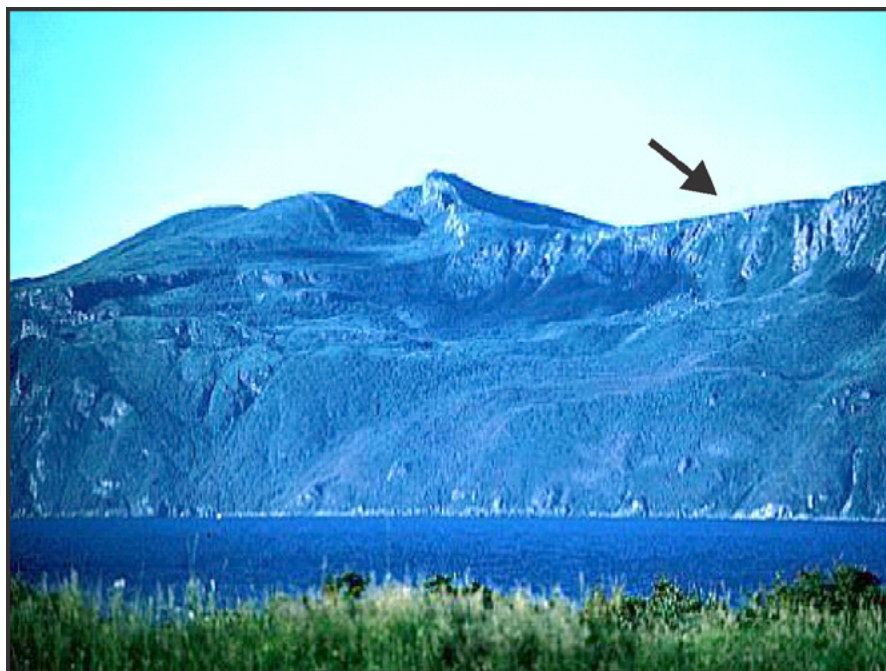
Figure 2. Sacking at Norris Point, Bonne Bay, Newfoundland. This is the largest of 24 examples of sacking in western Newfoundland identified by Grant (1974) and has an estimated volume of 10 km³. The arrow points to the headscarp.

The largest example of a sackung in Newfoundland is at Norris Point in Bonne Bay (Figs. 1, 2), where a rock mass estimated at 10 km^3 has moved vertically by approximately 100 m (Fig. 2; Grant 1974). The head of the failure consists of a complex arrangement of scarps and fissures that align roughly parallel with regional jointing. Grant (1974) suggested that the failure of these dense ultramafic rocks (which were thrust over relatively weak shale and carbonate during the early Paleozoic) was caused in part by the oversteepening of the fjord wall during the last glaciation. The deep-seated failure occurred along the basal thrust contact and spreading resulted on all slopes along Bonne

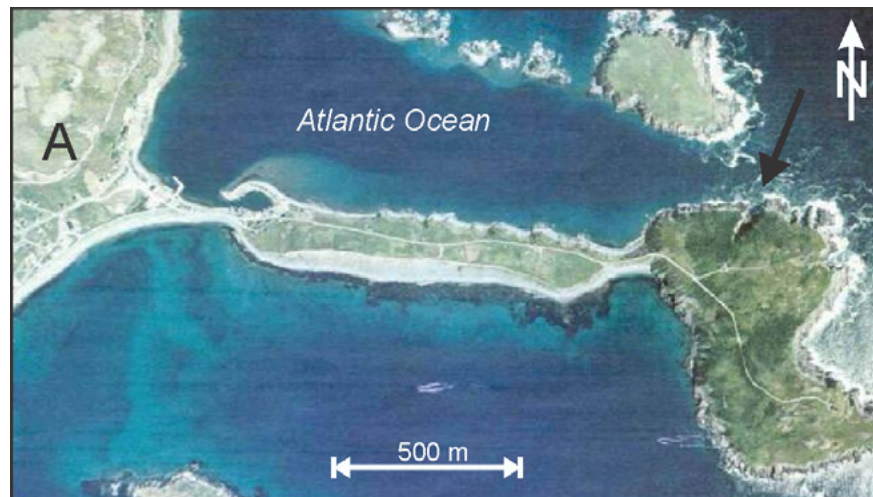
Figure 3. Ferryland Harbour, eastern Newfoundland. The village of Ferryland is to the left (A). The arrow points to “Deadman’s Gulch”, believed to be the site of a rockfall that killed 42 fishermen.

An intriguing story of what may be Canada’s fourth-worst landslide disaster was recounted in the Newfoundland Quarterly of March 1902 (White 1902). White reported a cave-in at Deadman’s Gulch in Ferryland Harbour that apparently occurred in 1823 (Figs. 1, 3, 4). Although the report is detailed, White did not indicate the source of his information. Corroboration of the story has proved difficult — few newspapers were published at the time, and archives of those that were published have much of 1823 missing.

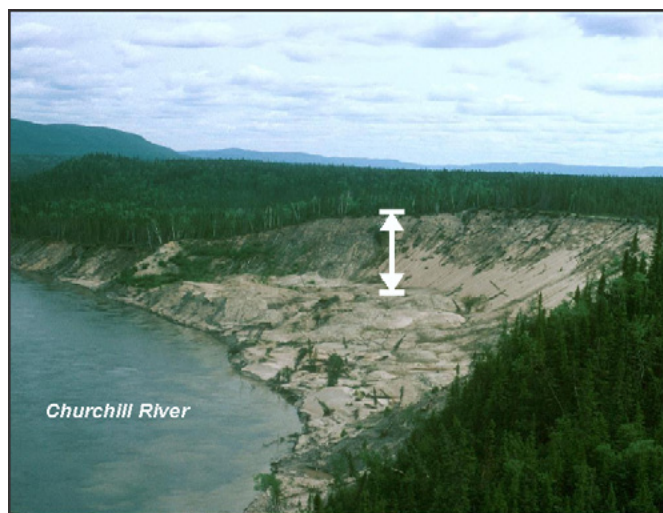
Figure 5. A large rotational slump on the east side of the lower Churchill River, Labrador. The active sediment is glaciomarine mud and overlying sand and gravel. Sliding was likely initiated by fluvial undercutting that over-steepened the slope. Scale bar is approximately 20 m high.

The lower Churchill River between Gull Island and Muskrat Falls shows numerous slope failures typical of many of the major valleys in coastal Labrador whose floors are underlain by glaciomarine silt and clay (Figs. 1, 5). As this area is the site of a proposed major hydro-electric dam, the potential for slope failures needs to be evaluated.

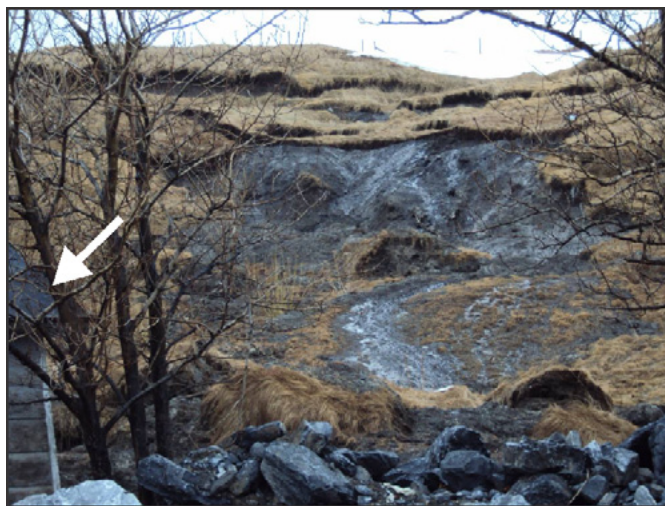
Figure 6. Debris flow deposit at Trout River, Newfoundland. The landslide displaced silt and clay and occurred following a period of heavy rain. Arrow points to house at right in Figure 7.

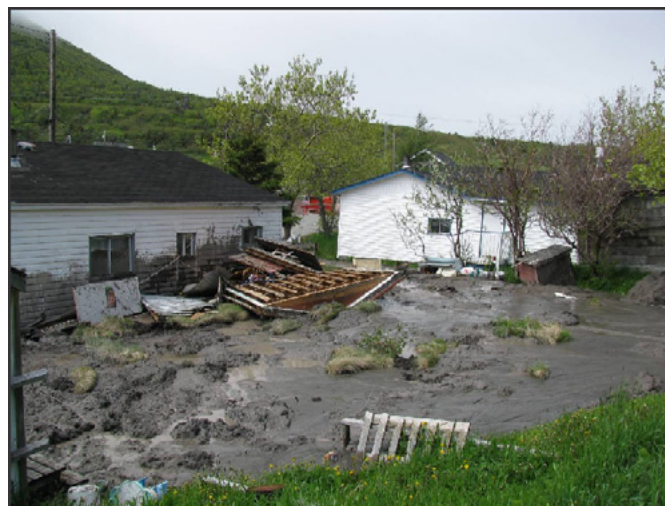
Figure 7. Debris flow deposit at Trout River, Newfoundland. The landslide, though small in volume, detached a house from its foundation and pushed it onto the adjacent road.

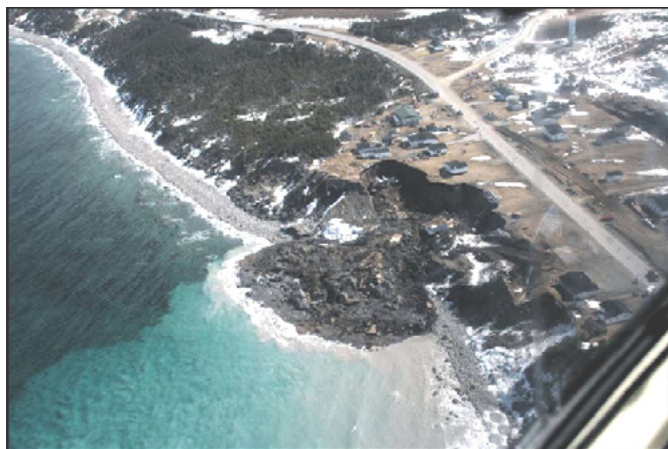
Figure 8. Landslide at Daniel's Harbour, Newfoundland. The slide was characterized as a combination of translational-slip failure and rotational-slip failure and occurred as a result of the saturation and subsequent loss of strength of a clay-rich layer underlying till.

On 15 April 2007, a landslide occurred in the community of Daniel's Harbour on the Great Northern Peninsula; it covered an area of at least 5300 m² and involved about 110 000 m³ of material (Figs. 1, 8). The landslide resulted in

significant loss of property, including several residences, the subsequent removal of others from the site, and the eventual relocation of 23 families. The April 2007 landslide was preceded by a smaller event that affected the same area on 20 October 2006, which covered an area of approximately 1000 m². The 2007 Daniel's Harbour landslide produced a large debris fan that extended about 60 m in front of the slide area (Fig. 8).

The 2007 landslide was a combination of a translational slip failure and a rotational slip failure, and likely occurred as the result of saturation and subsequent coastward movement of the clay-rich layer that underlies the compact till observed in the coastal exposures. As the clay-rich layer became saturated, it lost much of its cohesive strength. The pressure from the overlying till caused it to fracture along vertical

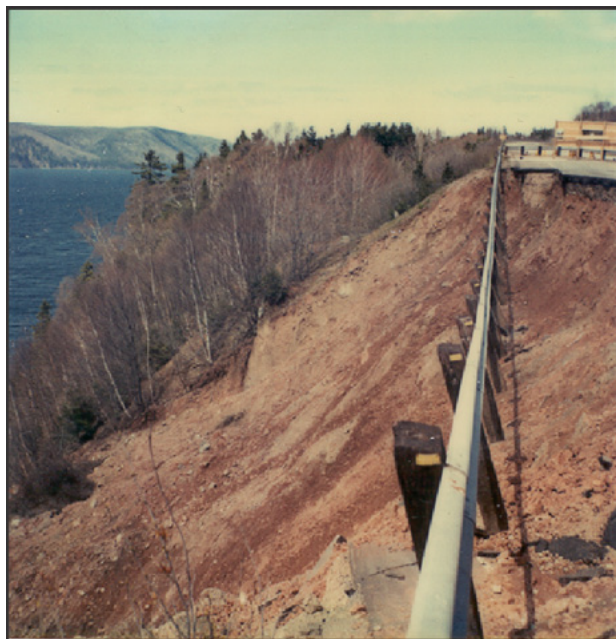
Figure 9. Debris-flow deposit at Kelly's Mountain, Cape Breton Island, Nova Scotia. This landslide has been characterized as a translational failure that developed into a debris flow.

The largest recent landslide consisted of a series of slope failures that caused near complete destruction of the road at Kellys Mountain on Cape Breton Island in 1982 (Figs. 1, 9). A creosote wood culvert had been installed earlier to take runoff from the south side of the highway to a gully on the north slope, guiding the flow into St. Anns Harbour. The principal cause of the 1982 slide was likely water seepage from the deteriorated culvert. This, combined with water from spring thaw and rainfall, saturated the soil surrounding the culvert and caused erosion at the base of the slope, which

resulted in a number of failures in late spring 1982. Bedrock underlying the gully may also have created natural failure planes for the saturated soil. The landslide was characterized as a translational slip failure that developed into a debris flow.

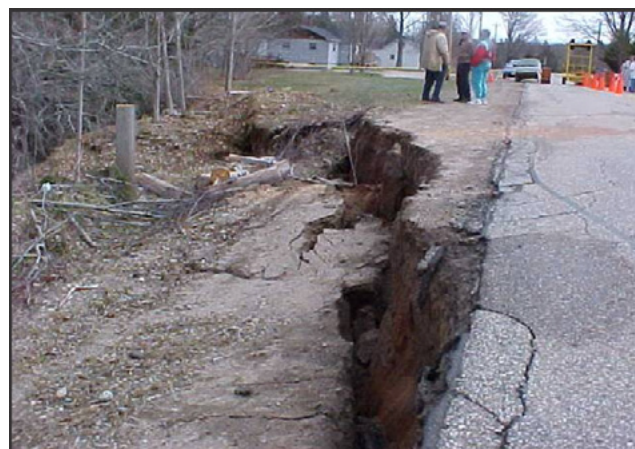
Figure 10. A large rotational slump in Middleton, Nova Scotia. This landslide was associated with fluvial erosion of 20 m-high slope along the Annapolis River when the water table was elevated activating a failure plane between impermeable clay-rich till and overlying outwash sediment.

Other smaller landslides frequently affect transportation routes in Nova Scotia, most commonly in spring, as thawing of frozen ground leaves slopes saturated. A large rotational slump occurred on the north side of Highway 201 near Middleton in late April 2003 and resulted in prolonged highway closure (Figs. 1, 10). Site investigation indicated that the Annapolis River was actively eroding the toe of a 20 m-high slope, which exhibited irregular topography and displayed evidence of previous movement, including tension cracks. The stratigraphy of the site is typical of the region: greater than 4 m of fluvial/glaciofluvial sand and gravel overlies sandy-clayey till and, in some cases, glaciomarine clay. Geotechnical analysis of the site indicates that two triggers most likely contributed to the slide: removal of toe support and a rise in the water table activating the failure plane between the outwash sediment and the impermeable clay-rich sediments.

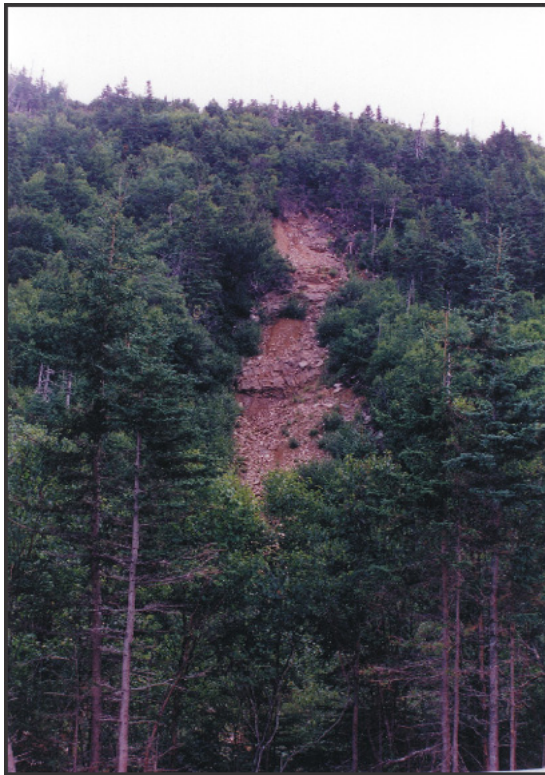
Figure 11. Debris-flow scar in the Cape Breton Highlands, Nova Scotia. These failures are typically complex and may involve rock topple, rotational slip, translational sliding and flow.

Finck (1993), Grant (1994), and Wahl (2003) have identified numerous debris flow/avalanche scars in the Cape Breton Highlands (Figs. 1, 11, 12). These complex failures involve rock topple, rotational slip, translational sliding and flow (Finck 1993, Wahl 2003, Wahl *et al.* 2003). Although
