Geomorphic Effects of Flooding Along Reaches of Selected Rivers in the Saguenay Region, Québec, July 1996

G. R. Brooks et D. E. Lawrence

Brooks, G. R. & Lawrence, D. E. (2000). Geomorphic Effects of Flooding Along Reaches of Selected Rivers in the Saguenay Region, Québec, July 1996. *Géographie physique et Quaternaire*, 54(3), 281–299. <https://doi.org/10.7202/005639ar>

GEOMORPHIC EFFECTS OF FLOODING ALONG REACHES OF SELECTED RIVERS IN THE SAGUENAY REGION, QUÉBEC, JULY 1996

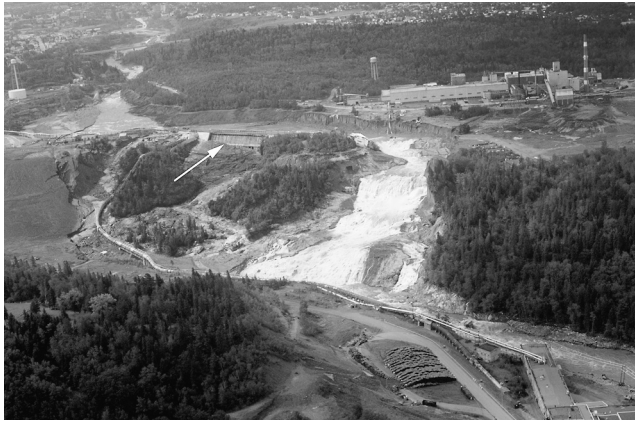
FIGURE 11. Post-flood view of the Chute-à-Besy dam, taken on July 26, 1996. The entire flow of the river has been diverted through the breach, as discussed in the text. The intact, but non-functional dam is marked by an arrow.

The incision at the breaches occurred into cohesive, fine-grained marine sediments, although at the Chute-à-Besy dam, floodwaters initially overtopped and incised an earthen dike (up to 6 m high and 180 m wide). At each location, the incision was arrested by bedrock, except at the Pont-Arnaud dam where it was arrested by a combination of bedrock and marine sediments. The breachings occurred progressively over a period of hours at at least three of the dams (CSTGB, 1997) and did not produce outburst floods downstream. At the Chute-à-Besy dam, the initial stages of incision occurred into an earthen dike (as mentioned above) that conceivably could have eroded much more rapidly relative to the other sites. However, we are not aware that the incision of the dike generated a flood wave downstream that significantly exceeded the overall peak flood discharge along the Rivière aux Sables.

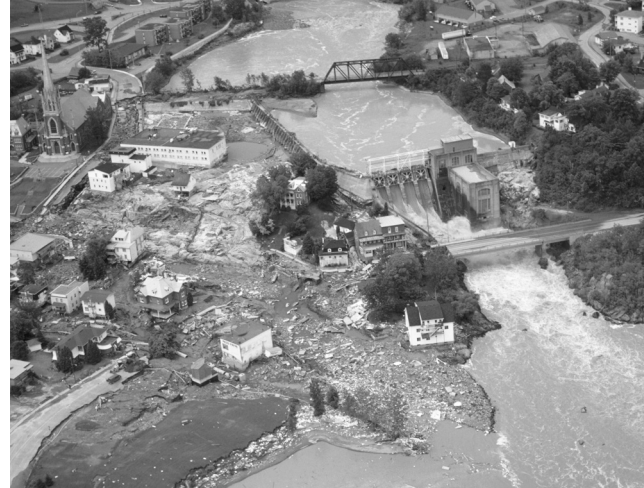
FIGURE 12. Post-flood view of the Chicoutimi dam located in downtown Chicoutimi, taken on July 26, 1996. During the flood, floodwaters overtopped the buttressed concrete wing-wall of the dam that extends to the left of the control structure in the photograph, and flowed rapidly through the residential-commercial area situated immediately down slope. Along the flow path, overburden and road beds were scoured in places to bedrock, and buildings were washed away or damaged. A bar composed of bed materials extends into the pre-flood channel (bottom centre right of photograph), where the flood flow re-entered the river.
