## Some Twentieth-Century Canadian Earthquakes

Volume 4, Number 1, March 1977

### St. Lawrence Earthquake—1925

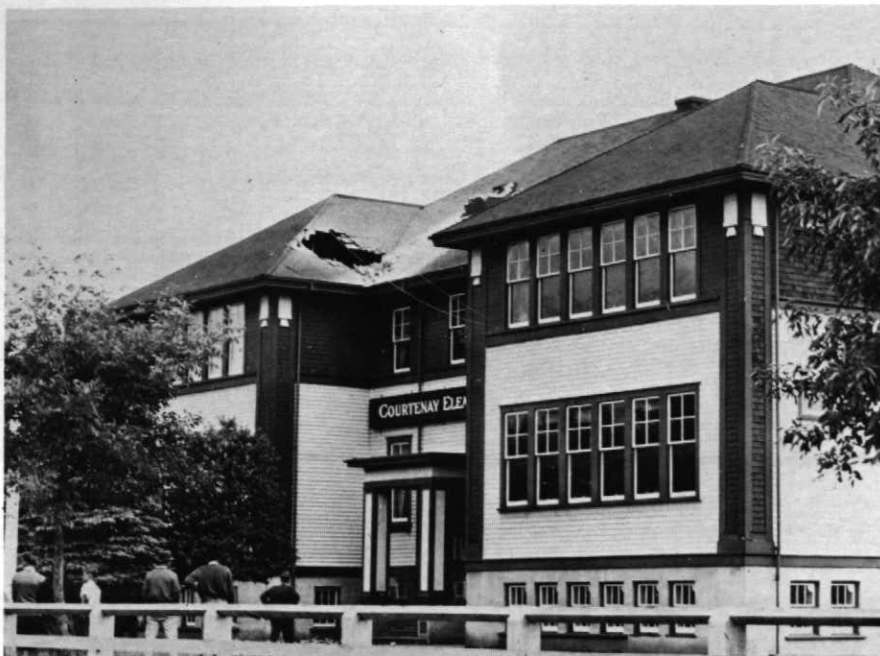
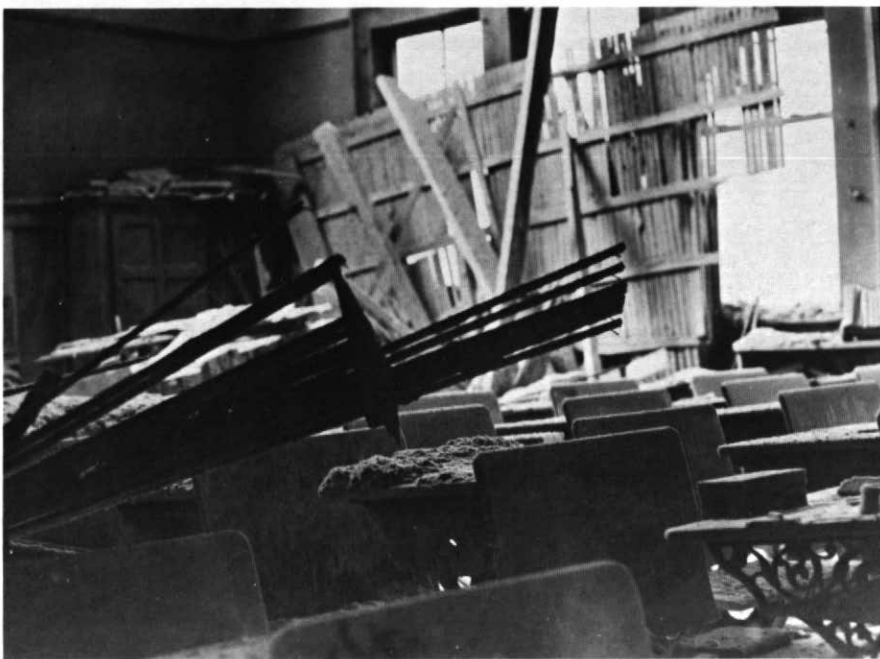
Chimney damage sometimes induces other damage. Figure 3b shows the interior of a schoolroom in Courtenay about 25 km south of the epicentre of the 1946 earthquake. Fortunately, the shock occurred about 10 a.m. local time on a Sunday morning when the classroom was empty. Damage here was caused when the large school chimney fell through the roof. In Courtenay about 25 per cent of the chimneys were damaged, mostly in the central part of town. Windows and bottles were cracked in some stores.

**Figure 3**  
June 23, 1946. Elementary School,  
Courtenay, B.C. The chimney, located above

the front entrance, fell sideways through the roof into a classroom. (Figs. 16 and 15, respectively, in Hodgson, 1946).

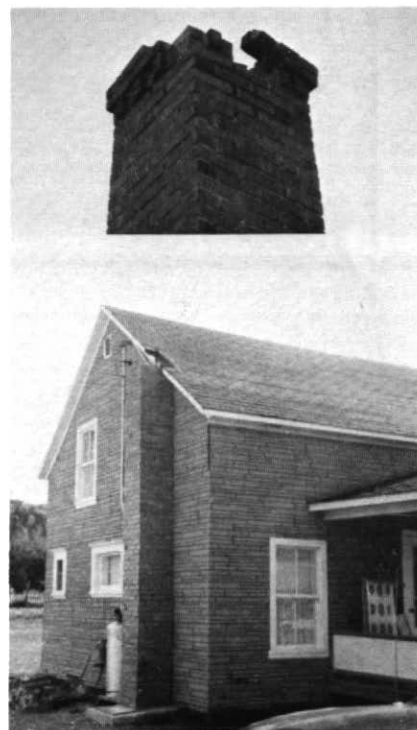
**Figure 4**  
June 14, 1973. Chimney damage at Woburn, Québec. Most chimneys in the town were undamaged. (Fig. 3 in Wetmiller, 1975).

in the town of Woburn on the Québec-Maine border about 80 km east of Sherbrooke. This moderate earthquake felt to about 300 km was somewhat smaller than the 1909 Prairie earthquake. The epicentre was located within about 20 km of Woburn. Several chimneys had bricks dislodged from the top, as shown in Figure 4, although many chimneys in Woburn were left undamaged. Articles on shelves in two
