Volume 9, Number 2, June 1982

Active Earth

Erosion at Point Grey, British Columbia

Howe Sound Debris Flows

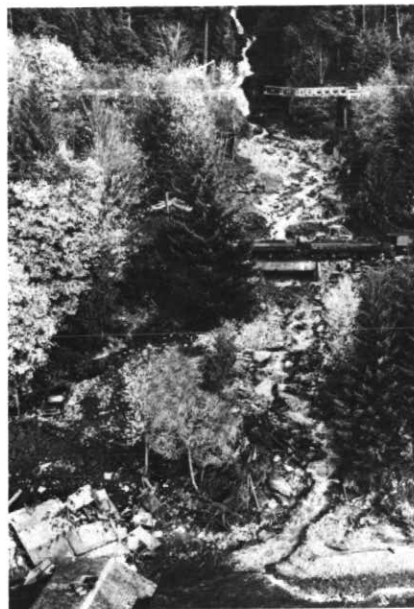
Figure 2 View of the mouth of M-Creek. Note remainders of demolished residence drifting in the sea and highway bridge under reconstruction.

astride the narrow channel of M-Creek. Soon thereafter a debris flow scoured down the torrent channel (average gradient 50%) and, having attained considerable momentum, took out the bridge carrying Highway 99; it then picked up an unoccupied residence along the shore and pushed it out to sea (Fig. 2). As visibility on the highway at the time was poor, the wide slash across the road bed was noticed only too late by drivers of several vehicles that plunged into the gap. The accidents claimed 9 lives.
