Geomorphological and vegetation interaction and its relationship to slope stability on the Niagara Escarpment, Bruce Peninsula, Ontario

Michael R. Moss et William G. Nickling

Moss, M. R. & Nickling, W. G. (1980). Geomorphological and vegetation interaction and its relationship to slope stability on the Niagara Escarpment, Bruce Peninsula, Ontario. *Géographie physique et Quaternaire*, 34(1), 95-106. <https://doi.org/10.7202/1000386ar>

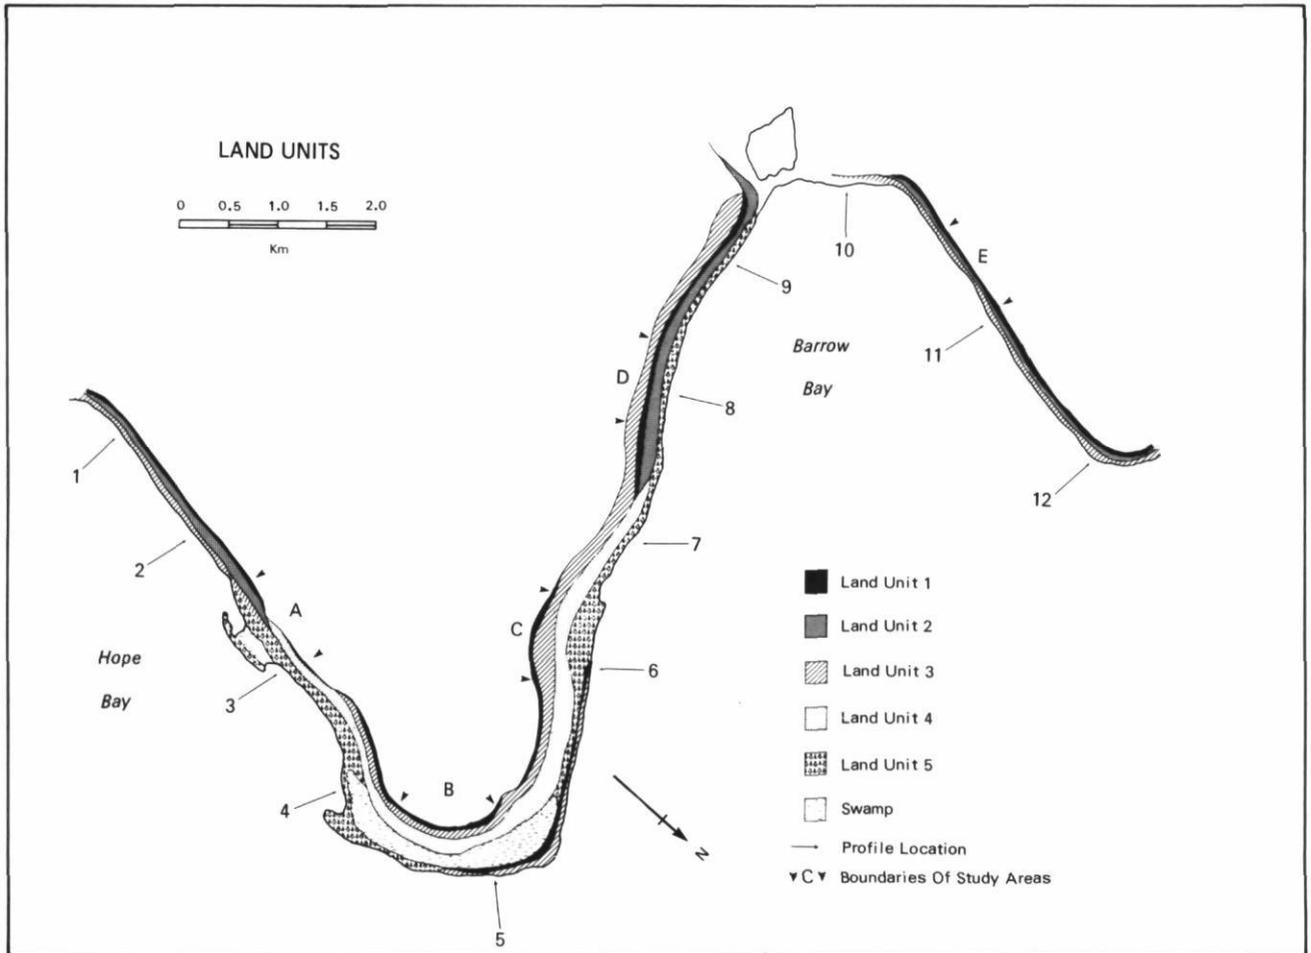
FIGURE 2. Land units in the Hope and Barrow Bay area. For characteristics of the individual units see Table II.

Les différentes unités de terrain dans la région à l'étude. Les caractéristiques de chacune des unités sont données dans le tableau II.

By using the basic profile data in conjunction with two recent sets of air photographs for the study area (1971 and 1976), it was possible to obtain a more comprehensive picture of the land surface as a whole. For convenience this information can be organized into a series of land units. Each of the land units recognized has, therefore, the common attributes of a limited range of slope angle, topography, soil development, and dominant vegetation. At the scale used the more individual features such as talus cones, debris slides, etc., were not included. The distribution of these land units is shown in Figure 2 and the details summarized in Table II.

At the second level of more detailed data collection five individual sections of the area were selected (A to E on Fig. 2 and Fig. 3). These were chosen to represent a range of conditions reflecting slope, aspect and lithology. Each section extended for 1 km in length along the Escarpment and data were collected from the scarp crest down to the shoreline. In each section the

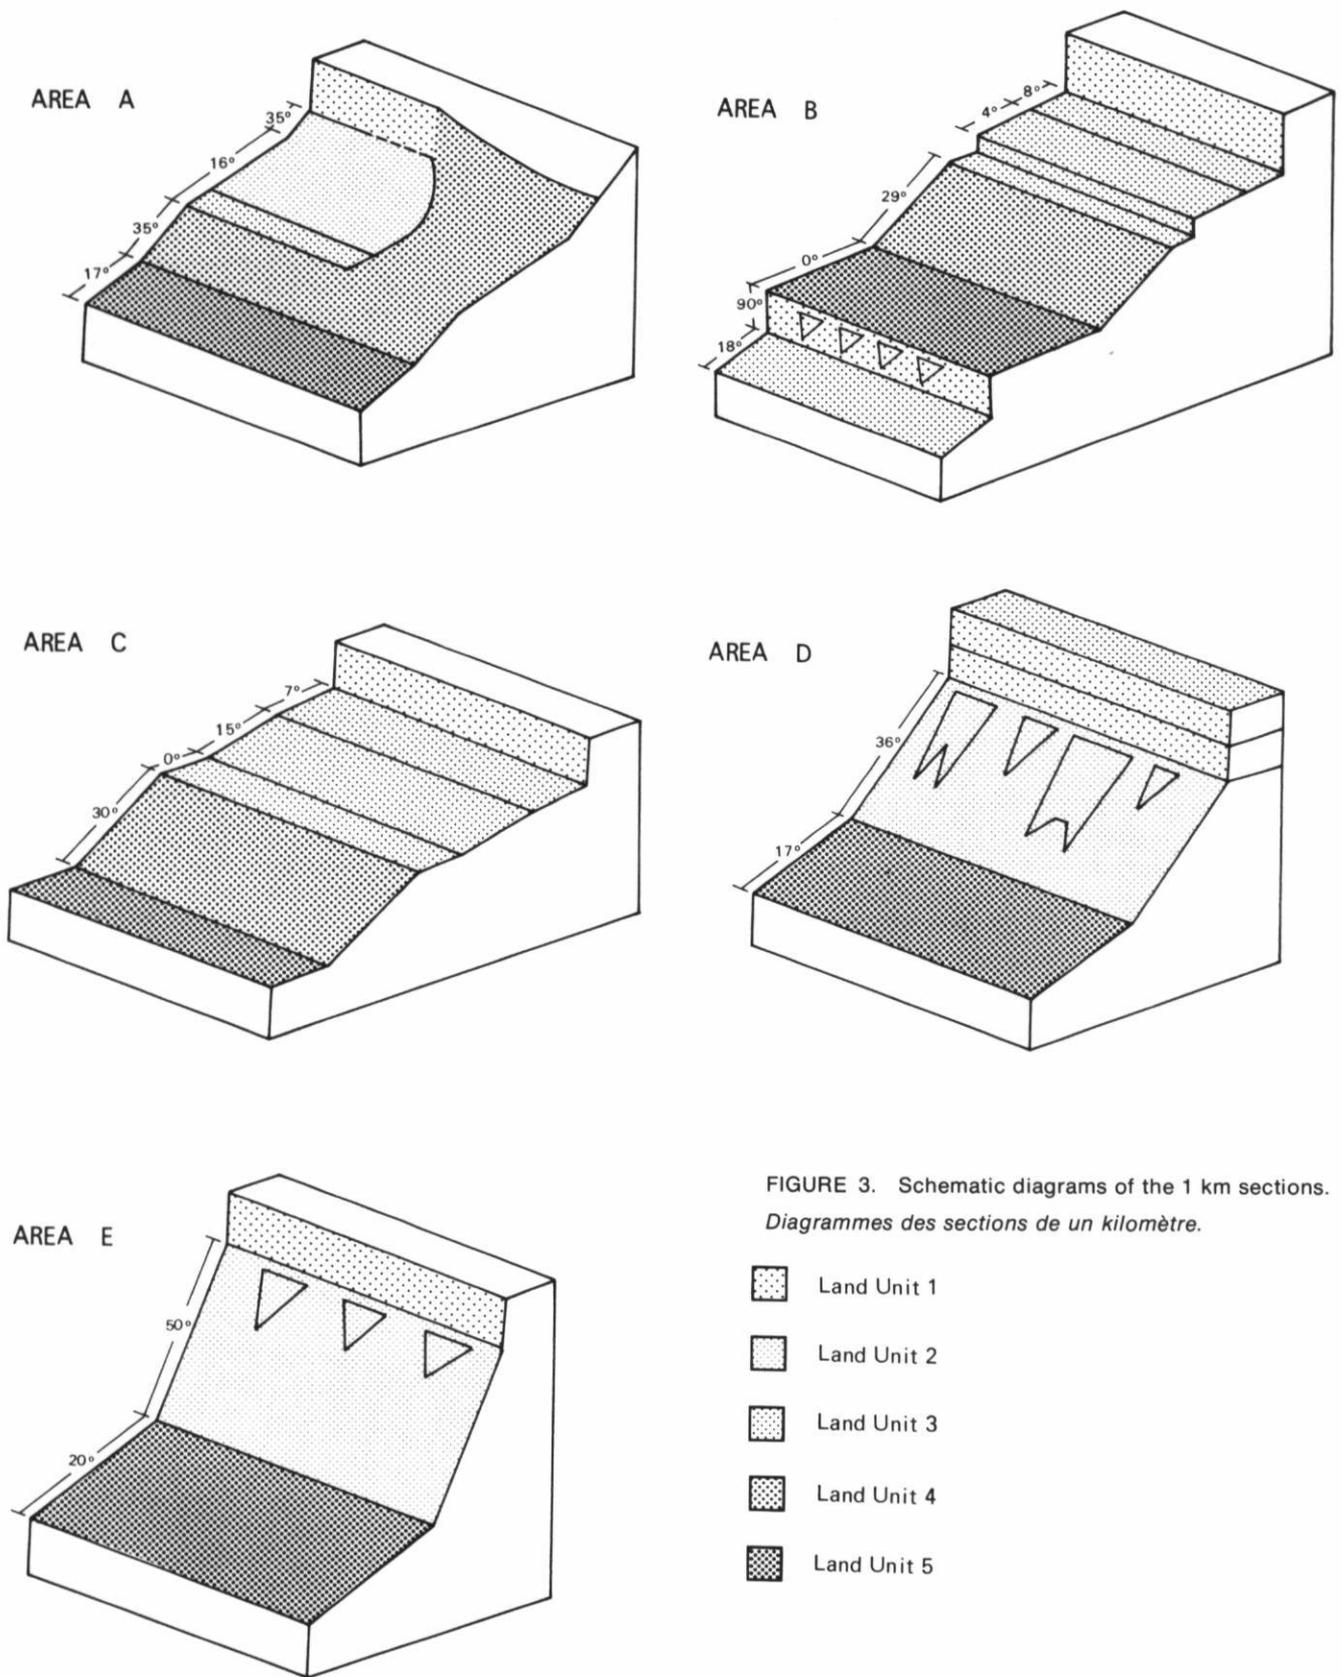
identified. The relative degree of *in situ* weathering of surficial rock debris and soil depth were also recorded. The surface form of each of these 1 km sections is shown in Figure 3.
