## Geomorphic Effects of Flooding Along Reaches of Selected Rivers in the Saguenay Region, Québec, July 1996

G. R. Brooks et D. E. Lawrence

Volume 54, numéro 3, 2000

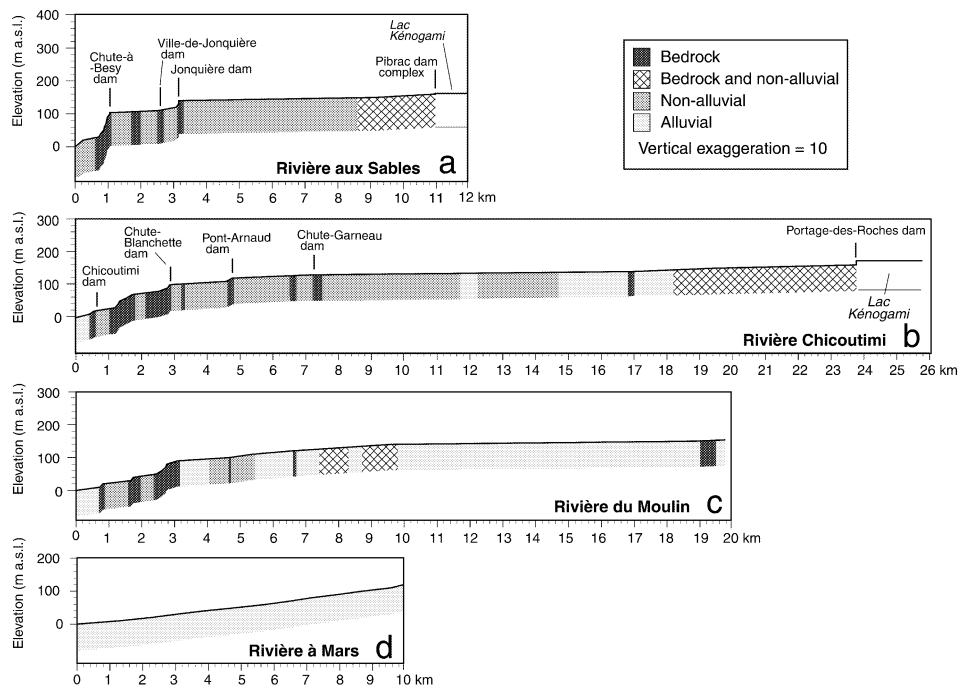
FIGURE 3. Longitudinal profiles and channel morphologies along the a) aux Sables, b) Chicoutimi, c) du Moulin and d) à Mars study reaches.

ing from 0.001 to 0.008) across the lowland surface of the Saguenay Valley, but steepen markedly along the lower 3 km where the channels descend several bedrock steps (Fig. 3a, b and c). On the lowland, the rivers occupy shallow stream-cut valleys that are entrenched roughly 10 to 20 m into the surficial materials and, in places, down to bedrock. Coinciding with the steepening of gradient along the lower 3 km, the valleys are up to 70 m deep and incised into marine sediments, commonly to bedrock. Although occurring well above the influence of the rivers, the sides of the lower aux Sables and du Moulin valleys are subject to instability and several large landslides scars are present (Dion, 1986); the most recent large landslide happened in 1924 (Brzezinski, 1971).

The pre-flood channel morphologies along the aux Sables, Chicoutimi and du Moulin study reaches vary between alluvial, non-alluvial and bedrock (Fig. 3a, b and c). The distinction between alluvial and non-alluvial is based qualitatively on the presence or absence of a floodplain surface along at least one side of the channel. Significantly, there is no obvious evidence of active lateral channel migration along any of the alluvial reaches in pre-flood aerial photographs (*e.g.*, active cutbanks, fresh point bar accretion, a succession of progressively older vegetation with increasing distance from the inner bank of a given meander). The outer banks of the bends regularly are confined against a valley side inhibiting lateral channel migration. The only "classic" example of an alluvial valley bottom was between km 18.9 and 15.2 along the Rivière du Moulin (Fig. 2c), where the channel was partially confined (less than 30 %) against the valley sides and numerous oxbow lakes and channel scars are present on the floodplain<sup>1</sup>. Rapids are present along the bedrock sections of rivers (Figs. 3a, b and c). A total of three and four run-of-the-river dams are situated on the aux Sables and Chicoutimi study reaches, respectively (Figs. 2a and b; Table I), while none are present on the du Moulin study reach.

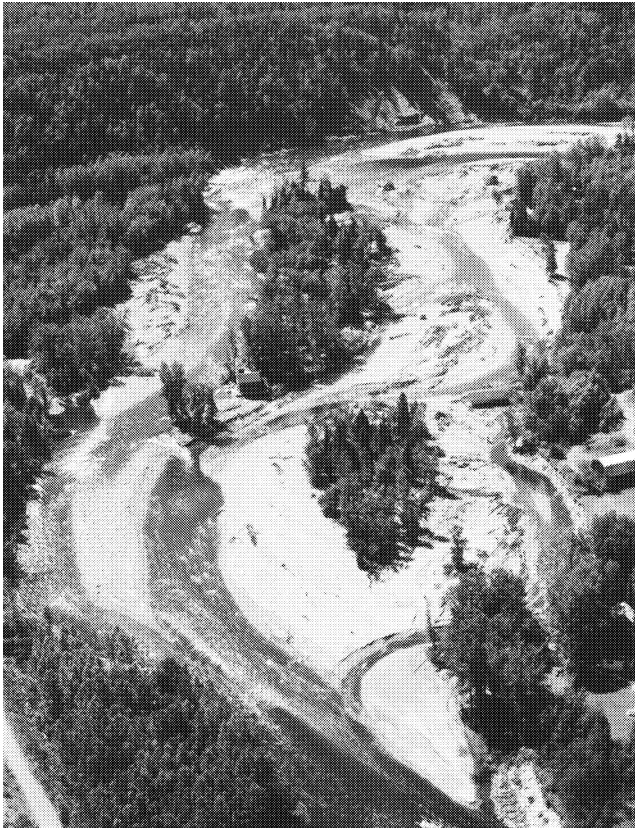
FIGURE 8. Oblique photograph of the post-flood channel of the Rivière à Mars looking upstream of km 8. Note, the multi-channelled character of the river and the broad width of the "flood" channel relative to that of the post-flood flow. Photograph taken July 29, 1996.

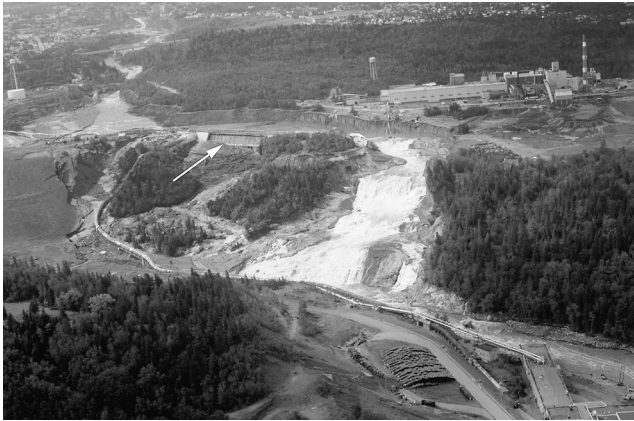
FIGURE 11. Post-flood view of the Chute-à-Besy dam, taken on July 26, 1996. The entire flow of the river has been diverted through the breach, as discussed in the text. The intact, but non-functional dam is marked by an arrow.

The incision at the breaches occurred into cohesive, fine-grained marine sediments, although at the Chute-à-Besy dam, floodwaters initially overtopped and incised an earthen dike (up to 6 m high and 180 m wide). At each location, the incision was arrested by bedrock, except at the Pont-Arnaud dam where it was arrested by a combination of bedrock and marine sediments. The breachings occurred progressively over a period of hours at at least three of the dams (CSTGB, 1997) and did not produce outburst floods downstream. At the Chute-à-Besy dam, the initial stages of incision occurred into an earthen dike (as mentioned above) that conceivably could have eroded much more rapidly relative to the other sites. However, we are not aware that the incision of the dike generated a flood wave downstream that significantly exceeded the overall peak flood discharge along the Rivière aux Sables.

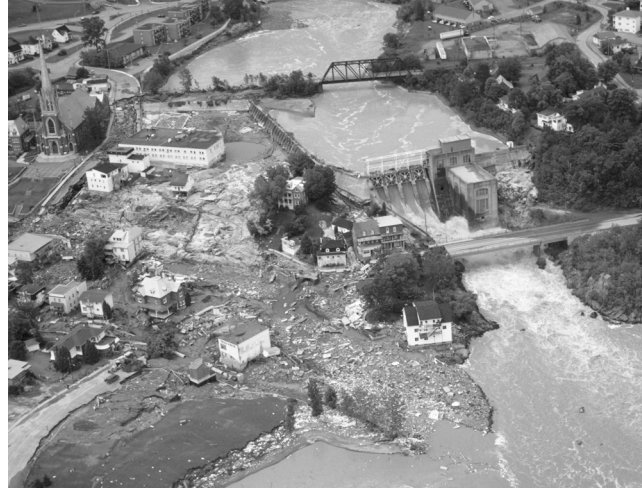
FIGURE 12. Post-flood view of the Chicoutimi dam located in downtown Chicoutimi, taken on July 26, 1996. During the flood, floodwaters overtopped the buttressed concrete wing-wall of the dam that extends to the left of the control structure in the photograph, and flowed rapidly through the residential-commercial area situated immediately down slope. Along the flow path, overburden and road beds were scoured in places to bedrock, and buildings were washed away or damaged. A bar composed of bed materials extends into the pre-flood channel (bottom centre right of photograph), where the flood flow re-entered the river.
