Slope Failure Hazard in the Atlantic Provinces: A Review

Ian Spooner, Martin Batterson, Norm Catto, David Liverman, Bruce Broster,
Kim Kearns, Fenton Isenor et Wayne MacAskill

Volume 49, 2013

Slope failure hazard in Canada's Atlantic Provinces: a review

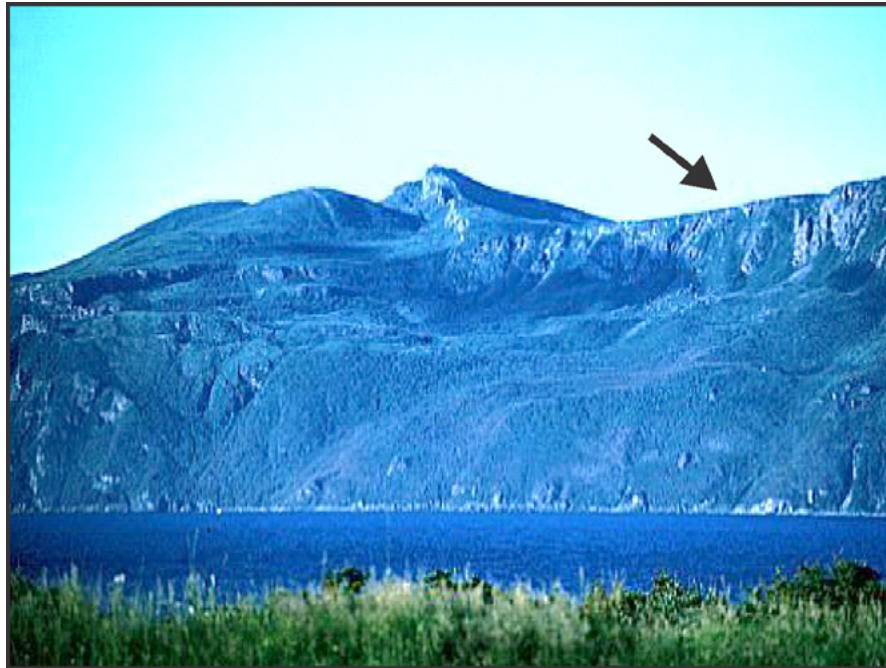
Figure 2. Sacking at Norris Point, Bonne Bay, Newfoundland. This is the largest of 24 examples of sacking in western Newfoundland identified by Grant (1974) and has an estimated volume of 10 km³. The arrow points to the headscarp.

The largest example of a sackung in Newfoundland is at Norris Point in Bonne Bay (Figs. 1, 2), where a rock mass estimated at 10 km^3 has moved vertically by approximately 100 m (Fig. 2; Grant 1974). The head of the failure consists of a complex arrangement of scarps and fissures that align roughly parallel with regional jointing. Grant (1974) suggested that the failure of these dense ultramafic rocks (which were thrust over relatively weak shale and carbonate during the early Paleozoic) was caused in part by the oversteepening of the fjord wall during the last glaciation. The deep-seated failure occurred along the basal thrust contact and spreading resulted on all slopes along Bonne

Bay. Although the failure was initiated post-glacially, a more precise age of failure has not been determined. Visual examination from 1974 to 2003 suggested that no discernable movement was occurring during that time.

The causal mechanism for the Bonne Bay and other sackung throughout western Newfoundland remains uncertain. The locations of the sackungen do not coincide with fault escarpments, making tectonic disturbance unlikely. As the majority of sackungen are located adjacent to glacially over-steepened valleys, the failures appear to have developed in response to the removal of laterally supporting bedrock during glaciation, triggering lateral expansion

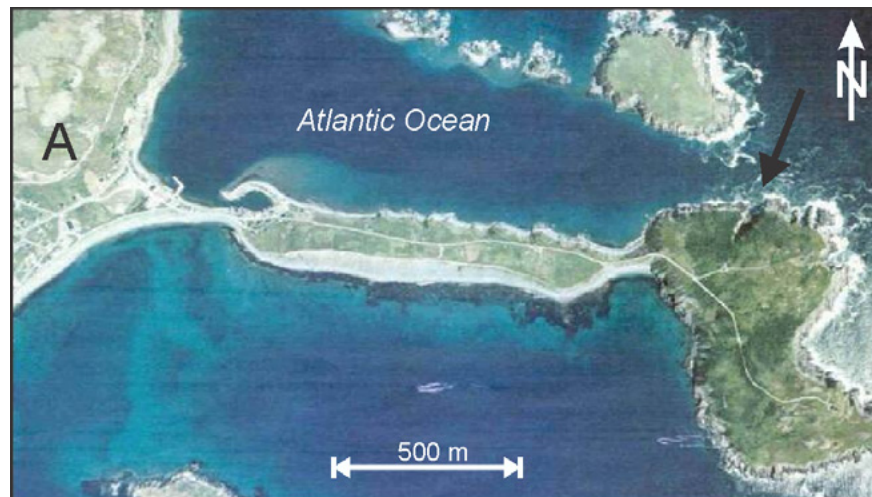
Figure 3. Ferryland Harbour, eastern Newfoundland. The village of Ferryland is to the left (A). The arrow points to “Deadman’s Gulch”, believed to be the site of a rockfall that killed 42 fishermen.

An intriguing story of what may be Canada’s fourth-worst landslide disaster was recounted in the Newfoundland Quarterly of March 1902 (White 1902). White reported a cave-in at Deadman’s Gulch in Ferryland Harbour that apparently occurred in 1823 (Figs. 1, 3, 4). Although the report is detailed, White did not indicate the source of his information. Corroboration of the story has proved difficult — few newspapers were published at the time, and archives of those that were published have much of 1823 missing.

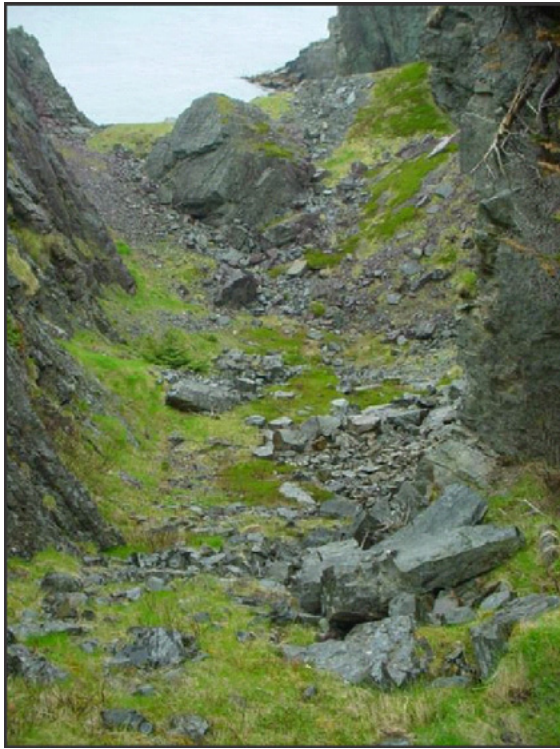
Figure 4. Deadman's Gulch at the entrance to Ferryland Harbour. Before the collapse, the site was believed to have been a sea cave that was frequented to catch baitfish and as a refuge during storms. The large boulder in the background is approximately 10 m across.

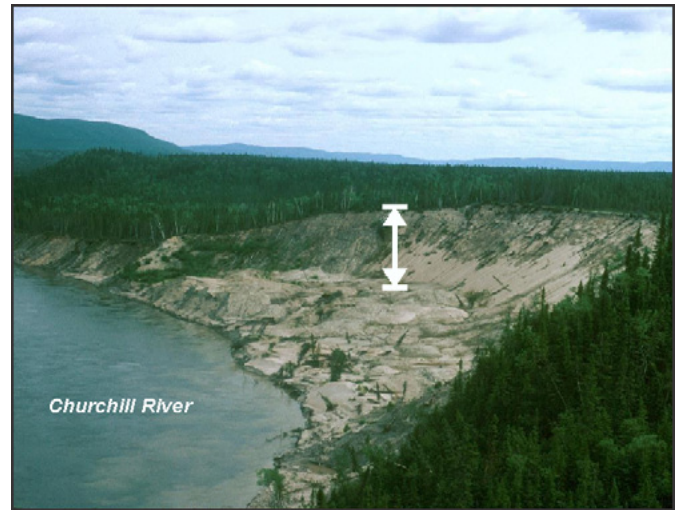
Figure 5. A large rotational slump on the east side of the lower Churchill River, Labrador. The active sediment is glaciomarine mud and overlying sand and gravel. Sliding was likely initiated by fluvial undercutting that over-steepened the slope. Scale bar is approximately 20 m high.

The lower Churchill River between Gull Island and Muskrat Falls shows numerous slope failures typical of many of the major valleys in coastal Labrador whose floors are underlain by glaciomarine silt and clay (Figs. 1, 5). As this area is the site of a proposed major hydro-electric dam, the potential for slope failures needs to be evaluated.

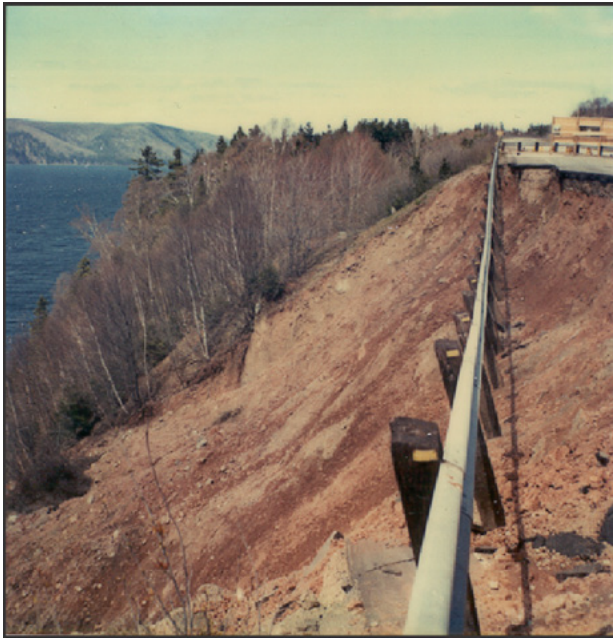
Figure 9. Debris-flow deposit at Kelly's Mountain, Cape Breton Island, Nova Scotia. This landslide has been characterized as a translational failure that developed into a debris flow.

The largest recent landslide consisted of a series of slope failures that caused near complete destruction of the road at Kellys Mountain on Cape Breton Island in 1982 (Figs. 1, 9). A creosote wood culvert had been installed earlier to take runoff from the south side of the highway to a gully on the north slope, guiding the flow into St. Anns Harbour. The principal cause of the 1982 slide was likely water seepage from the deteriorated culvert. This, combined with water from spring thaw and rainfall, saturated the soil surrounding the culvert and caused erosion at the base of the slope, which

resulted in a number of failures in late spring 1982. Bedrock underlying the gully may also have created natural failure planes for the saturated soil. The landslide was characterized as a translational slip failure that developed into a debris flow.

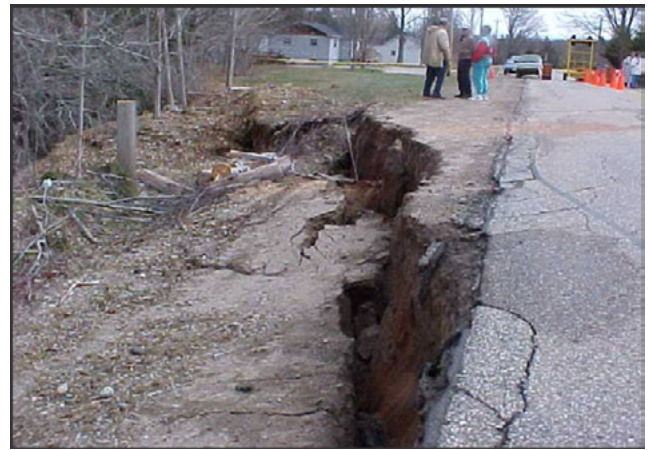
Figure 10. A large rotational slump in Middleton, Nova Scotia. This landslide was associated with fluvial erosion of 20 m-high slope along the Annapolis River when the water table was elevated activating a failure plane between impermeable clay-rich till and overlying outwash sediment.

Other smaller landslides frequently affect transportation routes in Nova Scotia, most commonly in spring, as thawing of frozen ground leaves slopes saturated. A large rotational slump occurred on the north side of Highway 201 near Middleton in late April 2003 and resulted in prolonged highway closure (Figs. 1, 10). Site investigation indicated that the Annapolis River was actively eroding the toe of a 20 m-high slope, which exhibited irregular topography and displayed evidence of previous movement, including tension cracks. The stratigraphy of the site is typical of the region: greater than 4 m of fluvial/glaciofluvial sand and gravel overlies sandy-clayey till and, in some cases, glaciomarine clay. Geotechnical analysis of the site indicates that two triggers most likely contributed to the slide: removal of toe support and a rise in the water table activating the failure plane between the outwash sediment and the impermeable clay-rich sediments.

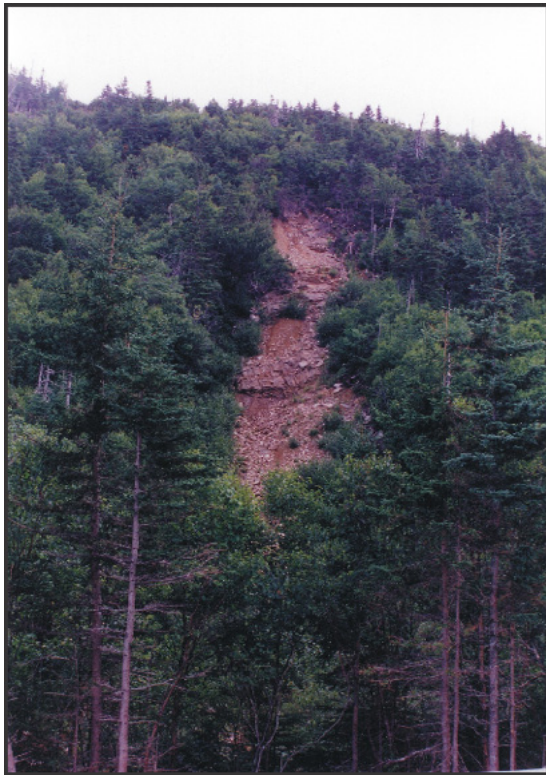
Figure 11. Debris-flow scar in the Cape Breton Highlands, Nova Scotia. These failures are typically complex and may involve rock topple, rotational slip, translational sliding and flow.

Finck (1993), Grant (1994), and Wahl (2003) have identified numerous debris flow/avalanche scars in the Cape Breton Highlands (Figs. 1, 11, 12). These complex failures involve rock topple, rotational slip, translational sliding and flow (Finck 1993, Wahl 2003, Wahl *et al.* 2003). Although

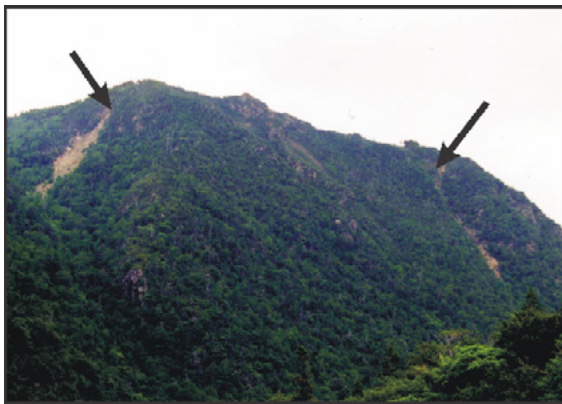
Figure 12. Debris-flow scars in the Cape Breton Highlands, Nova Scotia. Failure has been associated with excess water at the contact between colluvium and underlying weather bedrock or till.
