## Some Twentieth-Century Canadian Earthquakes

Anne E. Stevens

Volume 4, numéro 1, march 1977

Stevens, A. E. (1977). Some Twentieth-Century Canadian Earthquakes. *Geoscience Canada*, 4(1), 41–45.

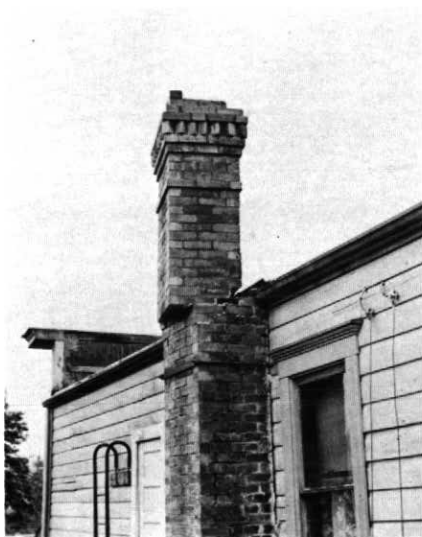
**Figure 2**

June 23, 1946. Chimney damage at Port Alberni, B.C. The house was not built on rock. (Fig. 19 in Hodson, 1946).

Figure 2 is a photograph taken in Port Alberni, about 55 km south of the epicentre. The chimney was broken at the roof line and rotated. Most of the chimneys affected in Port Alberni were buildings located on low-lying land. Houses built on rock were little damaged.

Chimney damage has been the most common type of damage in all Canadian earthquakes that have caused damage. In many cases houses were built on poor soil, which amplified vibrations, or chimneys were old or in need of repair. Thus chimney damage is not a direct measure of the size of an earthquake. One must endeavour to determine the probable condition of the chimney before the shock and the type of material beneath the building - whether soil or rock. If such information is not available, then the approximate proportion of damaged chimneys within a community may indicate whether the damage was due chiefly to the strength of the earthquake, or to soil amplification or some prior defects in the chimneys. This is an important consideration when reading descriptions of early earthquakes for which there were no instrumental recordings. An estimate of the size of such earthquakes must be based on a careful evaluation of reports of damage.

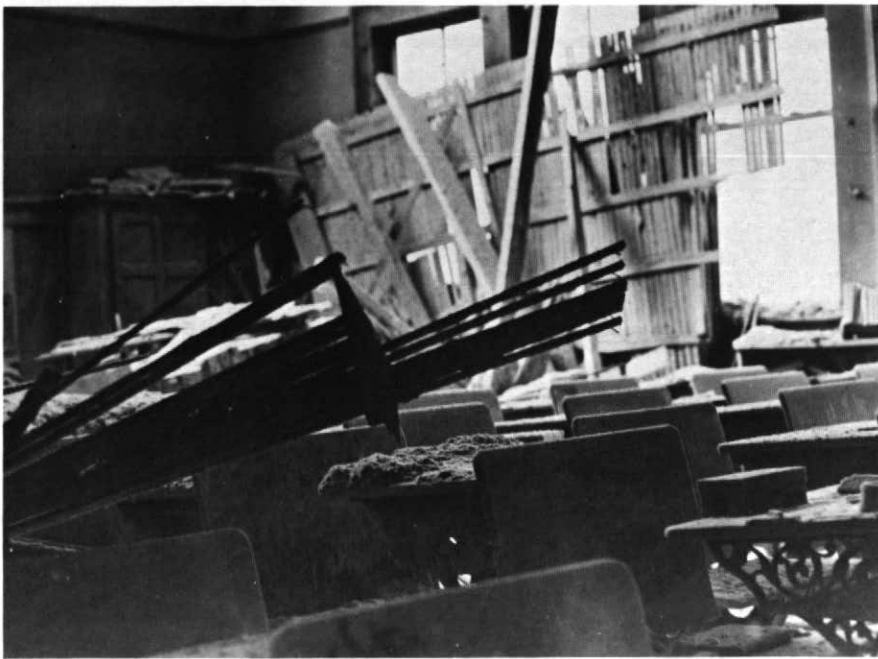
Chimney damage sometimes induces other damage. Figure 3b shows the interior of a schoolroom in Courtenay about 25 km south of the epicentre of the 1946 earthquake. Fortunately, the shock occurred about 10 a.m. local time on a Sunday morning when the classroom was empty. Damage here was caused when the large school chimney fell through the roof. In Courtenay about 25 per cent of the chimneys were damaged, mostly in the central part of town. Windows and bottles were cracked in some stores.

**Figure 3**  
June 23, 1946. Elementary School,  
Courtenay, B.C. The chimney, located above

the front entrance, fell sideways through the roof into a classroom. (Figs. 16 and 15, respectively, in Hodgson, 1946).
