Contemporary Subsidence and Ground Movement, Southwestern Ontario: Possible Bedrock Controls Affaissement et mouvements de terrain récents dans le sud-ouest de l'Ontario, probablement issus de la roche en place

Hendrik Veldhuyzen

Volume 47, Number 3, 1993

CONTEMPORARY SUBSIDENCE AND GROUND MOVEMENT, SOUTHWESTERN ONTARIO: POSSIBLE BEDROCK CONTROLS

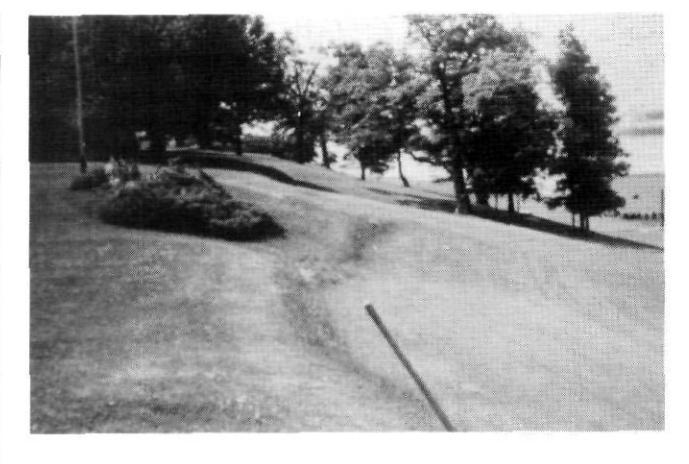
FIGURE 2. Trace of the continuous scarp, visible as a dark strip of grass. Located 1 km north of Mooretown.

Tracé de l'escarpement continu, qui apparaît comme un ruban d'herbes sombre, situé à 1 km au nord de Mooretown.

The central area of ground subsidence lies 2 km north of area 1 (Fig. 1). It extends in a north-northeasterly direction from just north of Mooretown to the village of Corunna, a distance of 6 km. The southern 1.5 km interval, nearest the village of Mooretown, is marked by a distinct, continuous scarp (Fig. 2). In contrast, the northern 4 km interval is discontinuous and no clear scarp was produced.

All ground subsidence in this area has occurred along a moderate to steep slope which has an approximately 15 m vertical drop over a lateral distance of less than 75 m. The subsidence-induced scarp is not confined to any particular part of the slope, but occurs at the top, in the middle and at the base, which is approximately 1 m above the level of the river high-water mark. Sinking on the southern 1.5 km section was first noticed as episodic, instantaneous drops on a northnortheasterly line that produced the 30 to 40 cm scarps. Short sections of scarp propagated along strike, eventually coalescing with adjacent drops to form a laterally continuous feature. Attempts by residents to level the relief by adding topsoil have not obscured the scarp line which remains visible as a distinct dark grass strip (Fig. 2), reflecting increased moisture and nutrient input along the ground rupture. One home was structurally damaged (Fig. 3), and was subsequently replaced. Adjacent to the damaged home, a buried electrical cable and waste line to a septic tank were severed by an instantaneous 20-30 cm drop. The septic system has been reconnected and severed again at least twice.

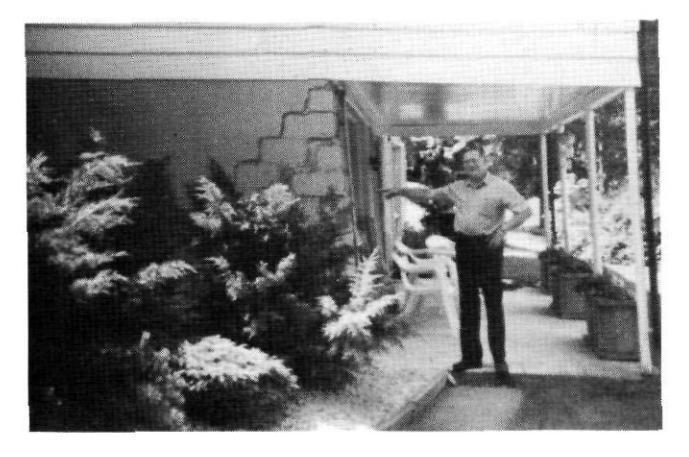
FIGURE 3. A structurally damaged home with a fractured concrete foundation and a downwarped overhang. Note that the supporting columns and the walls are no longer vertical. This house was replaced with a new one upslope, and away from the area of ground movement.

Structures d'une maison endommagées avec fracture dans les fondations de béton et affaissement. Noter que les poutres de soutien et les murs ne sont plus verticaux, Une nouvelle maison située plus haut, loin des mouvements de terrain, remplace la maison endommagée.

The northern section of the area 2, extending into the community of Corunna, lacks a laterally continuous scarp. It is recognized mainly by damage to buildings and truncation of a municipal water main. The water main was broken in two

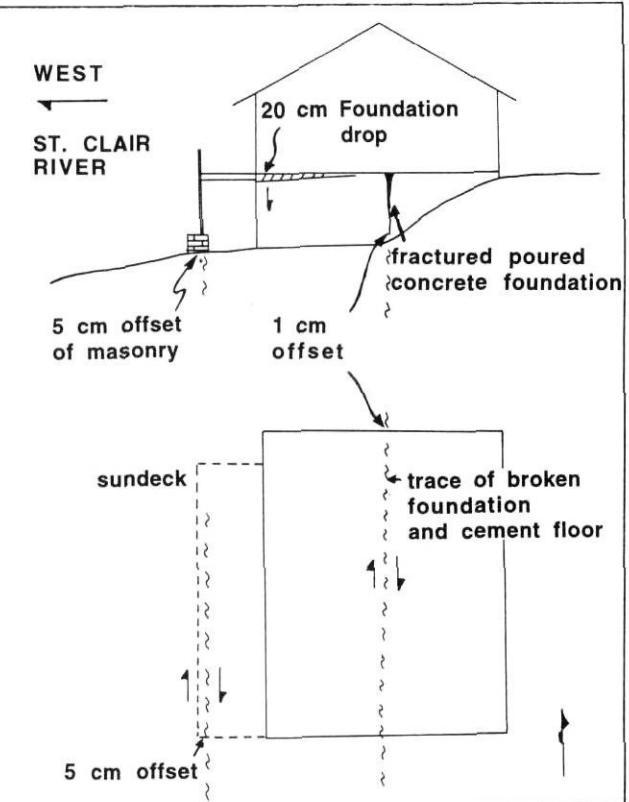
FIGURE 4. Plan (bottom) and cross section (top) schematic views of the home which underwent strike-slip displacement of a poured concrete foundation along with a 25 to 30 cm vertical displacement. There was parallel strike-slip displacement of masonry adjacent to the house.

Coupe (haut) et plan (bas) schématiques de la maison dont les fondations de béton ont été fracturées avec rejet vertical de 25 à 30 cm. On a observé un décrochement parallèle sur un ouvrage en pierre près de la maison.

The poured concrete foundation of a river front home showed 1 cm of right-lateral slip, along a north-south break, in addition to a vertical drop of 25-30 cm with the west (river) side down. Masonry supporting the attached porch of the same building, located 7 m west of the displaced foundation, underwent a 5-cm parallel strike-slip displacement without any apparent vertical offset (Fig. 4).

Right lateral displacement (Fig. 4) along a north-northeast trend is consistent with the current ambient stress field in which the greatest principal horizontal compressive stress is oriented N54°E (Plumb and Cox, 1987). High lateral stress, associated with karst collapse, has been documented at three sink holes near Windsor (Nieto et al., 1983). The removal of material by dissolution along a structural break might be expected to provide the focus for stress release which, in the current stress field, could be accommodated by dextral slip along north-northeast oriented faults. The 1922 intensity III earthquake (Smith, 1962), 10 km to the north, appears to lie near the projected strike of the linear zone of subsidence in the Mooretown-Corunna area. An immediate, detailed investigation is required to verify or refute the suspected cause of subsidence, as interpreted in this paper, not only because of the neotectonic implications of the deformation, but because of the on-going risk to people and property.
