Active Earth: The Development of Big Slide, near Quesnel, British Columbia, between 1953 and 1982

Volume 9, Number 4, December 1982

The Development of Big Slide, near Quesnel, British Columbia, between 1953 and 1982.

Stephen G. Evans
 Department of Geology
 University of Alberta
 Edmonton, Alberta T6G 2E3

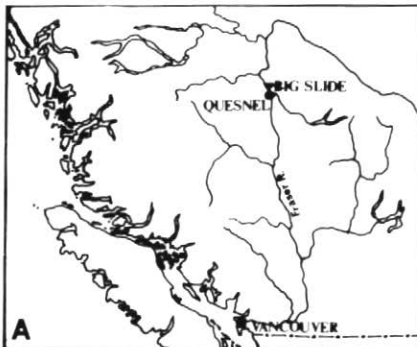
Figure 1A: Location of Big Slide within Fraser River system.

Big Slide is an extensive landslide complex on the east side of the Fraser River at the Big Bend, Moose Heights, 11.7 km north of Quesnel, British Columbia (Fig. 1). Aerial photographs dating from 1953, and field observations since 1973, show rapid landscape changes due to retrogressive slope movements. Changes are noticeable on a month to month basis and farmers in the vicinity mention the
