The Restorations of the Westminster Abbey Chapter House

Steven H. Wander

Wander, S. H. (1977). The Restorations of the Westminster Abbey Chapter House. *RACAR : Revue d'art canadienne / Canadian Art Review*, 4(2), 78–90.
<https://doi.org/10.7202/1077358ar>

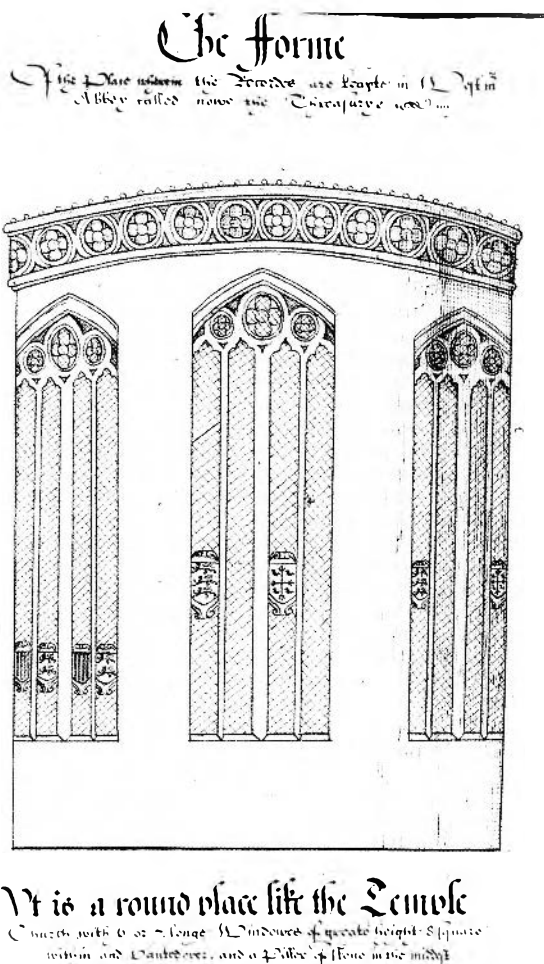
FIGURE 1. Chapter House, Westminster Abbey, early 17th century. Oxford, Bodleian Library, Rawlinson MS. C. 704, f. iii.

seventeenth-century manuscript (Fig. 1) includes a description: “The forme of the place wherein the Records are keapte in Westm. Abbey, called nowe the Threasurie. Yt is a round place like the Temple Church, with 6 or 7 longe windowes of greate height, 8 square within, and vaulted over, and a pillar of stone in the midst.” The shields-of-arms in the windows depict with some inaccuracies the arms of King Henry III (*gules three leopards or*), Saint Edward the Confessor (*a cross paly between five martlets or*), and Count Raymond of Provence (*or four pales gules*).¹¹ These escutcheons may copy original grisaille glass from the chapter house, but the tracery of all three windows shows a large quatrefoil head rather than the sexfoil depicted in later views. This inconsistency casts doubt not only on the authenticity of the window designs but also on the quatrefoil band encircling the building which is not illustrated elsewhere.

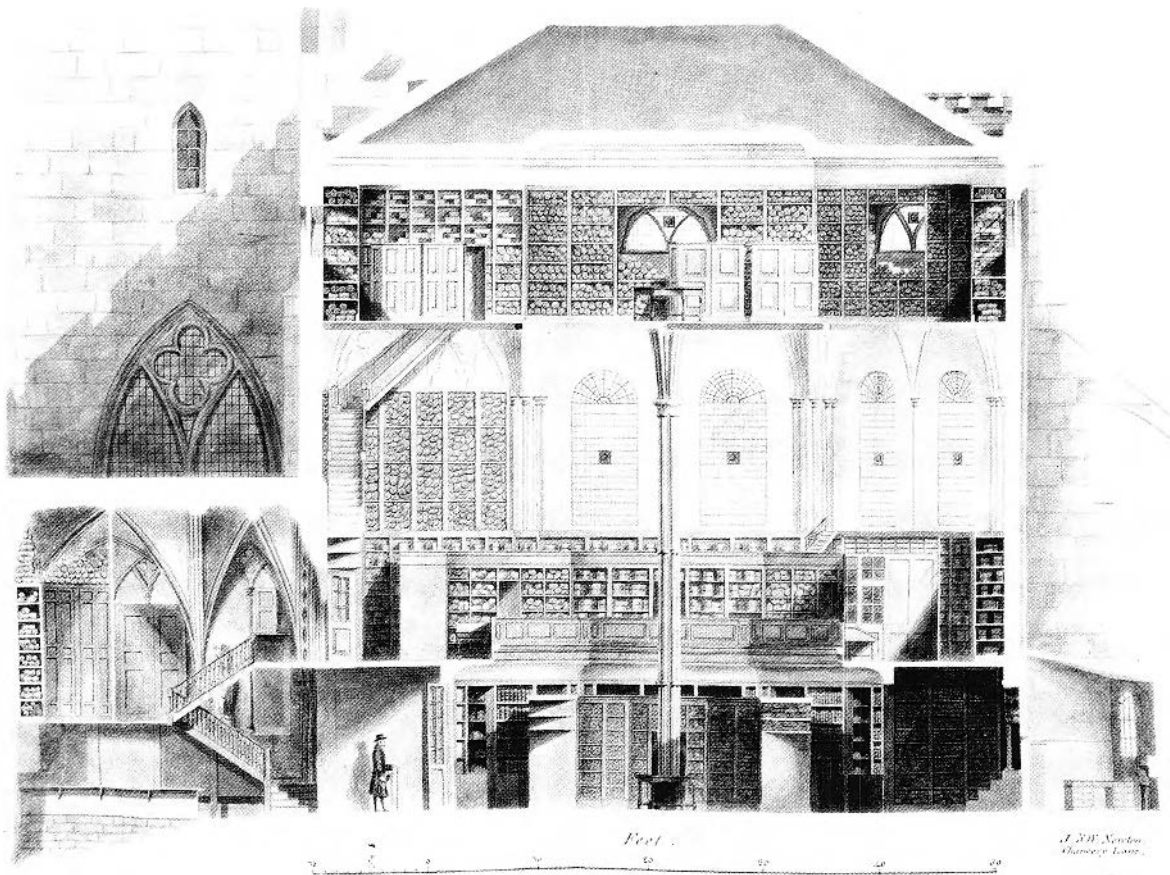
SECTION OF THE CHAPTER-HOUSE
WESTMINSTER

FIGURE 4. Chapter House, Westminster Abbey, Section, 1807. London, Public Record Office, MPB 2/99/1 (formerly OBS 692).

rebuild the window with tracery identical to the other chapter house windows. The central shaft of the doorway (Figs. 4, 5) had disappeared, and Scott here introduced a pair of trefoil arches and oculus in which were eventually placed back-to-back figures of God the Father — no doubt to many the most disturbing feature of Scott's restoration. During construction Scott replaced these round trefoil arches with acutely pointed ones similar in profile to the arch at the right of the entrance. The arches and trefoils above contained the thirteenth-century *Annunciation* group with censuring angels which had survived *in situ* behind record office presses.⁴³

The second drawing (Fig. 14) shows the elevation of the other interior bays, the black Purbeck marble shafts being indicated with wash. Scott established the window design from original blind tracery which survived in the northwestern bay. In the section from the *General Inventory* (Fig. 4), blind tracery of four lights with quatrefoils appears clearly beyond the staircase while a portion of the sexfoil head peeks

from behind a door in the adjacent attic storey. In addition, some mediaeval tracery mullions survived, as for example the one shown bricked-up in the northeastern window. The *General Inventory* plan (Fig. 5) reveals that all the bases of the wall arcade shafts had survived, despite the openings made through the wall into Wyatt's offices and the North Walk.

The drawings numbered 3 and 4 show the longitudinal section and ground plan of the chapter house and vestibule (Figs. 15, 16). Scott had already removed the staircase leading to the chapter library from the northern aisle of the outer vestibule and rebuilt the destroyed vaults.⁴⁴ A view of 1782 shows that a portion of the wall arcade in the south aisle, along with the vaulting, had survived, and upon this Scott was able to base his restoration.⁴⁵ As shown in the section in the *General Inventory* (Fig. 4), original tracery with two pairs of twin lights and quatrefoils

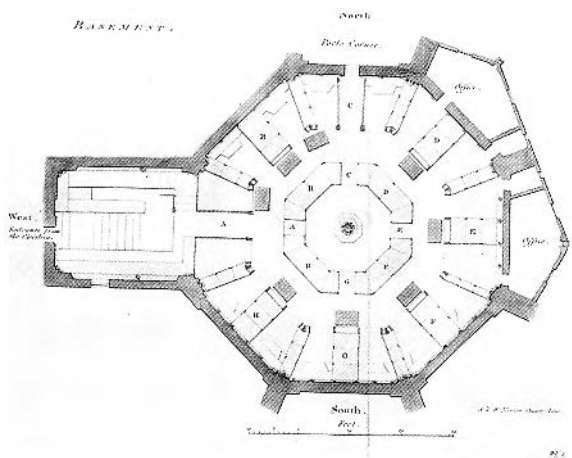
FIGURE 5. Chapter House, Westminster Abbey, Plan of the Ground Floor ("Basement"), 1807. London, Public Record Office, MPB 2/99/2 (formerly OBS 692).

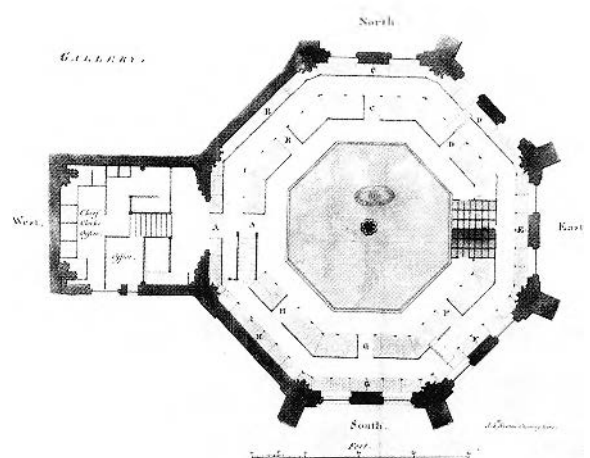
FIGURE 6. Chapter House, Westminster Abbey, Plan of the Gallery, 1807. London, Public Record Office, MPB 2/99/3.

in a view of the "Chief Clerk's Office" from the *General Inventory* (Fig. 8). Furthermore, a plan of the Chief Clerk's Office (Fig. 6), even though indicating other tracery mullions, shows no shafts on the west wall of the inner vestibule. If this arcading existed in 1807, it is difficult to explain why the draftsmen of the *General Inventory*, so sensitive to other tracery survivals, failed to record it.

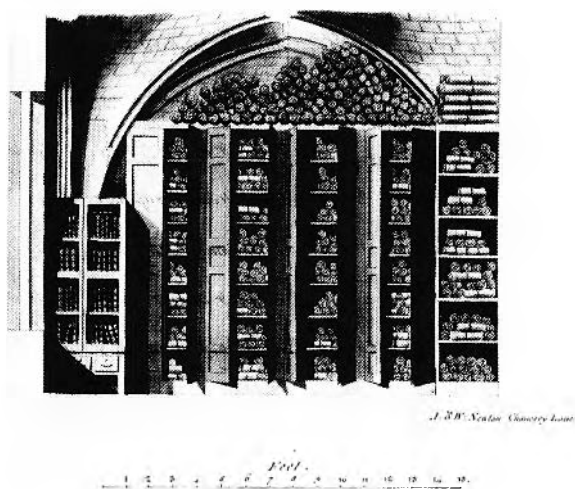
CHIEF CLERK'S OFFICE.

FIGURE 8. Chapter House, Westminster Abbey, West Wall of the Inner Vestibule, 1807. London, Public Record Office, OBS 692.

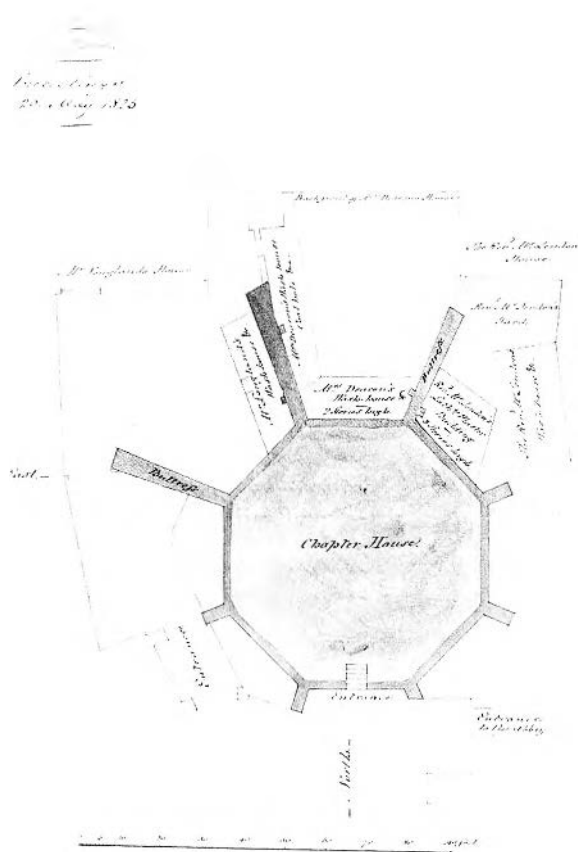
FIGURE 9. John Soane, *Chapter House Precinct Plan, Westminster Abbey*, 1825. London, Public Record Office, Works, 1/13, 348.

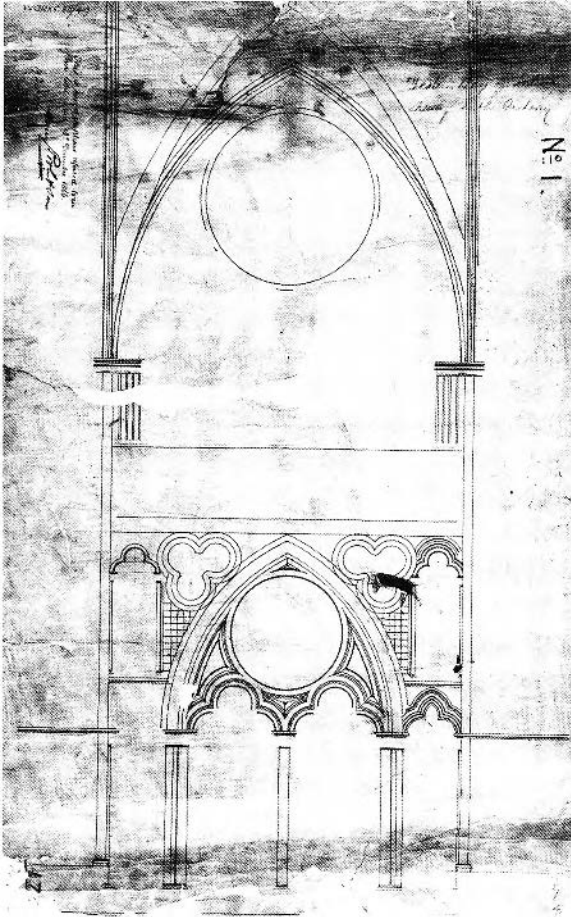
FIGURE 13. G.G. Scott, Chapter House, Westminster Abbey. Entranceway, 1866. London, Public Record Office, Works, 38/49.

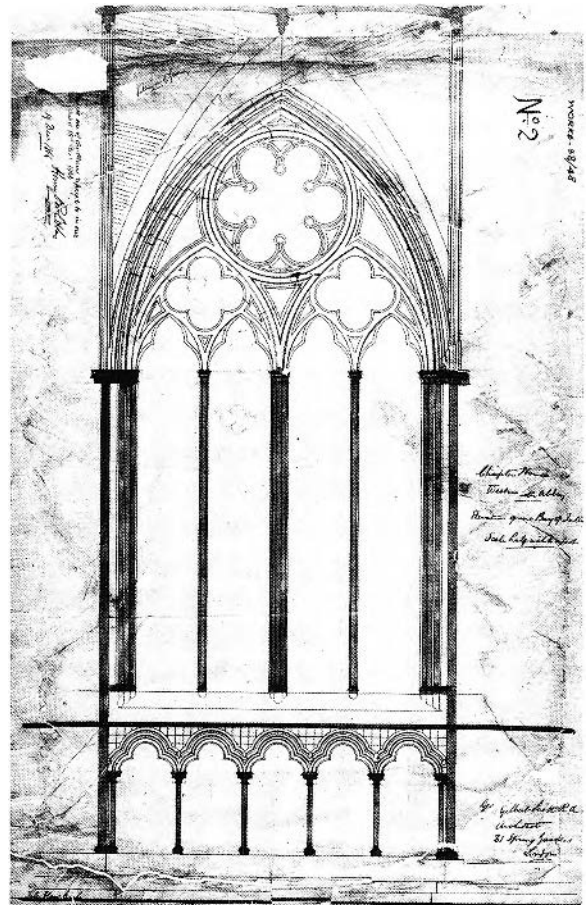
FIGURE 14. G.G. Scott, Chapter House, Westminster Abbey. Interior Elevation, 1866. London, Public Record Office, Works 38/48.

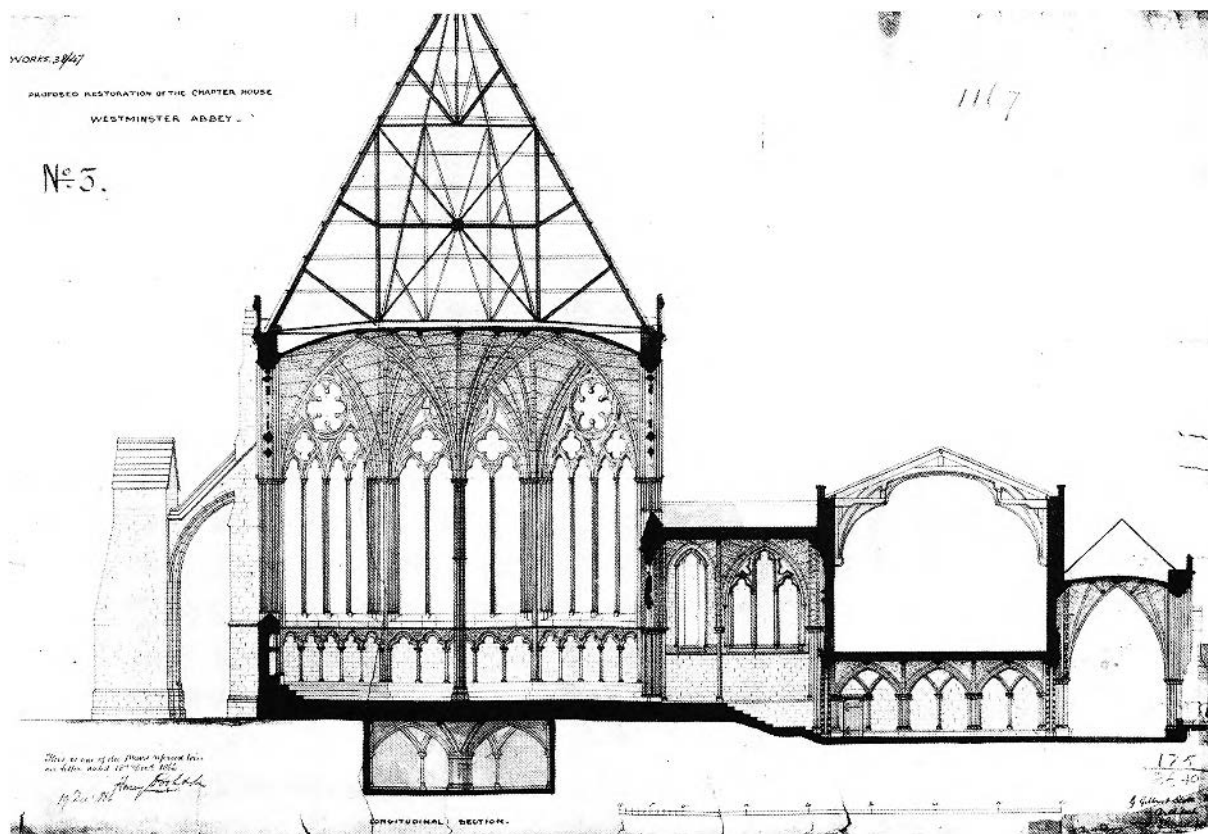
FIGURE 15. G.G. Scott, Chapter House, Westminster Abbey, Longitudinal Section, 1866. London, Public Record Office, Works 38/47.

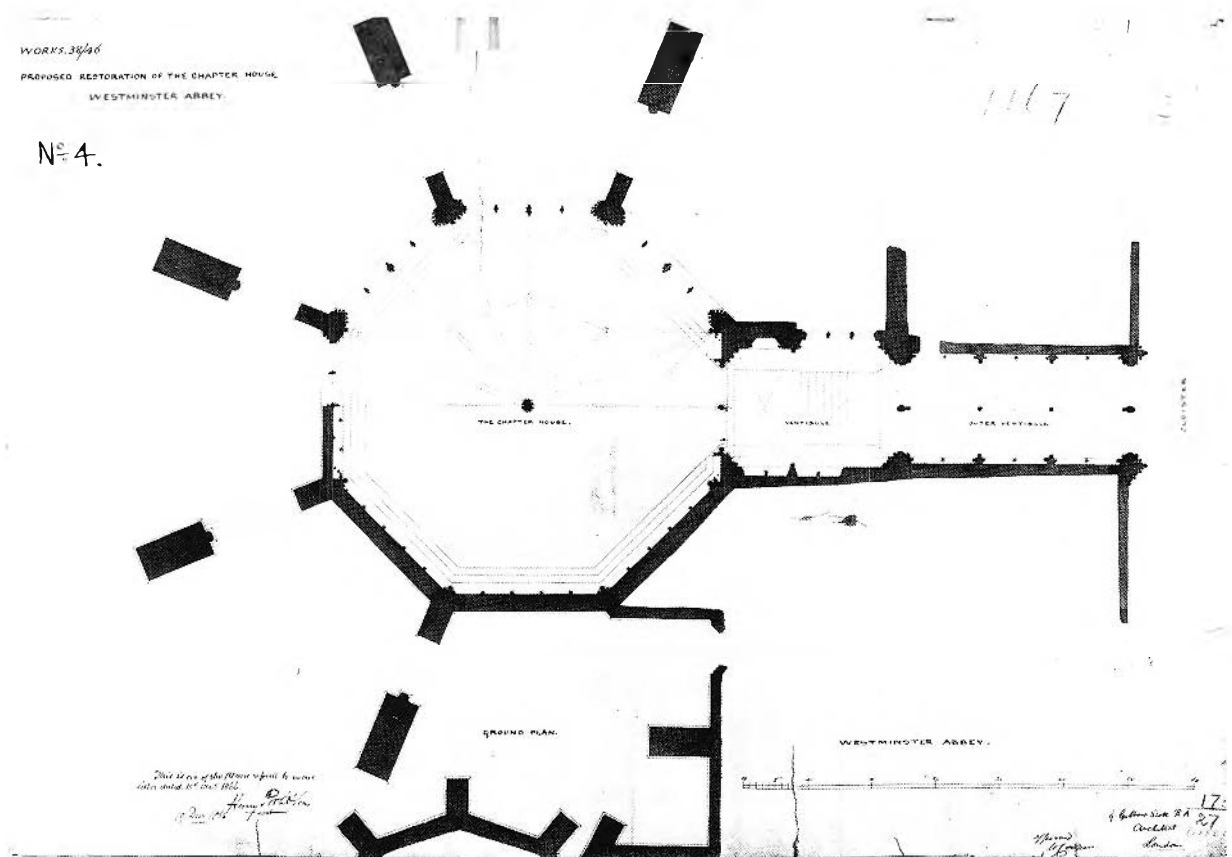
FIGURE 16. G.G. Scott, Chapter House, Westminster Abbey, Ground Plan, 1866. London, Public Record Office, Works 38/46.

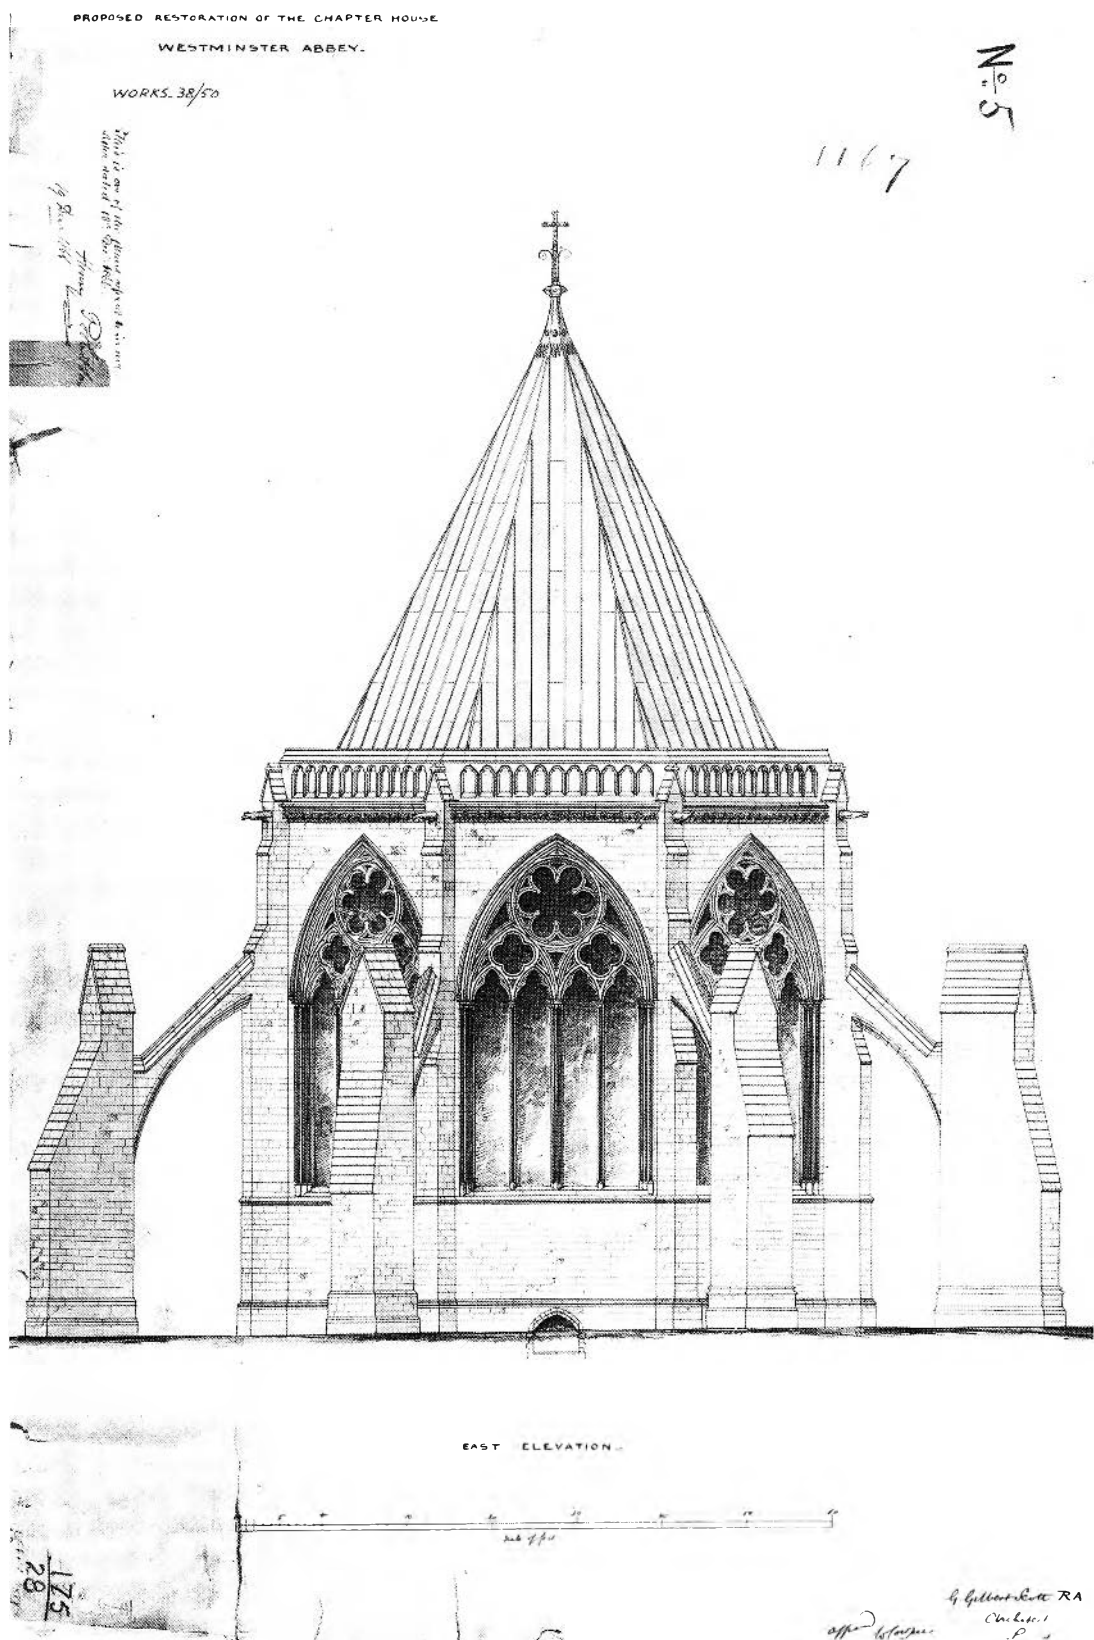
FIGURE 17. G.G. Scott, Chapter House, Westminster Abbey, East Elevation, 1866. London, Public Record Office, Works 38/50.

The fifth drawing of 1866 (Fig. 17) shows the eastern view of the exterior of the chapter house crowned by Scott's pyramidal roof. Scott reintroduced tracery into the blocked windows and, along with replacing the buttress at the northeast corner, redesigned the flyers. The wall buttresses were provided with elegant gable caps similar to those of the flyers and with water spouts in the form of gargoyles. At the summit of the wall, Scott substituted a parapet of blind arcading for the older battlements "of brick, with a stone coping."⁵¹ During the course of construction, Scott altered the design of this parapet by introducing diaperwork panels and adding tall pinnacles at the corners to continue the vertical lines of the wall buttresses.
