The Restorations of the Westminster Abbey Chapter House

Steven H. Wander

Wander, S. H. (1977). The Restorations of the Westminster Abbey Chapter House. *RACAR : Revue d'art canadienne / Canadian Art Review*, 4(2), 78–90.
<https://doi.org/10.7202/1077358ar>

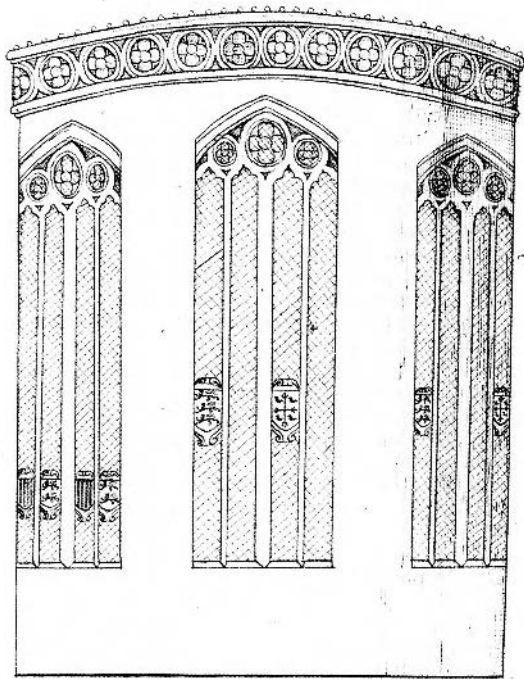
FIGURE 1. Chapter House, Westminster Abbey, early 17th century. Oxford, Bodleian Library, Rawlinson MS. C. 704, f. iii.

seventeenth-century manuscript (Fig. 1) includes a description: “The forme of the place wherein the Recordes are keapte in Westm. Abbey, called nowe the Threasurie. Yt is a round place like the Temple Church, with 6 or 7 longe windowes of greate height, 8 square within, and vaulted over, and a pillar of stone in the middest.” The shields-of-arms in the windows depict with some inaccuracies the arms of King Henry III (*gules three leopards or*), Saint Edward the Confessor (*a cross paly between five martlets or*), and Count Raymond of Provence (*or four pales gules*).¹¹ These escutcheons may copy original grisaille glass from the chapter house, but the tracery of all three windows shows a large quatrefoil head rather than the sexfoil depicted in later views. This inconsistency casts doubt not only on the authenticity of the window designs but also on the quatrefoil band encircling the building which is not illustrated elsewhere.

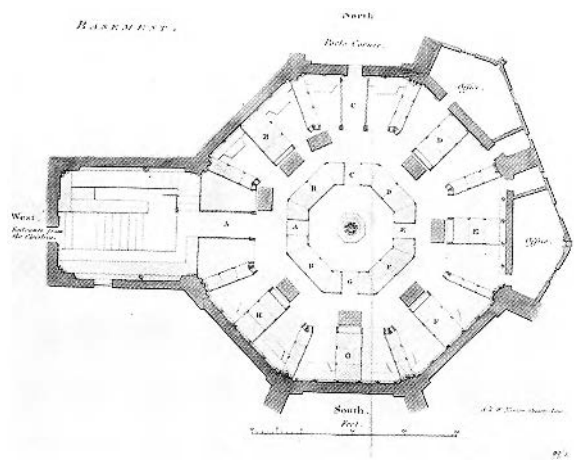
FIGURE 5. Chapter House, Westminster Abbey, Plan of the Ground Floor ("Basement"), 1807. London, Public Record Office, MPB 2/99/2 (formerly OBS 692).

rebuild the window with tracery identical to the other chapter house windows. The central shaft of the doorway (Figs. 4, 5) had disappeared, and Scott here introduced a pair of trefoil arches and oculus in which were eventually placed back-to-back figures of God the Father — no doubt to many the most disturbing feature of Scott's restoration. During construction Scott replaced these round trefoil arches with acutely pointed ones similar in profile to the arch at the right of the entrance. The arches and trefoils above contained the thirteenth-century *Annunciation* group with censuring angels which had survived *in situ* behind record office presses.⁴³

from behind a door in the adjacent attic storey. In addition, some mediaeval tracery mullions survived, as for example the one shown bricked-up in the northeastern window. The *General Inventory* plan (Fig. 5) reveals that all the bases of the wall arcade shafts had survived, despite the openings made through the wall into Wyatt's offices and the North Walk.

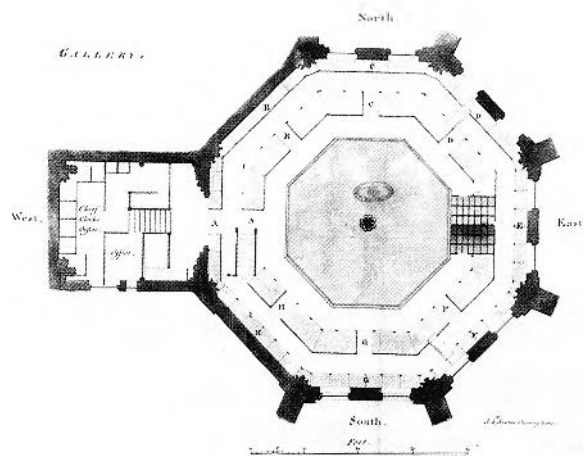
FIGURE 6. Chapter House, Westminster Abbey, Plan of the Gallery, 1807. London, Public Record Office, MPB 2/99/3.

in a view of the "Chief Clerk's Office" from the *General Inventory* (Fig. 8). Furthermore, a plan of the Chief Clerk's Office (Fig. 6), even though indicating other tracery mullions, shows no shafts on the west wall of the inner vestibule. If this arcading existed in 1807, it is difficult to explain why the draftsmen of the *General Inventory*, so sensitive to other tracery survivals, failed to record it.

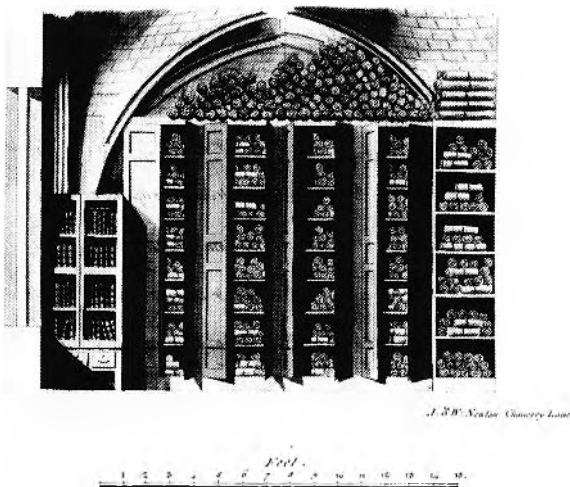
CHIEF CLERK'S OFFICE

FIGURE 8. Chapter House, Westminster Abbey, West Wall of the Inner Vestibule, 1807. London, Public Record Office, OBS 692.

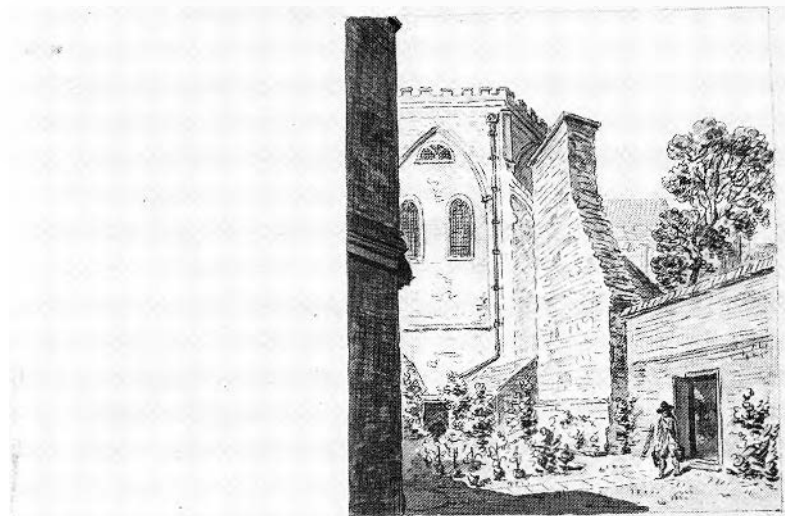
South view of the Chapterhouse of Westminster Abbey.

FIGURE 11. William Capon (?), South [actually southeast] view of the Chapter house of Westminster Abbey and Plan of the Undercroft of the Chapter house. London, Westminster Abbey Library, Drawer 7, IIB, 6 (Photo: courtesy the Dean and Chapter of Westminster Abbey).

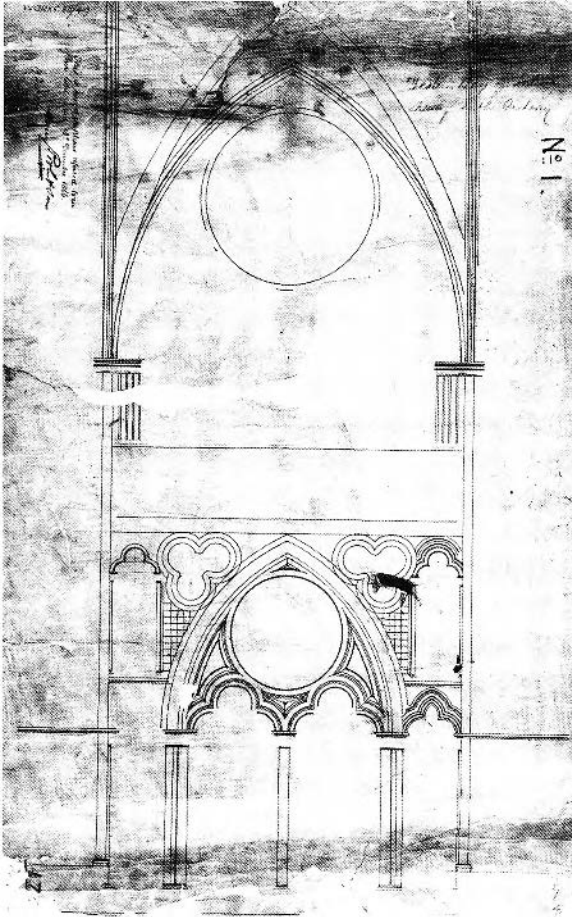
FIGURE 13. G.G. Scott, Chapter House, Westminster Abbey, Entranceway, 1866. London, Public Record Office, Works, 38/49.

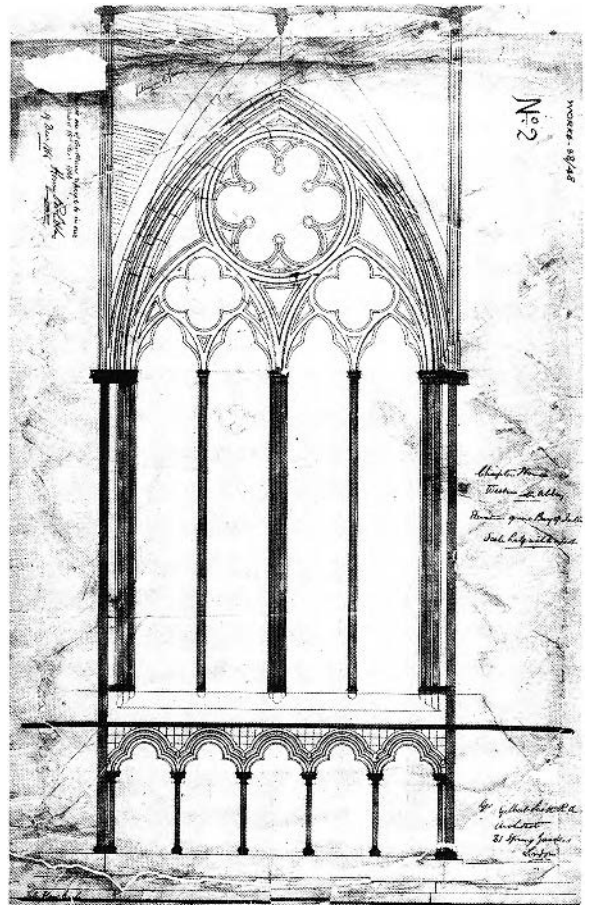
FIGURE 14. G.G. Scott, Chapter House, Westminster Abbey, Interior Elevation, 1866. London, Public Record Office, Works 38/48.

The second drawing (Fig. 14) shows the elevation of the other interior bays, the black Purbeck marble shafts being indicated with wash. Scott established the window design from original blind tracery which survived in the northwestern bay. In the section from the *General Inventory* (Fig. 4), blind tracery of four lights with quatrefoils appears clearly beyond the staircase while a portion of the sexfoil head peeks

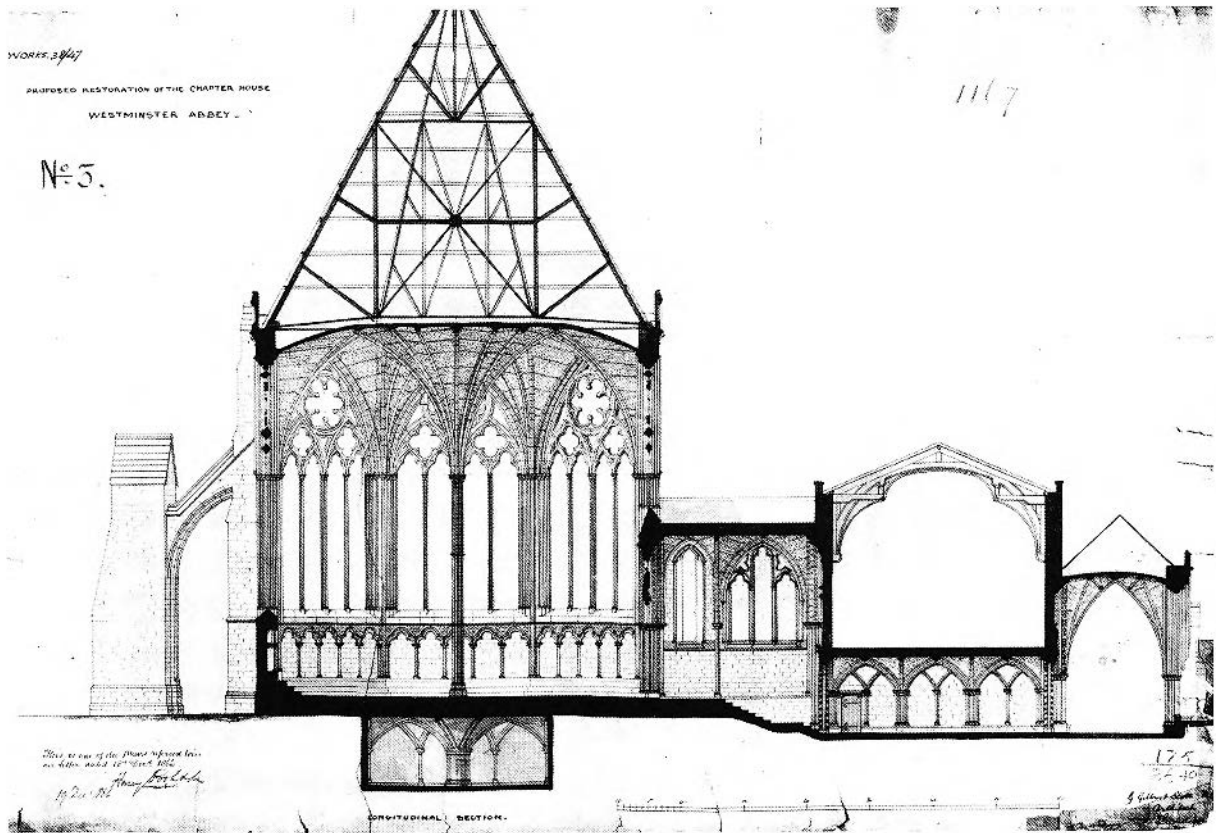
FIGURE 15. G.G. Scott, Chapter House, Westminster Abbey, Longitudinal Section. 1866. London, Public Record Office, Works 38/47.

The drawings numbered 3 and 4 show the longitudinal section and ground plan of the chapter house and vestibule (Figs. 15, 16). Scott had already removed the staircase leading to the chapter library from the northern aisle of the outer vestibule and rebuilt the destroyed vaults.⁴⁴ A view of 1782 shows that a portion of the wall arcade in the south aisle, along with the vaulting, had survived, and upon this Scott was able to base his restoration.⁴⁵ As shown in the section in the *General Inventory* (Fig. 4), original tracery with two pairs of twin lights and quatrefoils

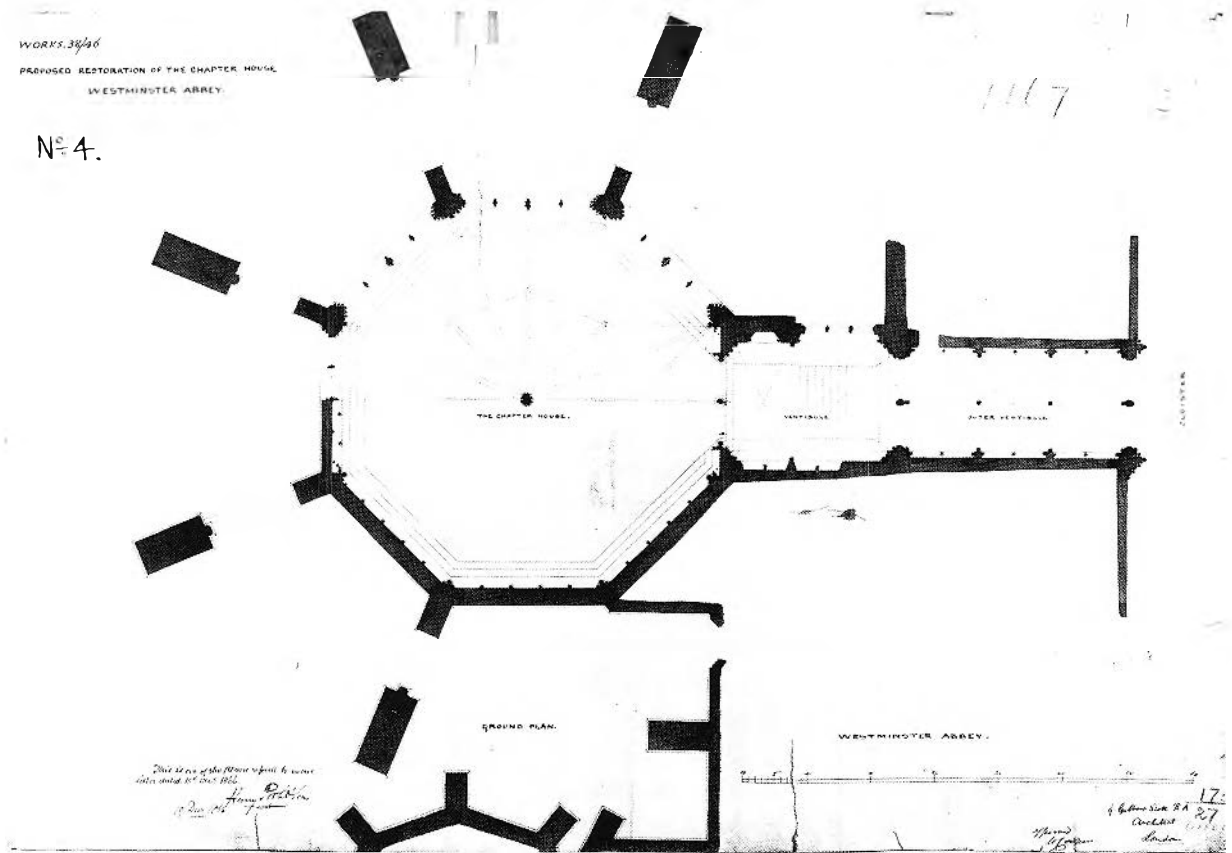
N^o 4.

FIGURE 16. G.G. Scott, Chapter House, Westminster Abbey, Ground Plan, 1866. London, Public Record Office, Works 38/46.
