The Chancel of St. Paul's Anglican Church, Halifax, Nova Scotia: Form Follows Convenience?

J. Philip McAleer

Volume 17, numéro 1, 1990

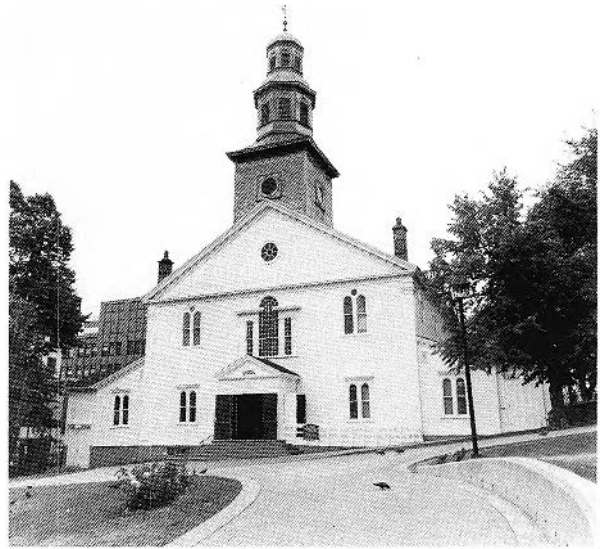
FIGURE 36. *St. Paul's*, Halifax. The (north) façade of 1812, as it appeared in 1987 (porch of the 1950s) (Photo: T.U.N.S./P. Toman).

During the century following its completion, St. Paul’s underwent only two significant alterations, both being expansions of the original rectangular box. An entrance vestibule containing new, more ample stairs to the galleries, and two rooms to be used as vestries were added at the north façade in

1812 (Fig. 36).¹⁶ In 1868, the church was enlarged again, this time laterally by the addition of an outer pair of aisles, the solution to a chronic shortage of pews (Fig. 37).¹⁷ Both of these additions were made for reasons of convenience. It is with some surprise that one notes there was no discussion about constructing a separate chancel during the 1840s, 1850s, or 1860s as a reflection of the ideas promulgated by the Ecclesiologists. Indeed, when a chancel was finally added in 1872, it too came as a result of concerns about “convenience,” and appears rather as an afterthought in the wake of the enlargement of 1868.
