## The Restorations of the Westminster Abbey Chapter House

Steven H. Wander

Volume 4, numéro 2, 1977

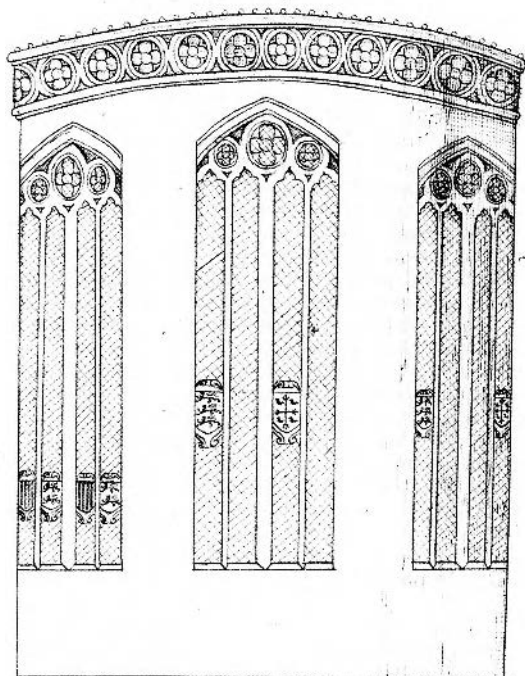
FIGURE 1. Chapter House, Westminster Abbey, early 17th century. Oxford, Bodleian Library, Rawlinson MS. C. 704, f. iii.

seventeenth-century manuscript (Fig. 1) includes a description: “The forme of the place wherein the Records are kepte in Westm. Abbey, called nowe the Threasurie. Yt is a round place like the Temple Church, with 6 or 7 longe windowes of greate height, 8 square within, and vaulted over, and a pillar of stone in the middest.” The shields-of-arms in the windows depict with some inaccuracies the arms of King Henry III (*gules three leopards or*), Saint Edward the Confessor (*a cross paly between five martlets or*), and Count Raymond of Provence (*or four pales gules*).<sup>11</sup> These escutcheons may copy original grisaille glass from the chapter house, but the tracery of all three windows shows a large quatrefoil head rather than the sexfoil depicted in later views. This inconsistency casts doubt not only on the authenticity of the window designs but also on the quatrefoil band encircling the building which is not illustrated elsewhere.

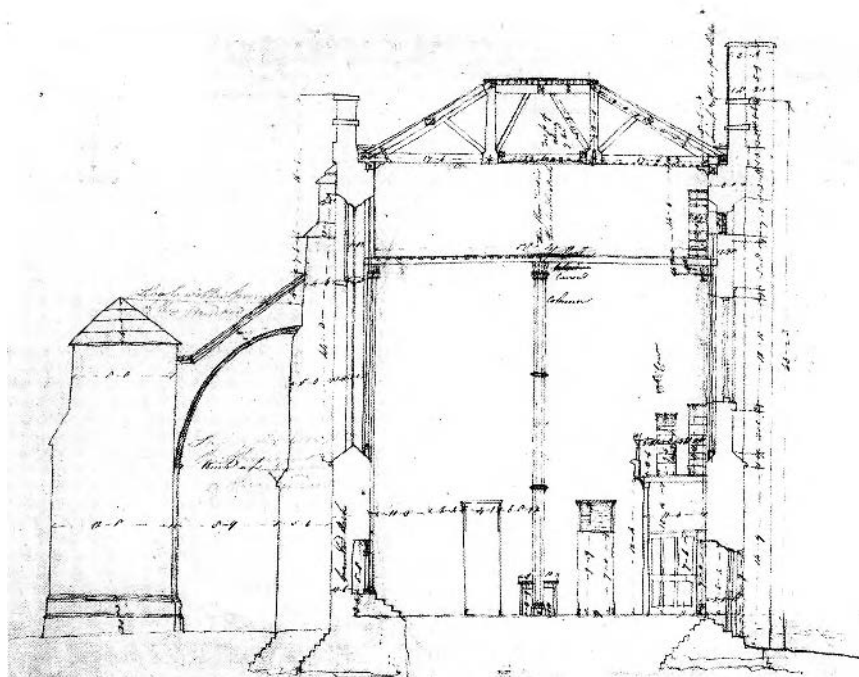
FIGURE 2. Chapter House, Westminster Abbey, Section, late 18th century. London, Royal Institute of British Architects Drawings Collection, J7/48.

A measured section along the east-west axis of the chapter house (Fig. 2) shows the effect of these successive restorations. A truss ceiling has replaced the mediaeval vaulting, and an attic storey now rests on the original vault springing. A raised passageway has been constructed around the interior, and both here and in the attic are presses for the records. Although not drawn in, the large mediaeval windows were closed by this time to provide additional support for the attic floor. In each of the six bays open to the outside a pair of round-headed windows and a lunette

replaced the original tracery. The openings for these windows, along with their dimensions, are indicated on the right-hand edge of the building; even the projecting bottom sill of the round-headed windows is shown. The recessed eastern arcade is inscribed “painted back” while the flying buttress is described as “bricked-up.” An exterior view (Fig. 3) clearly shows both the bricked-up windows and the buttresses along with the additional entrance that had been pierced through the north chapter house bay for direct access to the record office in 1755/56.<sup>29</sup> Both this view and the section must date from before 1800. In that year James Wyatt was commissioned to add a building to the chapter house for additional office space.<sup>30</sup> As shown in section and plan from the *General Inventory of all the Records and other Public Documents preserved in the Chapter House at Westminster* of 1807 (Figs. 4, 5), Wyatt erected two offices with pent roofs and round-headed windows against the eastern and northeastern bays of the chapter house, sandwiched between the projecting wall buttresses.

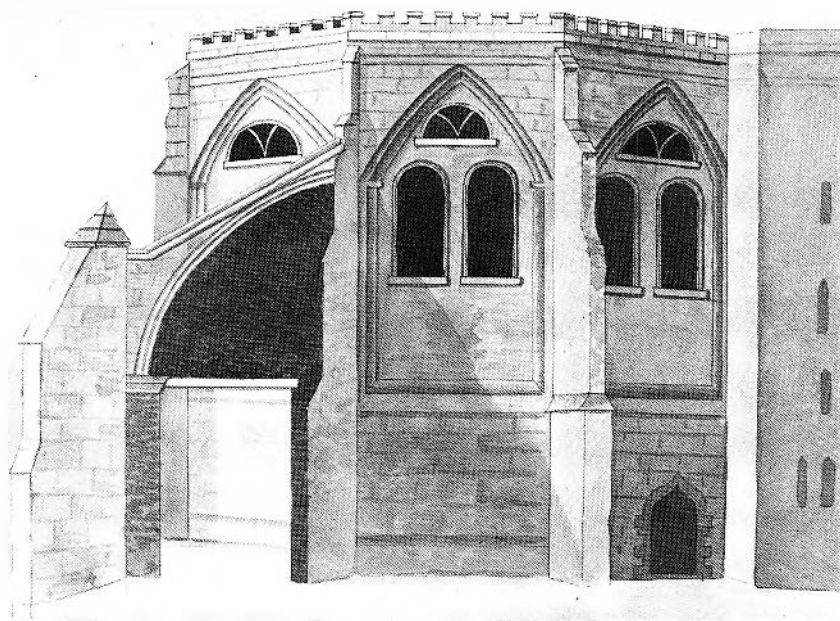
FIGURE 3. Chapter House. Westminster Abbey, late 18th century. London, British Museum, Department of Prints and Drawings, *Pennant*, III, 82.

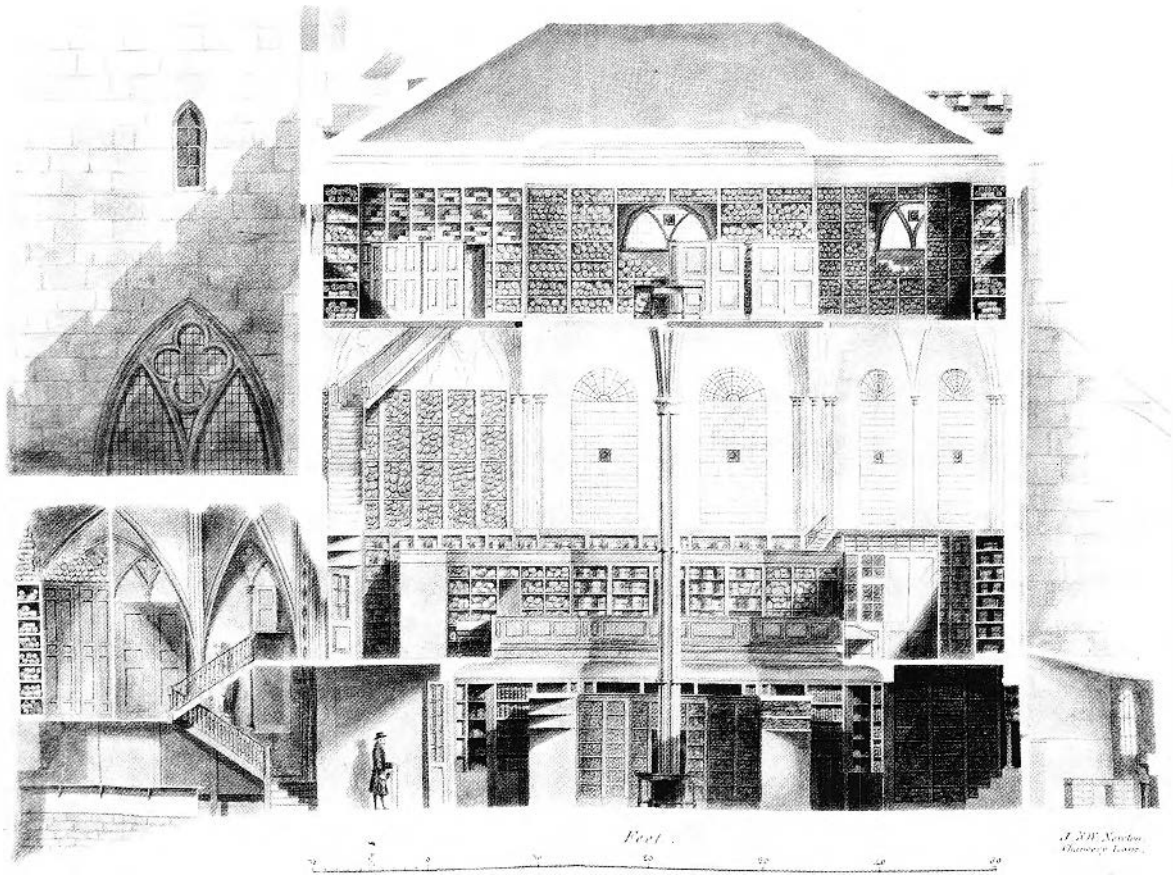
FIGURE 4. Chapter House, Westminster Abbey, Section, 1807. London, Public Record Office, MPB 2/99/1 (formerly OBS 692).

The second drawing (Fig. 14) shows the elevation of the other interior bays, the black Purbeck marble shafts being indicated with wash. Scott established the window design from original blind tracery which survived in the northwestern bay. In the section from the *General Inventory* (Fig. 4), blind tracery of four lights with quatrefoils appears clearly beyond the staircase while a portion of the sexfoil head peeks

from behind a door in the adjacent attic storey. In addition, some mediaeval tracery mullions survived, as for example the one shown bricked-up in the northeastern window. The *General Inventory* plan (Fig. 5) reveals that all the bases of the wall arcade shafts had survived, despite the openings made through the wall into Wyatt's offices and the North Walk.

rebuild the window with tracery identical to the other chapter house windows. The central shaft of the doorway (Figs. 4, 5) had disappeared, and Scott here introduced a pair of trefoil arches and oculus in which were eventually placed back-to-back figures of God the Father — no doubt to many the most disturbing feature of Scott's restoration. During construction Scott replaced these round trefoil arches with acutely pointed ones similar in profile to the arch at the right of the entrance. The arches and trefoils above contained the thirteenth-century *Annunciation* group with censuring angels which had survived *in situ* behind record office presses.<sup>43</sup>

The drawings numbered 3 and 4 show the longitudinal section and ground plan of the chapter house and vestibule (Figs. 15, 16). Scott had already removed the staircase leading to the chapter library from the northern aisle of the outer vestibule and rebuilt the destroyed vaults.<sup>44</sup> A view of 1782 shows that a portion of the wall arcade in the south aisle, along with the vaulting, had survived, and upon this Scott was able to base his restoration.<sup>45</sup> As shown in the section in the *General Inventory* (Fig. 4), original tracery with two pairs of twin lights and quatrefoils

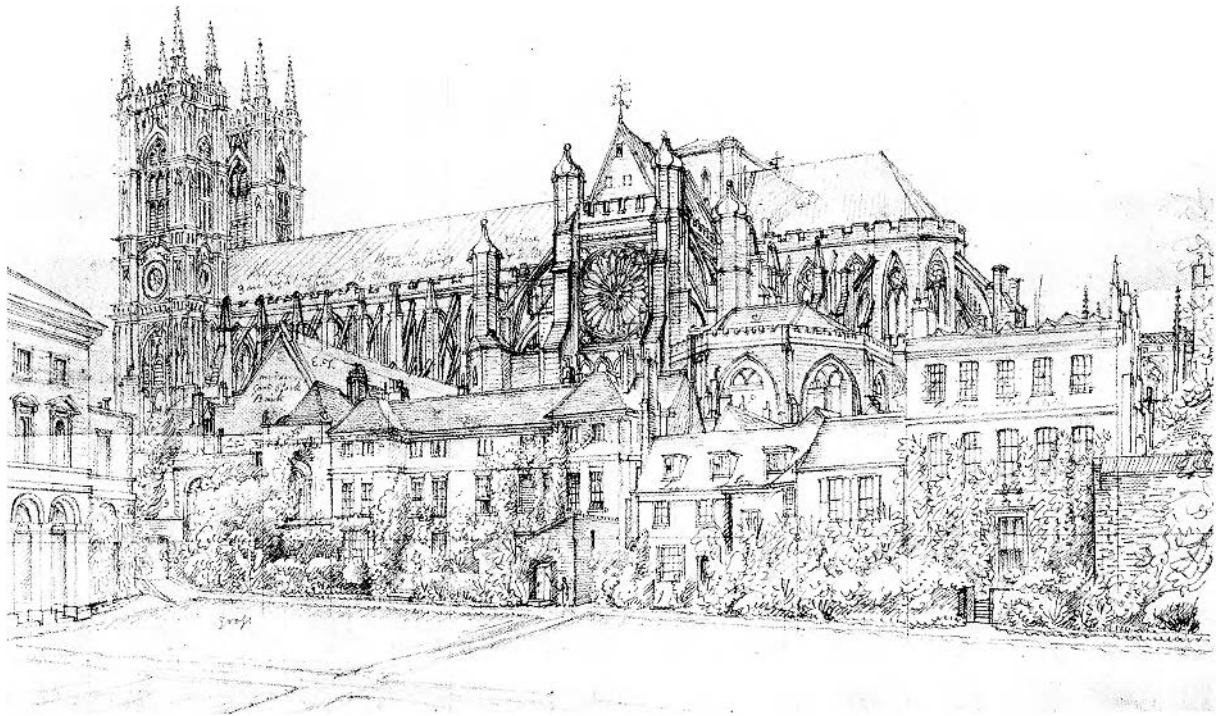
FIGURE 7. William Capon, *Westminster Abbey*, 1819. London, British Museum, Department of Prints and Drawings, *Crace Views of London*, portfolio XIV, no. 86.

1819 by William Capon (Fig. 7), houses flanked the southern edge of the chapter house, and by the beginning of the eighteenth century outbuildings of the prebendal houses along the north walk of the Little Cloister already abutted against the walls and buttresses of the chapter house.<sup>31</sup> The plan of these outbuildings is included in a report by John Soane from 20 May 1825 (Fig. 9). Soane recognized that these outbuildings posed a serious threat of fire to the contents of the record office “from the materials with which some of them are constructed (*viz.* wood, and lath and plaster) and the manner in which the chimnies of most of them are situated with respect to the windowes of the chapter house.”<sup>32</sup> According to a letter of 31 December 1832 from Edward Blore, architect to Westminster Abbey, the most dangerous outbuildings were taken down in 1826;<sup>33</sup> but since

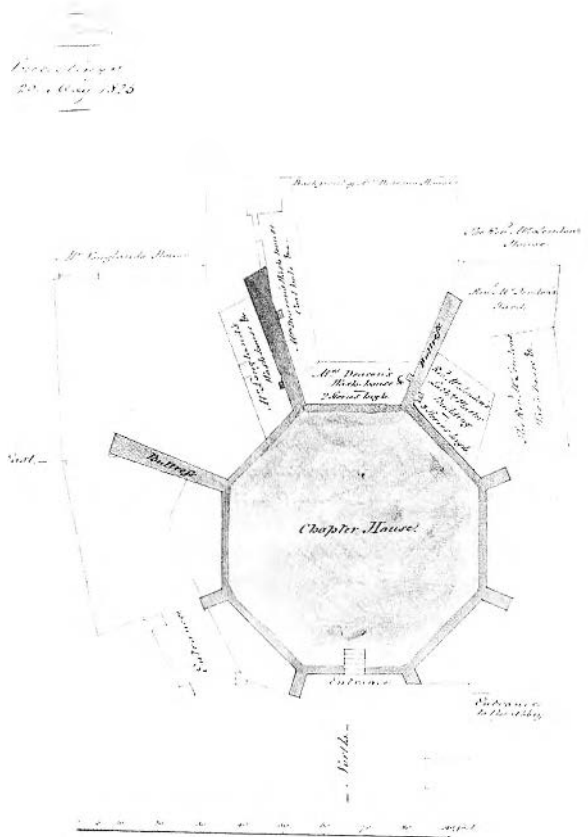
FIGURE 9. John Soane, *Chapter House Precinct Plan, Westminster Abbey*, 1825. London, Public Record Office, Works, 1/13, 348.

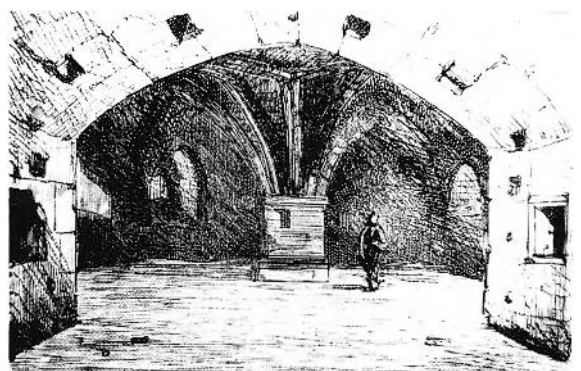
FIGURE 10. H.W. Brewer, *The Chapter House Crypt, Westminster Abbey*. From *The Graphic*, 13 August 1881.

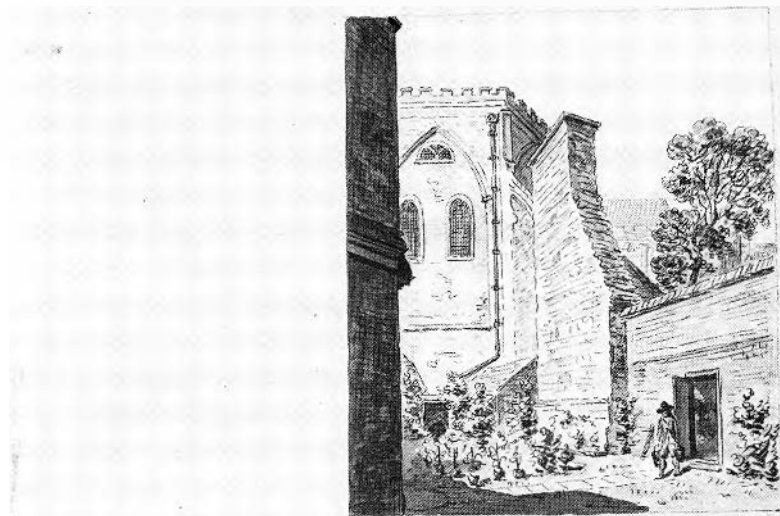
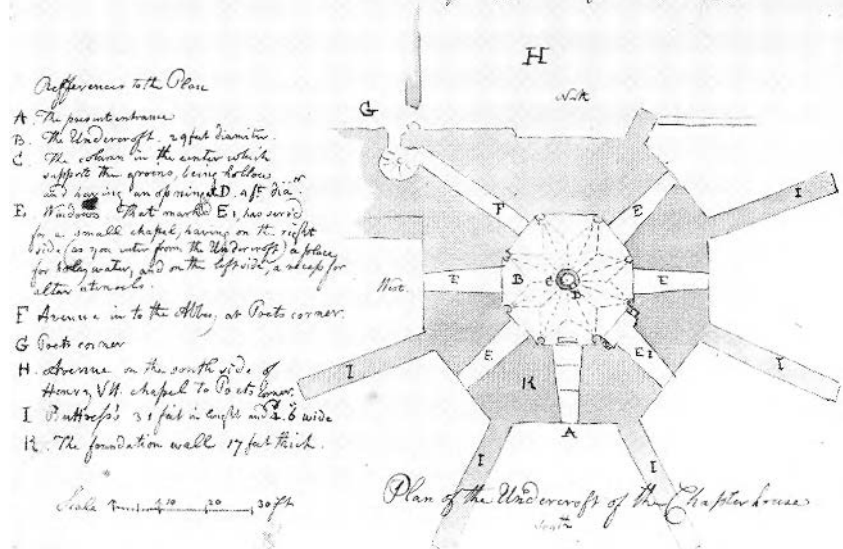
South view of the Chapterhouse of Westminster Abbey.

FIGURE 11. William Capon (?), South [actually southeast] view of the Chapter house of Westminster Abbey and Plan of the Undercroft of the Chapter house. London, Westminster Abbey Library, Drawer 7, IIB, 6 (Photo: courtesy the Dean and Chapter of Westminster Abbey).

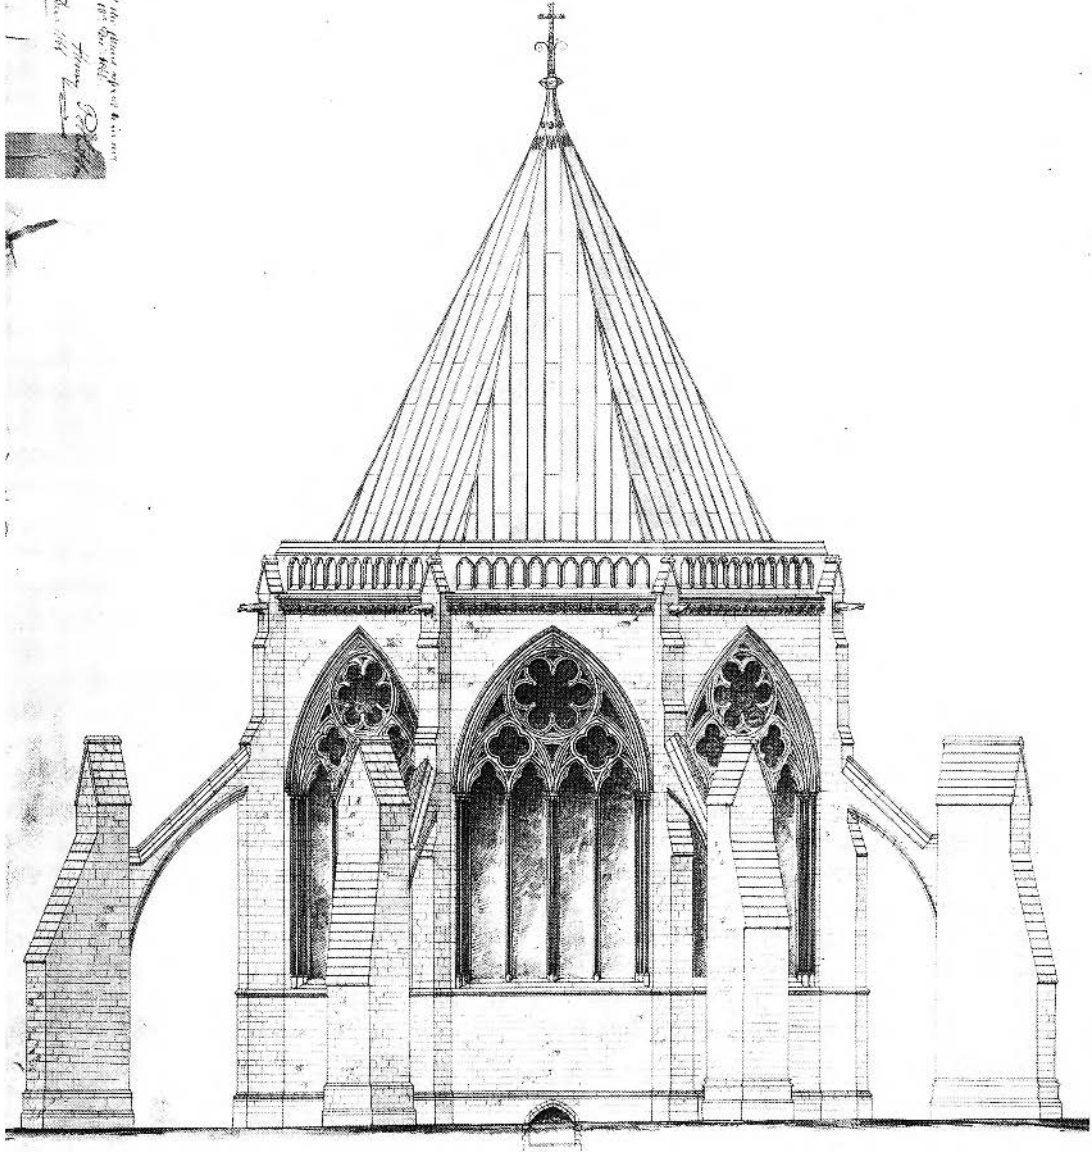
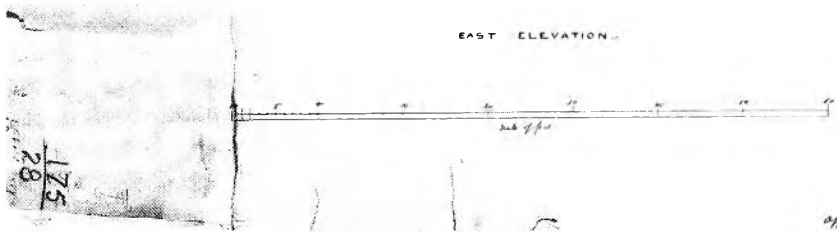
FIGURE 17. G.G. Scott, Chapter House, Westminster Abbey, East Elevation, 1866. London, Public Record Office, Works 38/50.

The fifth drawing of 1866 (Fig. 17) shows the eastern view of the exterior of the chapter house crowned by Scott's pyramidal roof. Scott reintroduced tracery into the blocked windows and, along with replacing the buttress at the northeast corner, redesigned the flyers. The wall buttresses were provided with elegant gable caps similar to those of the flyers and with water spouts in the form of gargoyles. At the summit of the wall, Scott substituted a parapet of blind arcading for the older battlements "of brick, with a stone coping."<sup>51</sup> During the course of construction, Scott altered the design of this parapet by introducing diaperwork panels and adding tall pinnacles at the corners to continue the vertical lines of the wall buttresses.
