## The Lesson of the Quebec Bridge

Wilfred G. Lockett

Volume 11, numéro 2 (33), automne–hiver–autumn–winter 1987

## THE LESSON OF THE QUEBEC BRIDGE

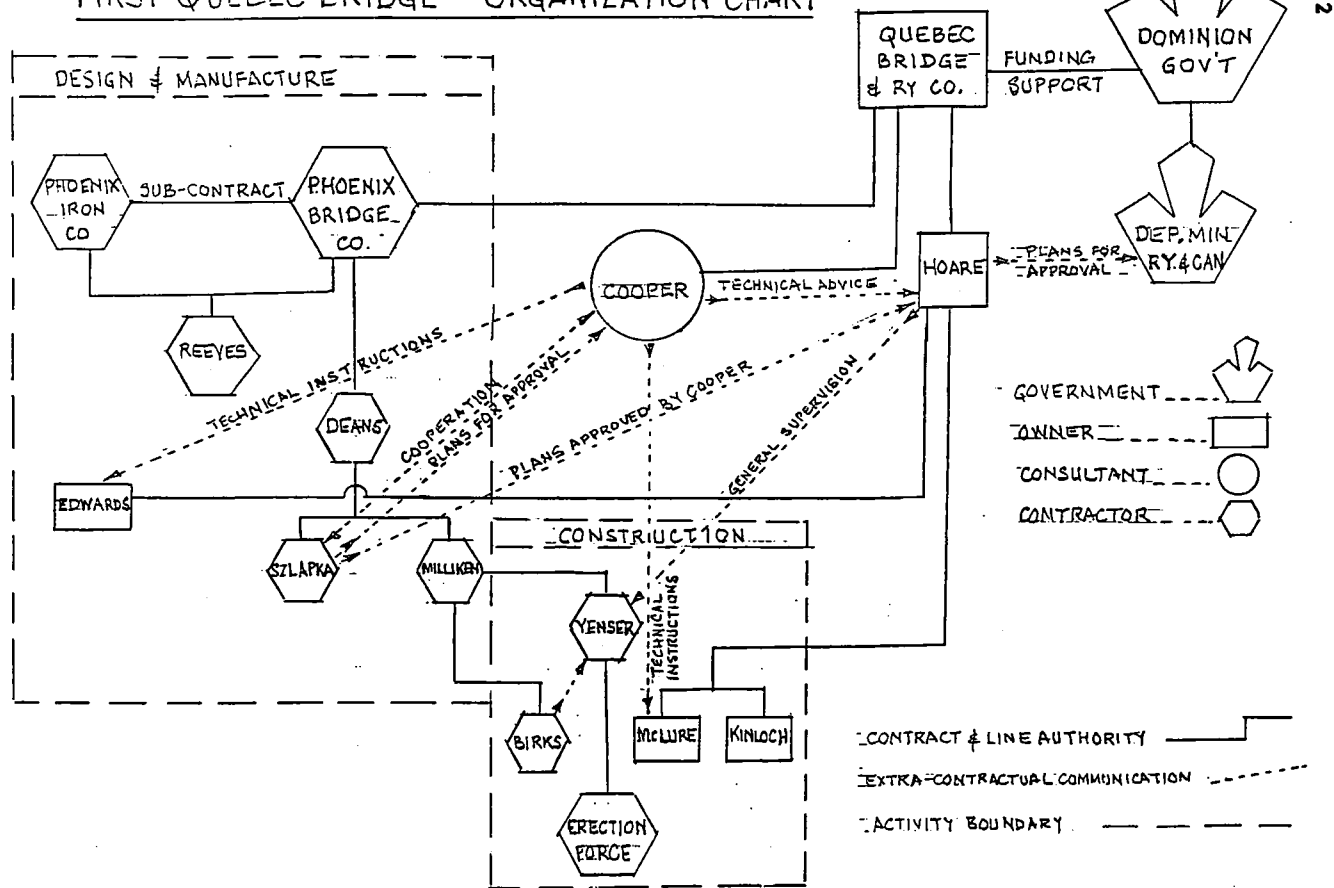
FIGURE 4

The organization which evolved to carry out the design and construction of the bridge is illustrated in the diagram on Figure 4.[11]. The Company's Chief Engineer, E.A. Hoare, was in principle the senior man on the whole project, responsible to the Company for final decision-making, at least in technical matters. But his lack of experience in major bridges led him to defer greatly to the Consulting Engineer, Cooper, who effectively assumed the reins of Chief Engineer.

The Organization Chart shows the formal procedure for approval of plans: Szlapka -> Cooper -> Szlapka -> Hoare -> Deputy Minister. In practice, as indicated in a table of dates at which various operations were performed,[12] when approved drawings were

# FIRST QUEBEC BRIDGE - ORGANIZATION CHART

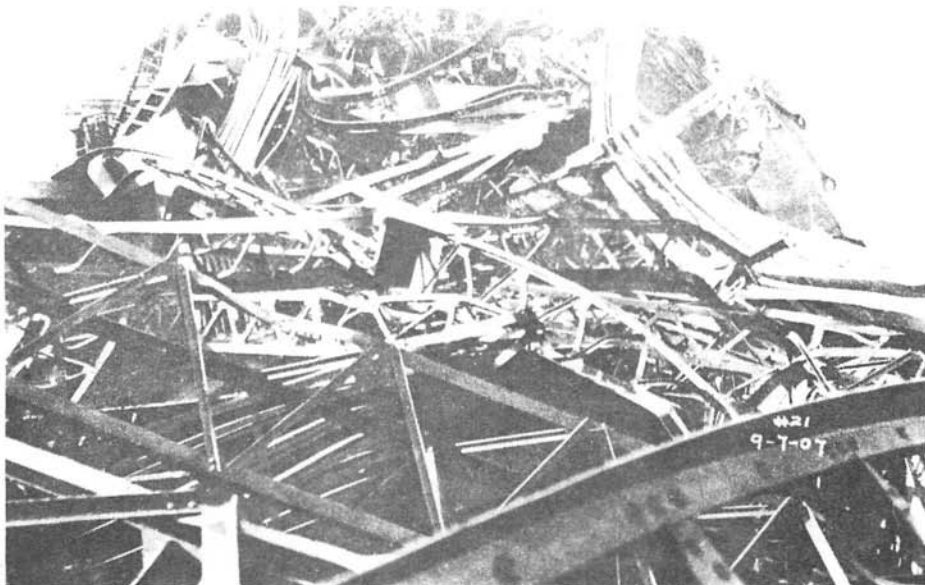
Cooper instructed McLure to discuss the problem with Deans. McLure's arrival in Phoenixville, at about 5.00 pm on Thursday, 29 August, coincided with the collapse into a tangled heap of the whole superstructure, taking the lives of 74 men, including Yenser and Birks. (Figures 7)

Figure 7(a) Wreckage, looking south [top]; 7(b) looking north
